Stinemire Engineering
John Stinemire, P.E.
Consulting Engineer
208 Broadway, PO Box 1206 Port Ewen, New York 12466
Telephone (845) 331-8806
Fax (845) 331-4890

July 19, 2023

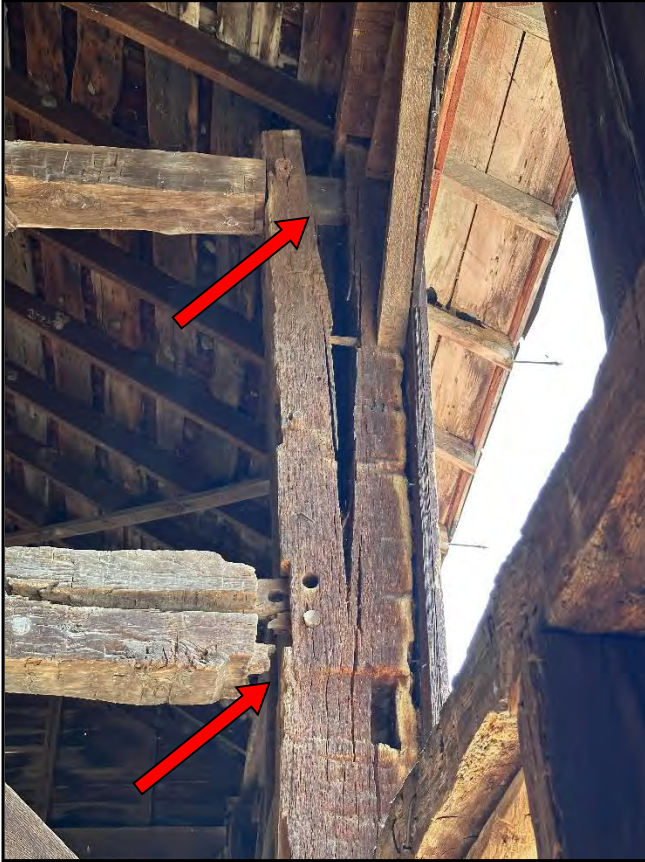
Photo 3-Barn 1:
View of crack in Eastern post of the middle bent in Barn 1. The lower connection at this bent has also failed.

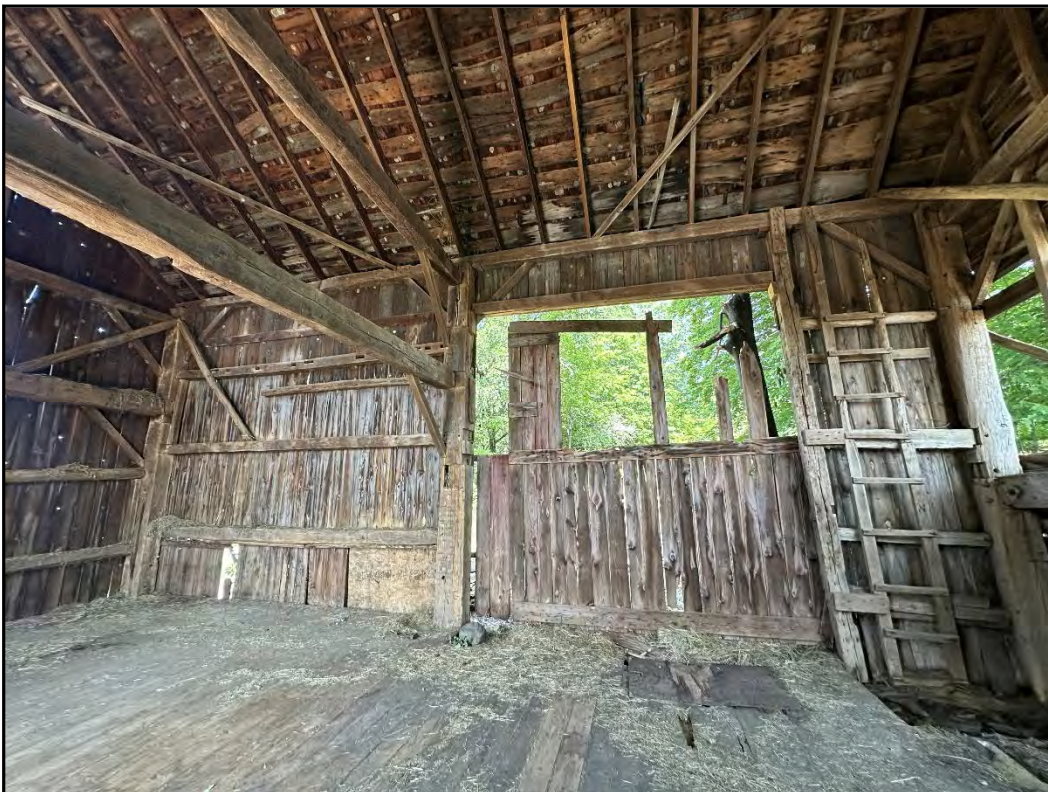
Photo 4-Barn 1:
View of Western wall with non-functioning door. All walls at this level contain little-to-no lateral bracing.

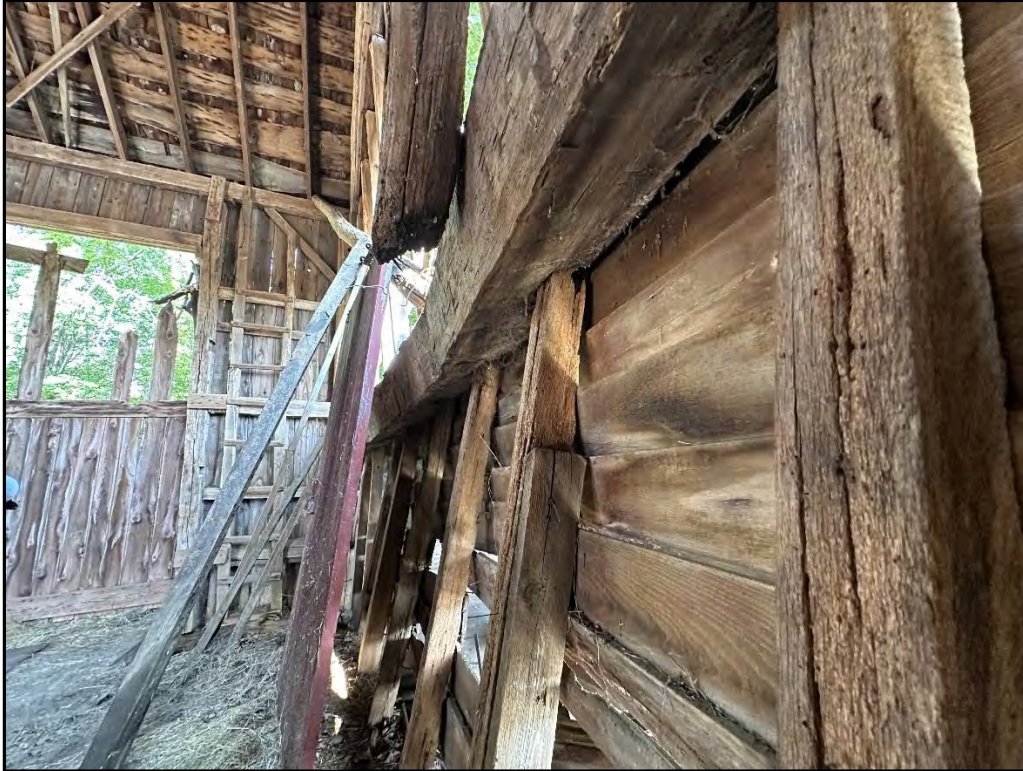
Photo 5-Barn 1:
View of significant movement and deterioration in the Northern bent.

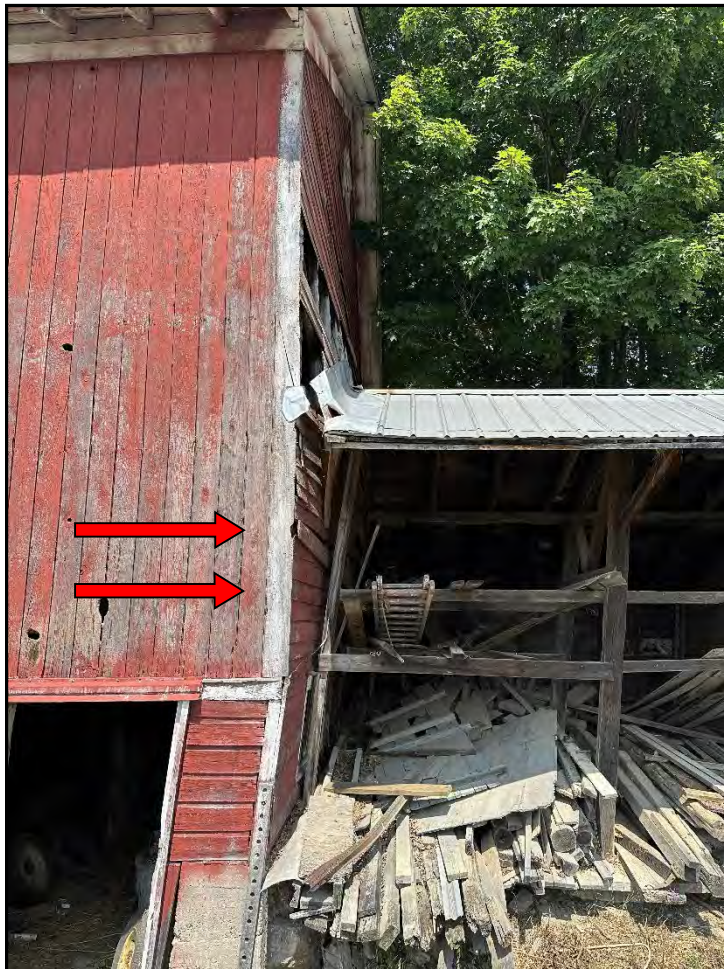
Photo 6-Barn 1:
Exterior view of lateral movement to the North. The adjacent pole barn has pulled the northern wall of Barn 1 outward.

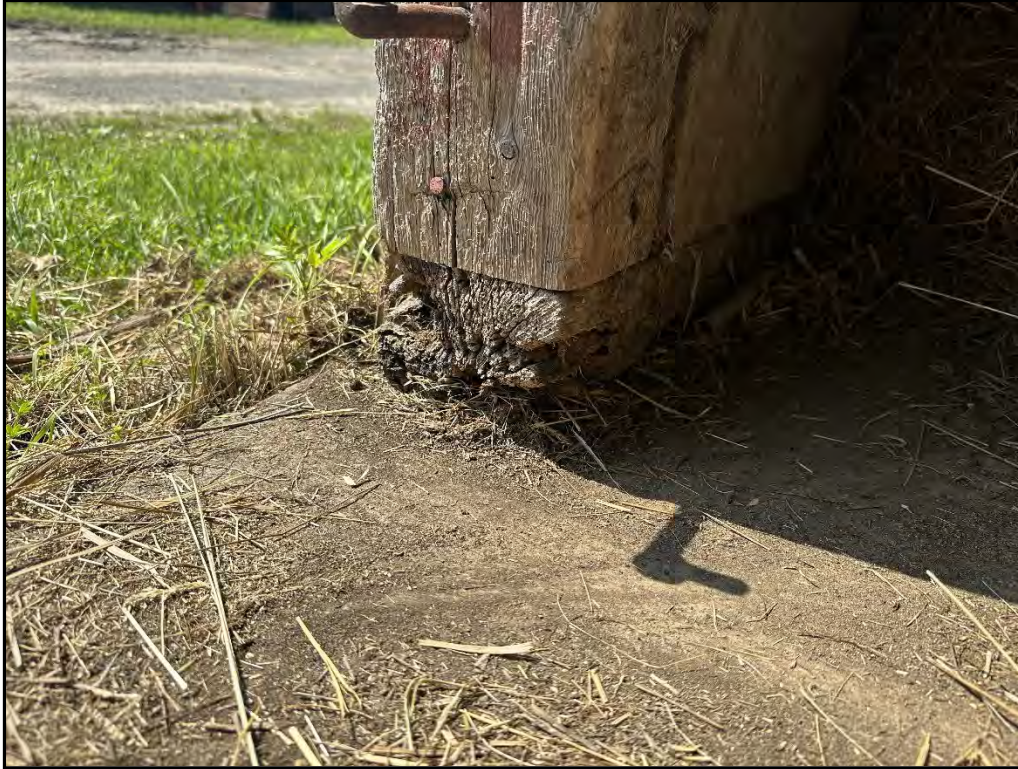
Photo 7-Barn 1:
View of deteriorated sill plate in Barn 1. This has caused significant settlement to the building.

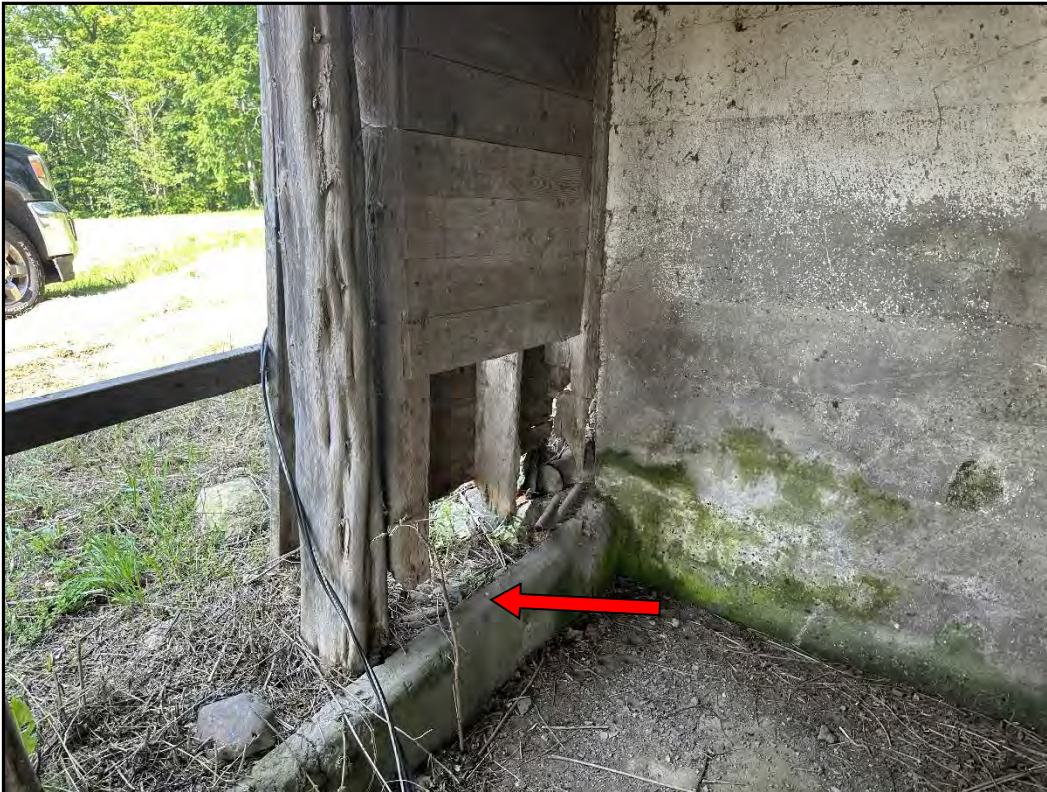
Photo 8 Barn 1:
View of wall studs significantly deteriorated an no longer in contact with the sill plate or the ground.

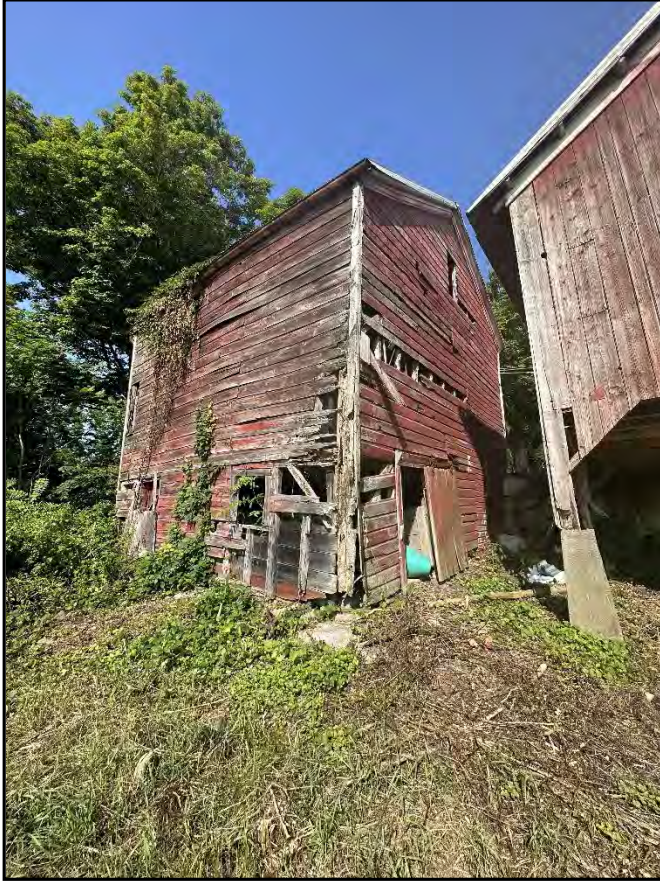
Photo 9-Barn 2:
Overall view of Barn #2
from the lower side.

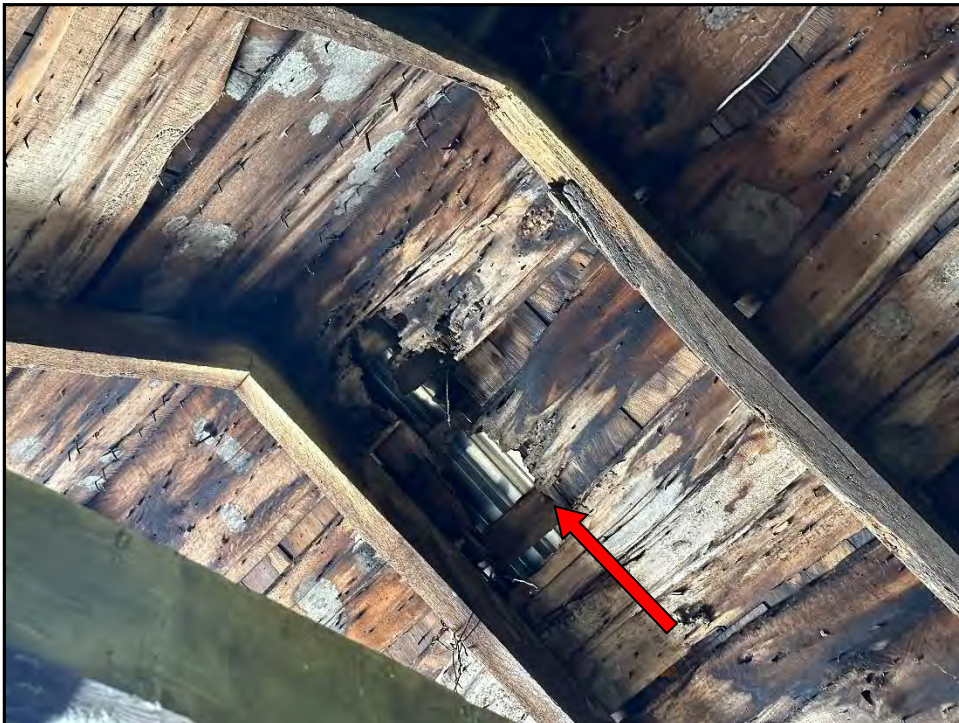
Photo 10-Barn 2:
View of undersized rafters
with no ridge board in
Barn 2. Significant
deflection is present and
some rafters show signs of
section loss.
Also view of highly
deteriorated roof sheathing
that has been covered with
corrugated metal roofing.
This condition is typical
throughout.

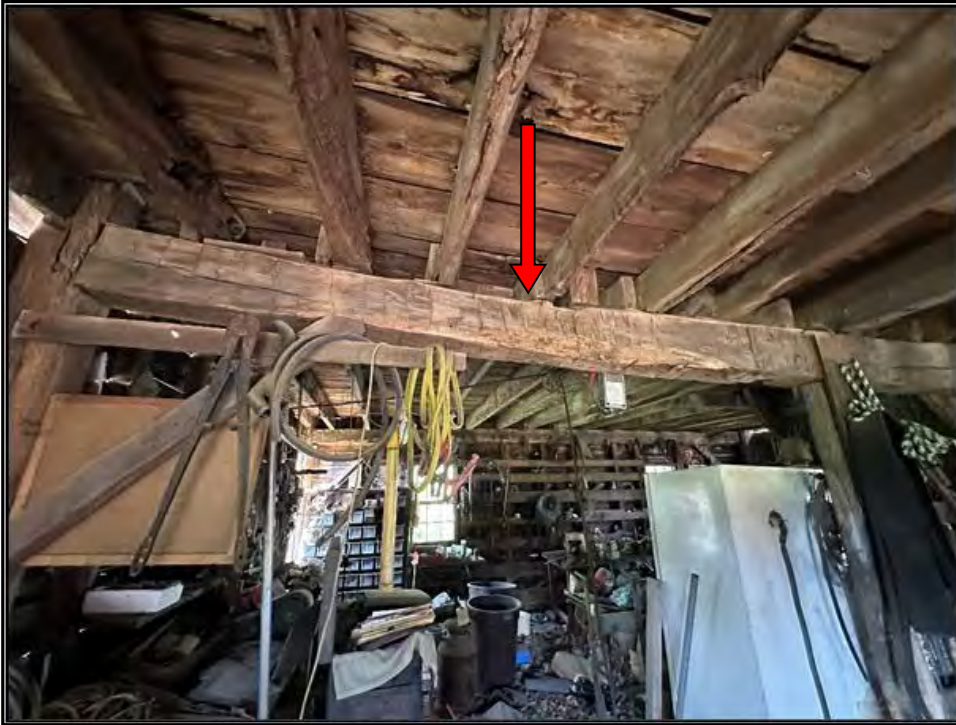
Photo 11-Barn 2:
View of Barn 2 support
beam exhibiting
significant deflection.

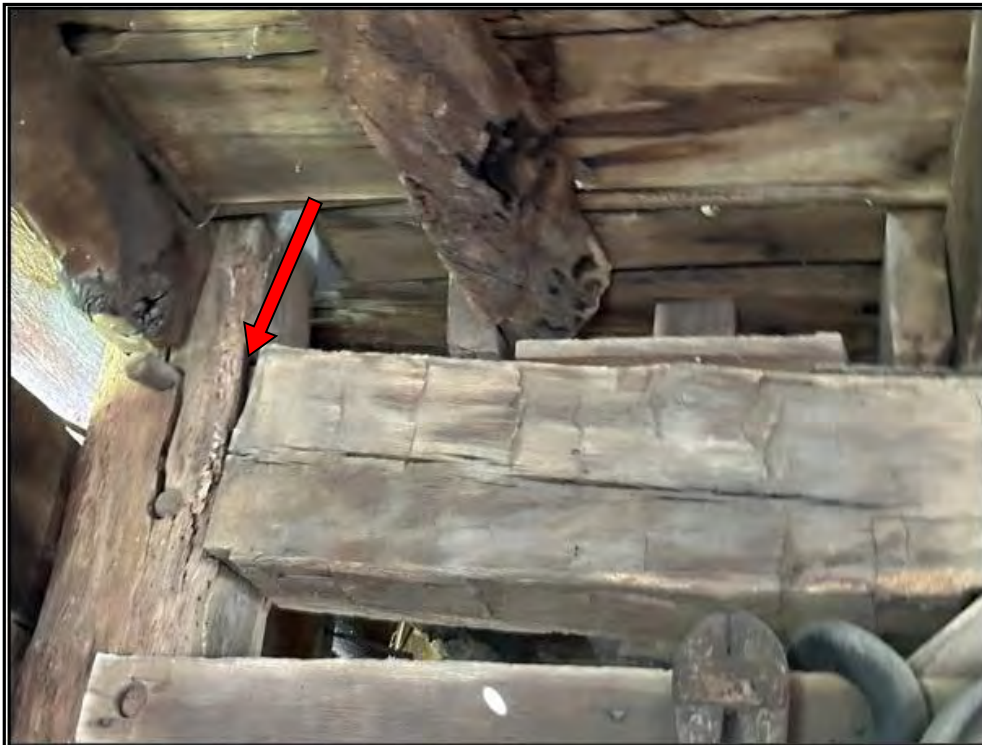
Photo 12-Barn 2:
View of failing main
support beam connection.

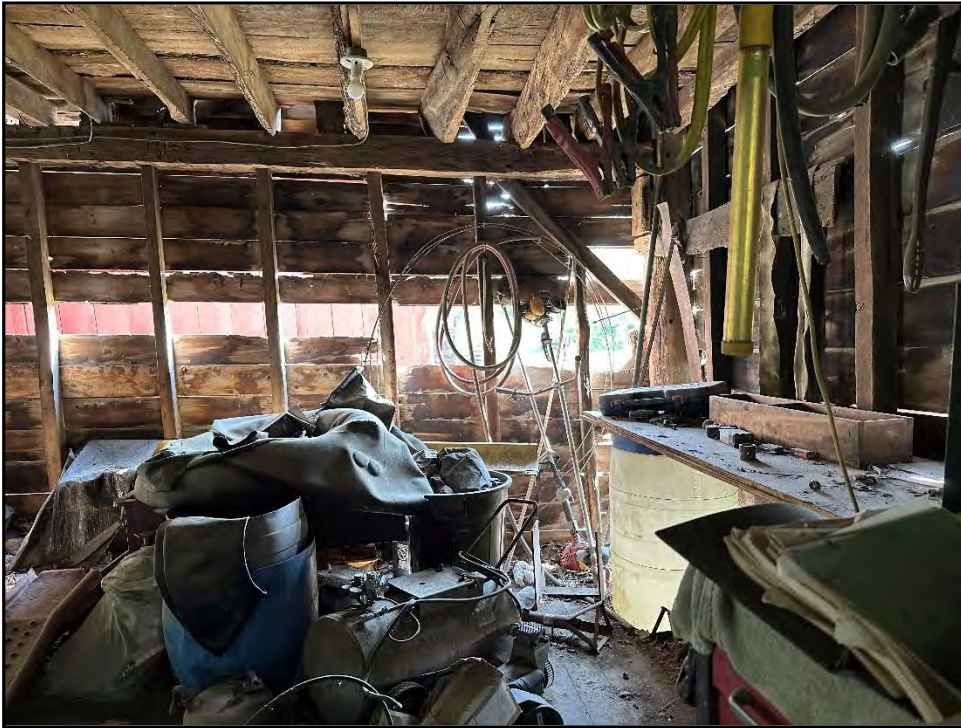
Photo 13-Barn 2:
View of wall with missing sheathing. This has allowed the building to be subject to rain, snow, and sun exposure.

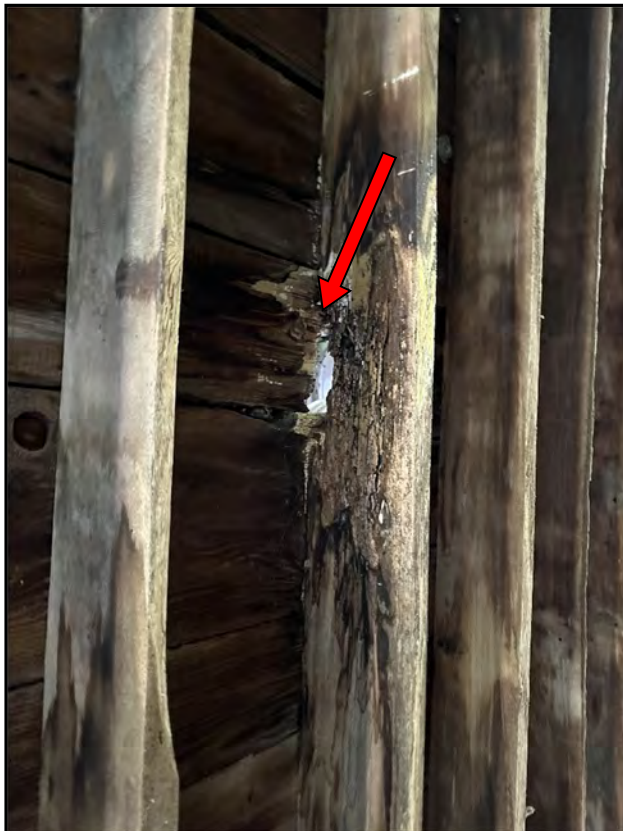
Photo 14-Barn 2:
View of wall stud exposed to a gap in sheathing. Stud is crumbling and has lost $\pm 30\%$ of its section.

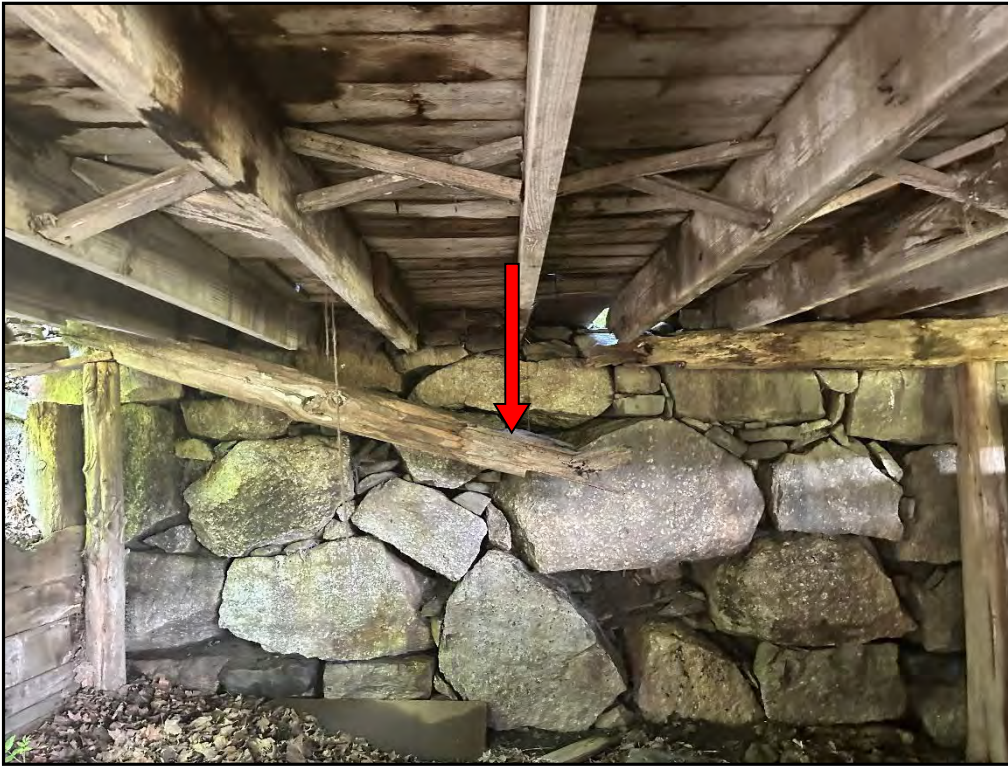
Photo 15-Barn 2:
View of stone retaining wall with no mortar and visible gaps. View of edge support beam that has dynamically failed.

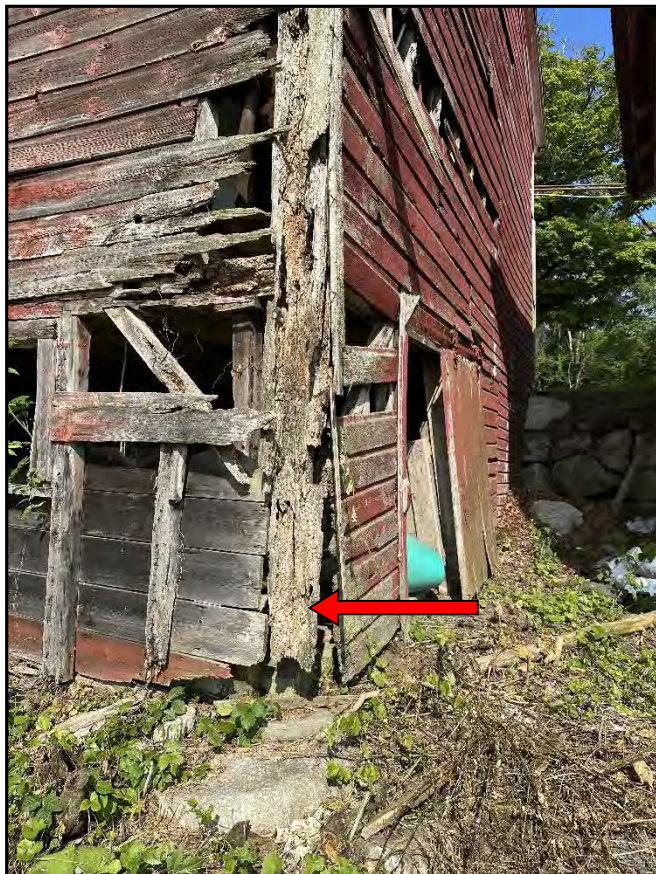
Photo 16-Barn 2:
View of highly deteriorated corner support post. The post is no longer in contact with the ground. This level of deterioration is typical throughout.

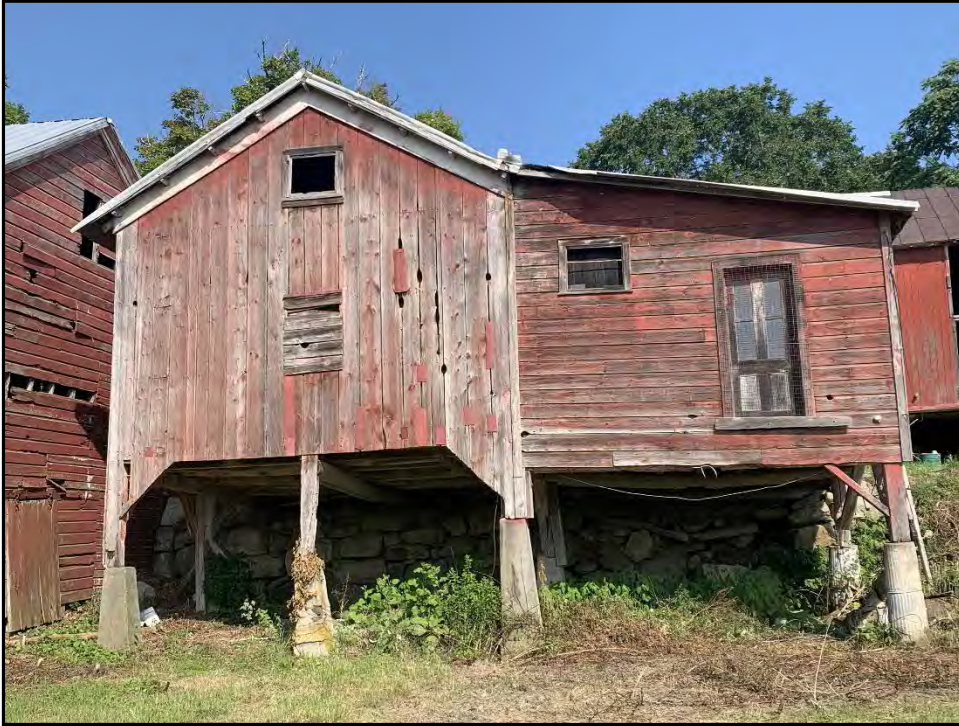
Photo 17-Barn 3:
Overall View of Barn 3.

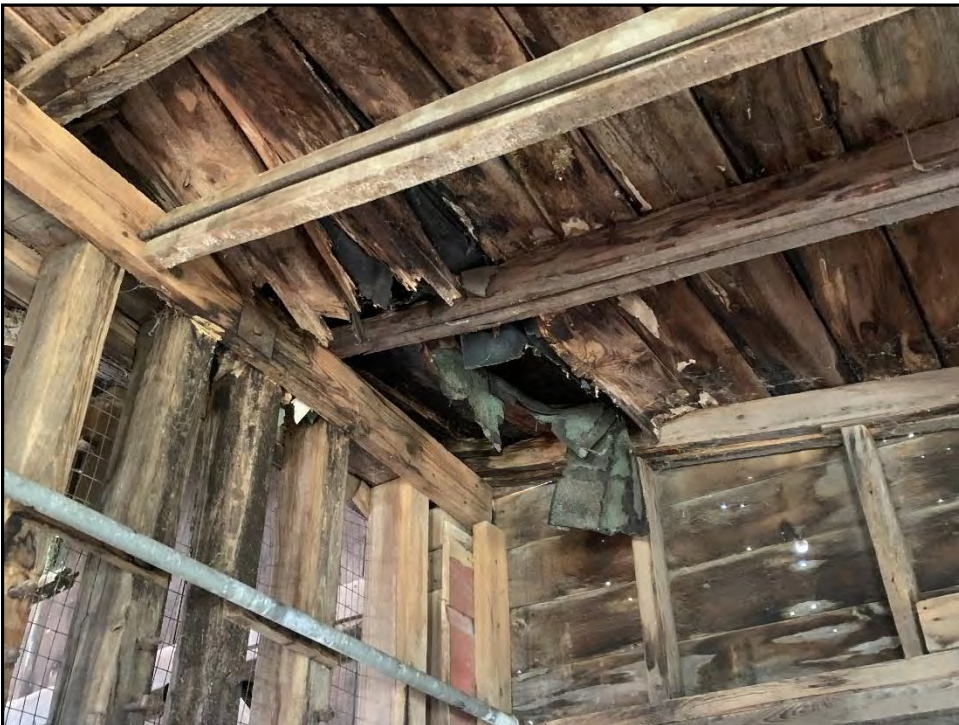
Photo 18-Barn 3:
View of highly
deteriorated roof
sheathing.

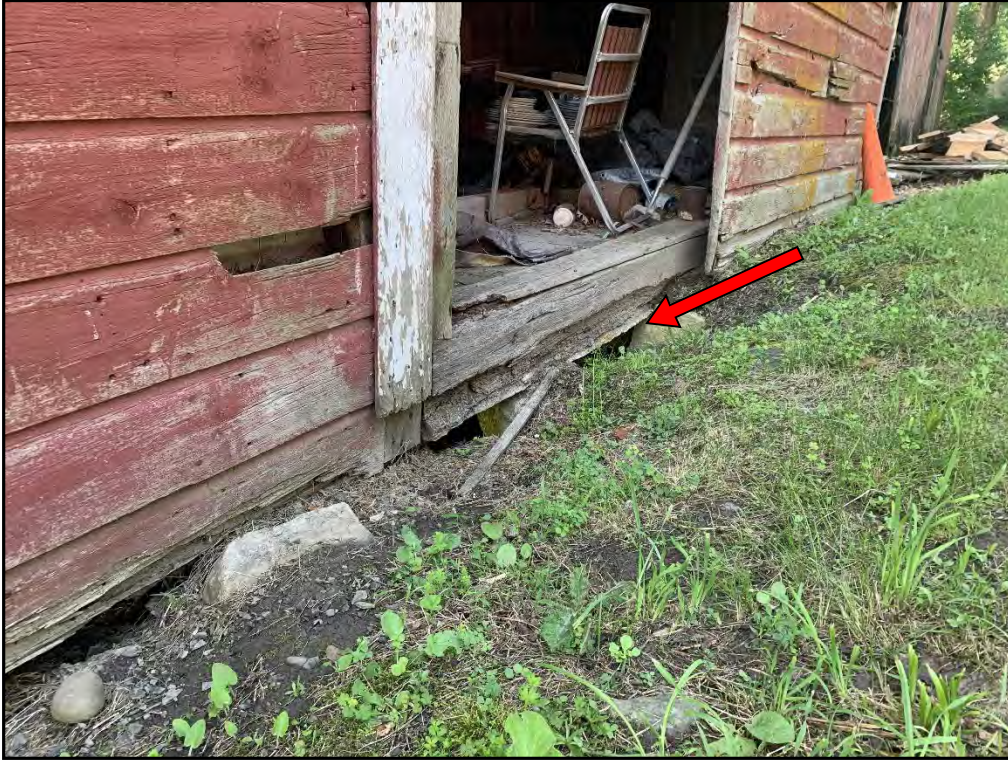
Photo 19-Barn 3:
View of erosion at the deteriorated sill of Barn 3. This is creating a gap between the stone retaining wall and the wall of the barn.

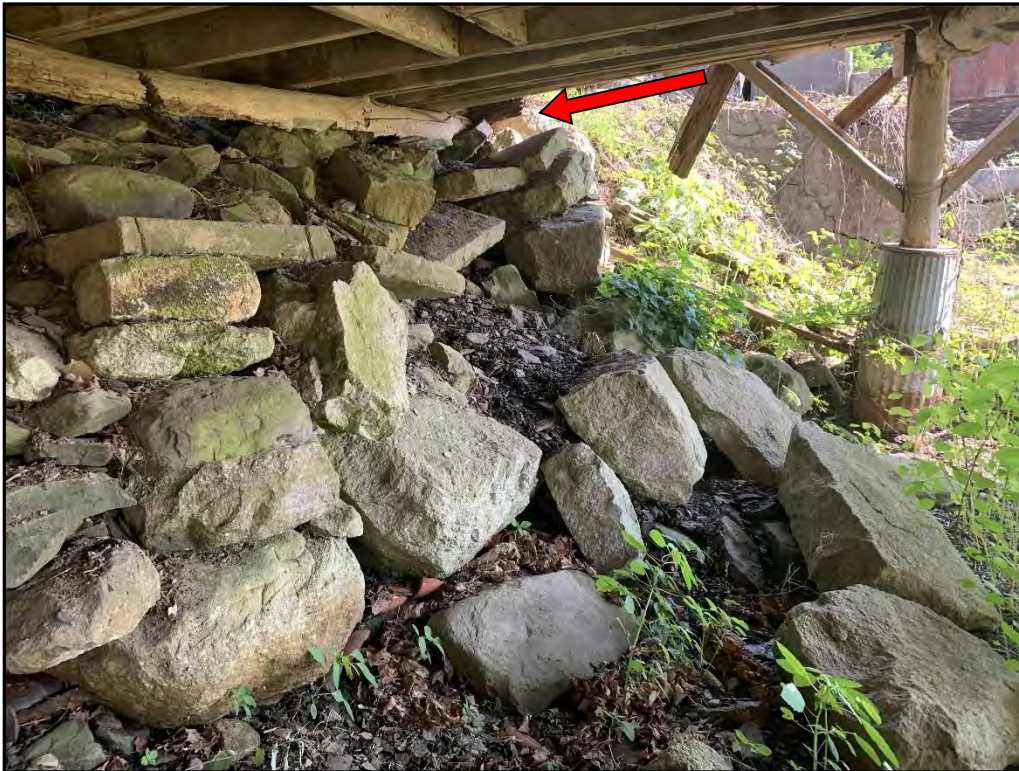
Photo 20-Barn 3:
View of stone retaining wall at Barn 3. The wall has failed and caused significant settlement to the building.

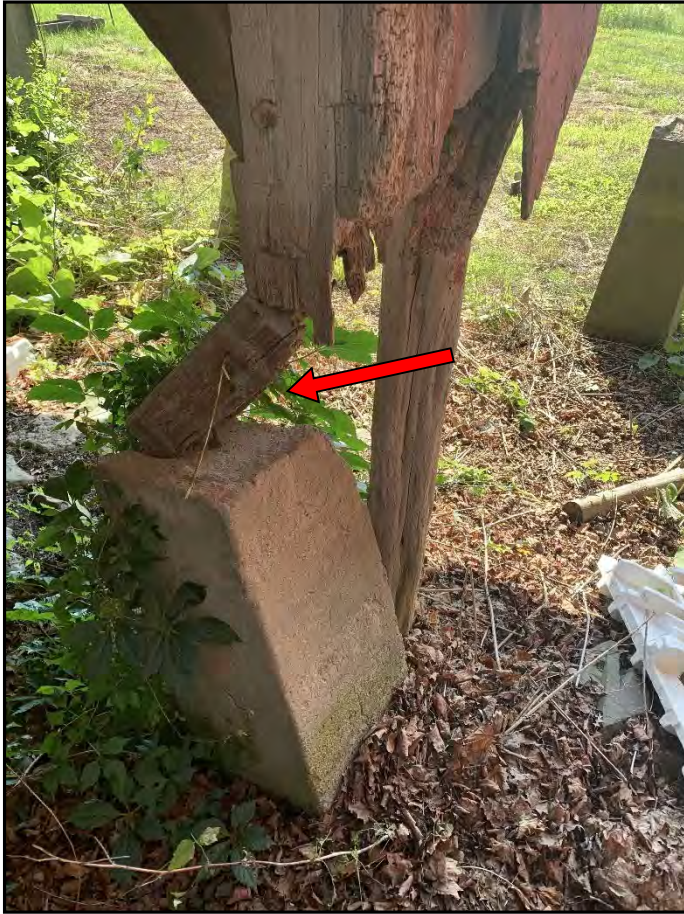
Photo 21-Barn 3:
View of failing concrete pier. Framing above this location is essentially unsupported.

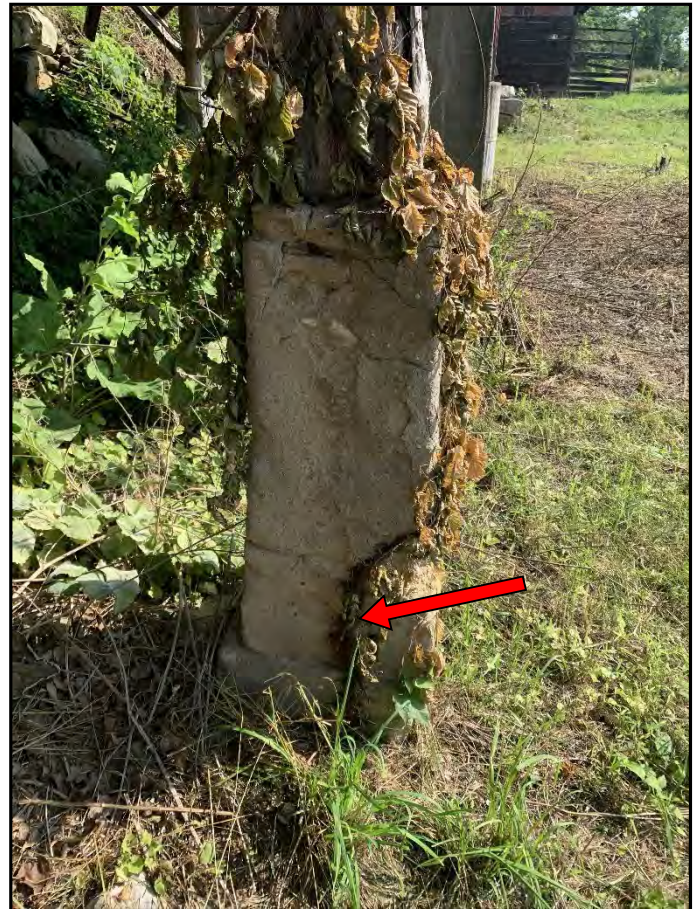
Photo 22-Barn 3:
View of cracked concrete pier.

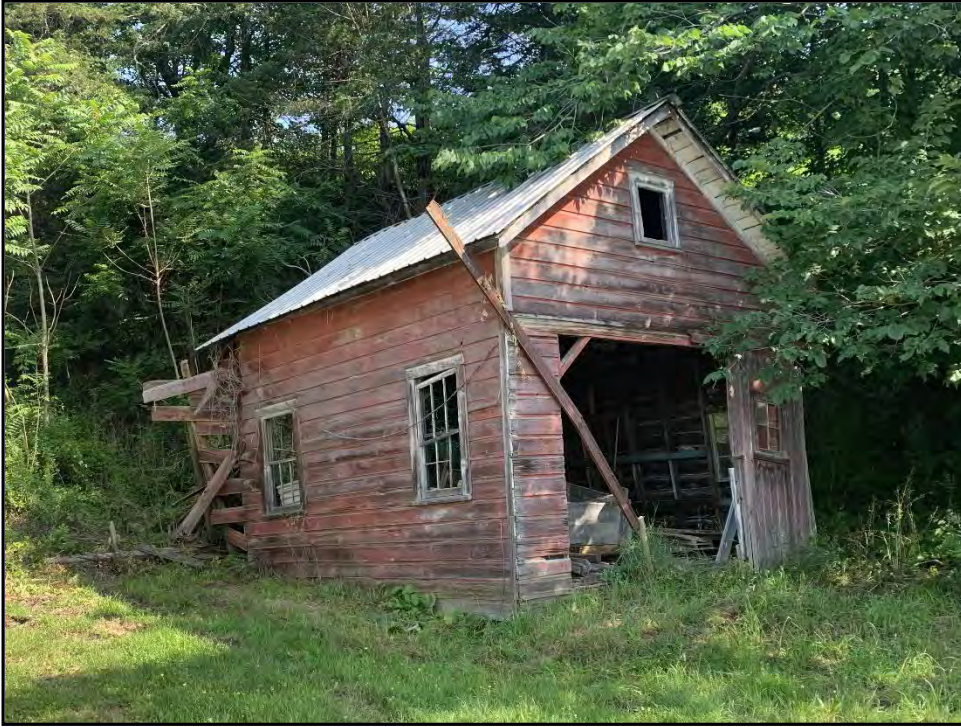
Photo 23-Barn 4:
Overall view of Barn 4.

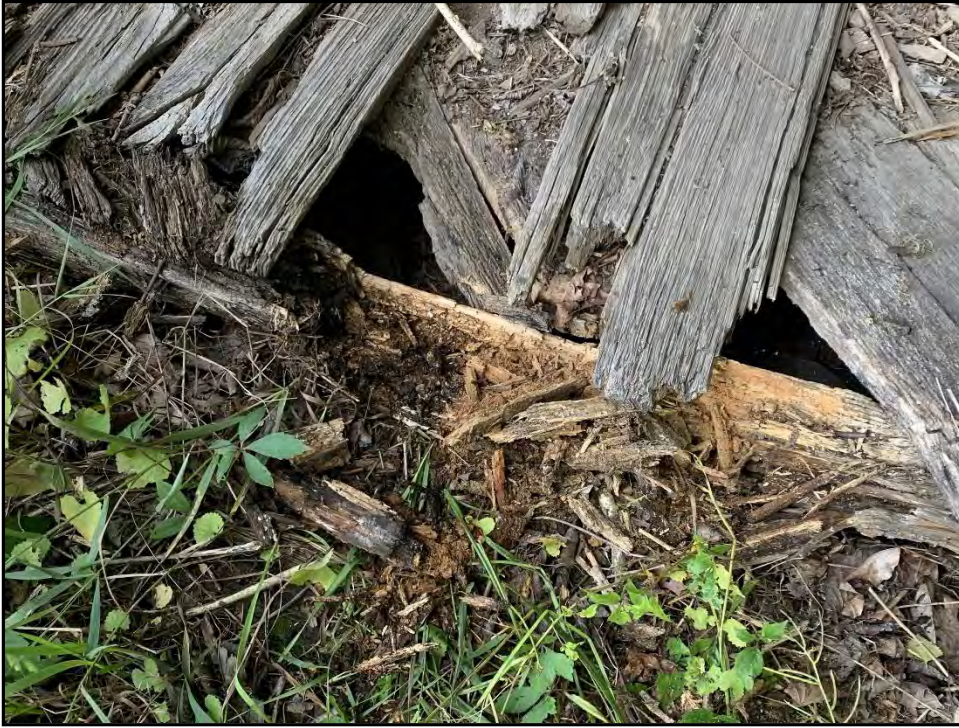
Photo 25-Barn 4:
View of heavily
deteriorated sill plate at
Barn 4.
