Existing Conditions Report

Brook Farm House
Lenape Lane, New Paltz, NY

Carolyn M. Coppola
Coppola Preservation Consulting LLC
8 Haviland Street
Bluffton, SC 29910

July 19, 2023

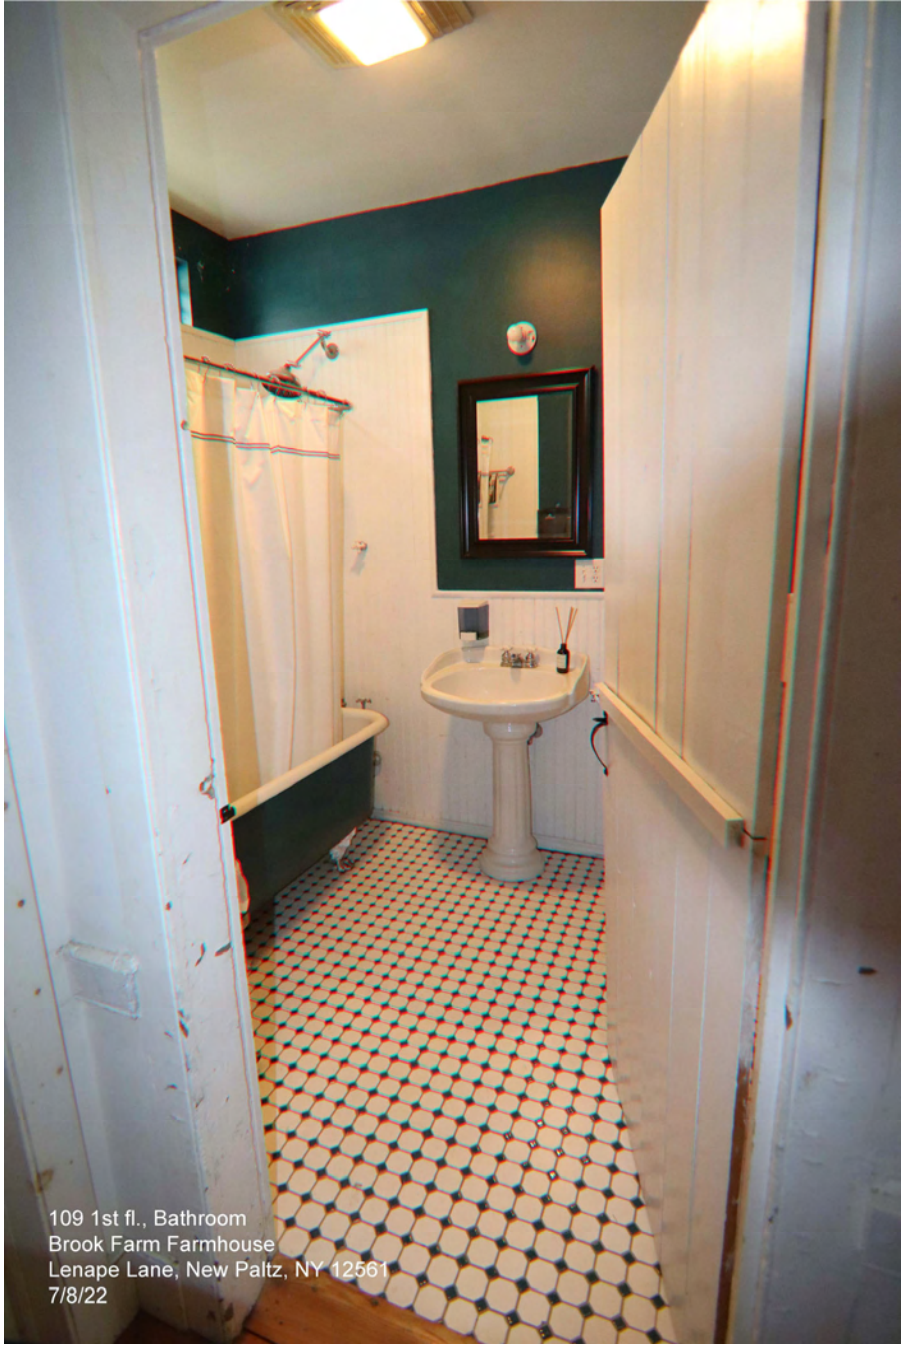
109 1st fl., Bathroom
Brook Farm Farmhouse
Lenape Lane, New Paltz, NY 12561
7/8/22

Some historic features remain in the first-floor hall bathroom, including a claw and ball foot bathtub and small geometric-patterned black and white floor tile (photo 109).

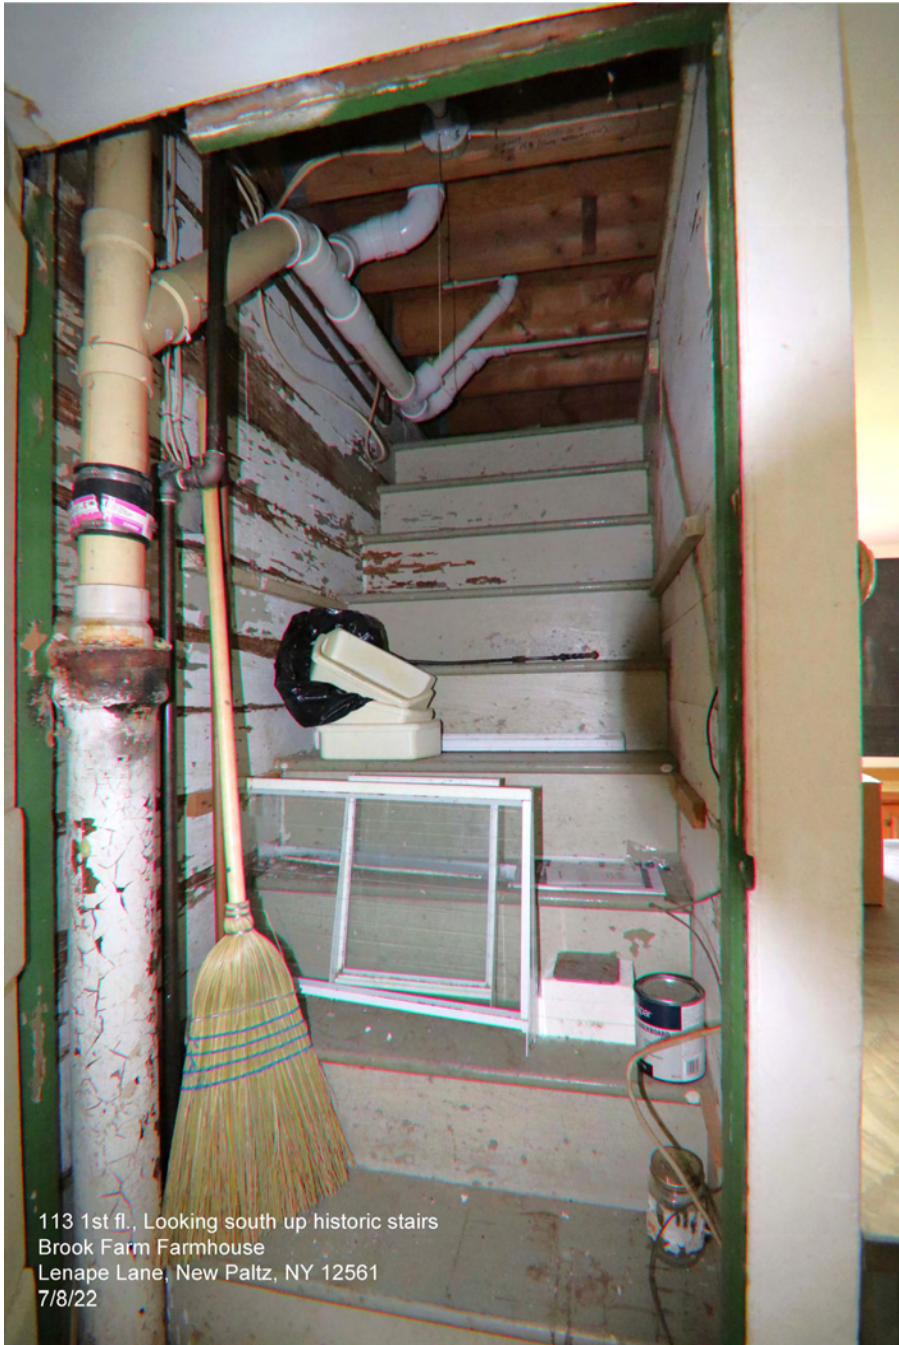
113 1st fl., Looking south up historic stairs
Brook Farm Farmhouse
Lenape Lane, New Paltz, NY 12561
7/8/22

Stairs, original to the c. 1865 house, survive along the east kitchen wall (photo 113). Access to the second floor is blocked. This space serves as storage and to house plumbing. Stairs to the basement are directly below these stairs, accessible from the other side of the east wall (photo 118).

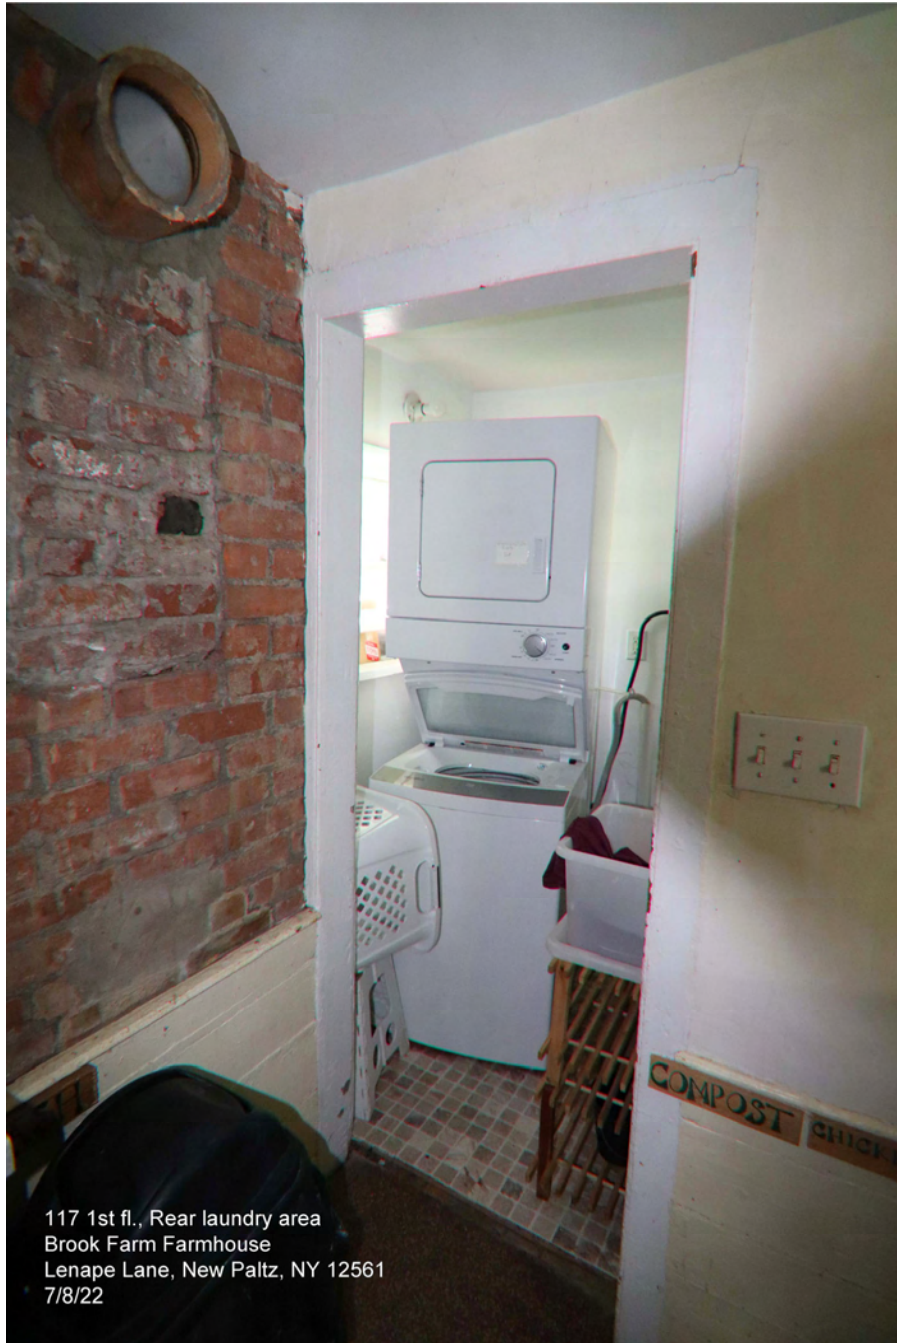
117 1st fl., Rear laundry area
Brook Farm Farmhouse
Lenape Lane, New Paltz, NY 12561
7/8/22

The north kitchen wall has horizontal wood paneling below a chair rail. A small, closed-in window opening with casing and sill, similar in size to that in the southeast room, remains. Contemporary cabinetry and appliances are installed in the kitchen (photos 117 and 118). An exposed brick chimney breast remains on the west wall. A small laundry room occupies the northwest corner, just north of the chimney breast (photo 117).

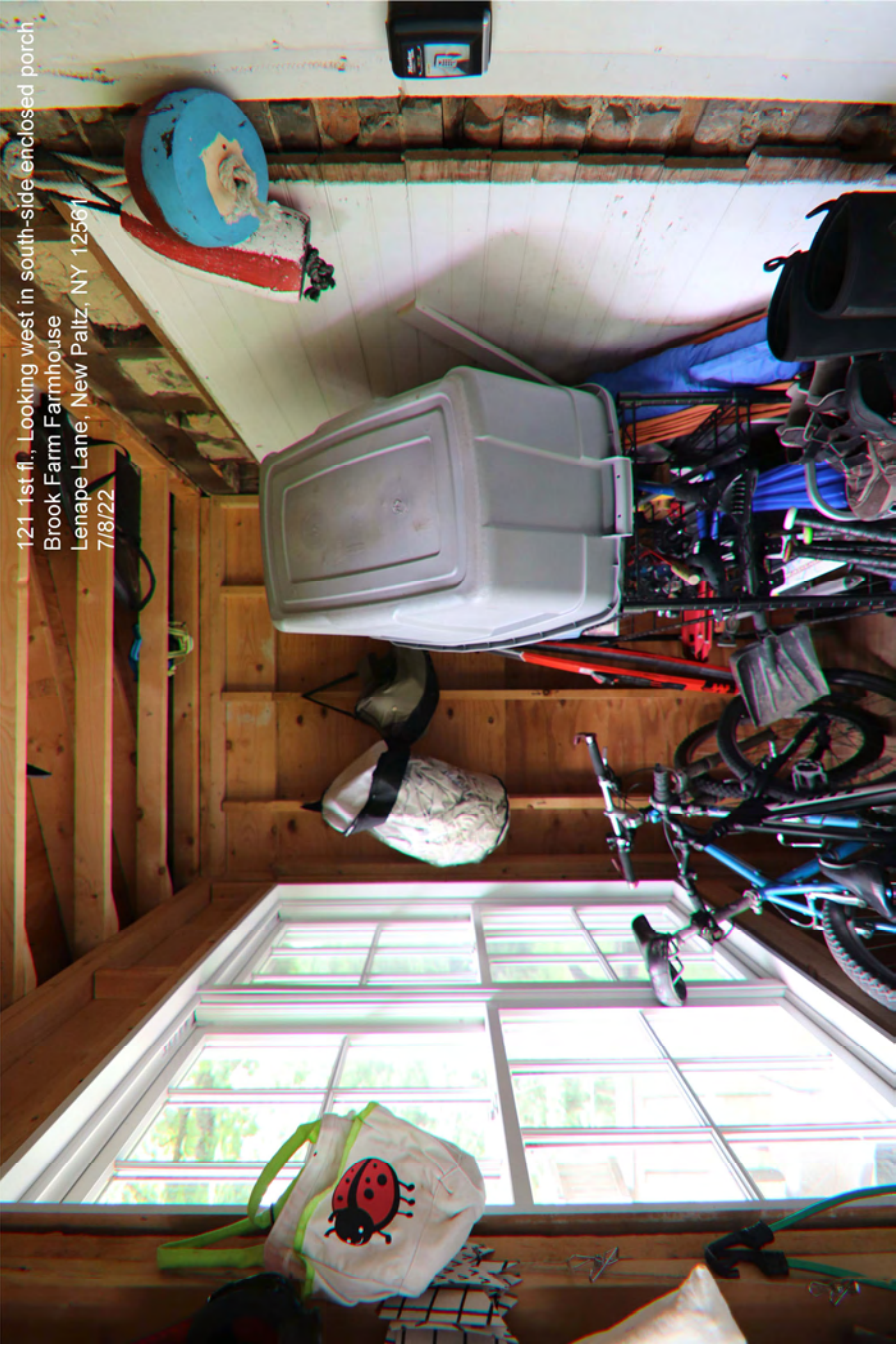
121 1st fl., Looking west in south-side enclosed porch
Brook Farm Farmhouse
Lenape Lane, New Paltz, NY 12561
7/8/22

The current front porch and accessible ramp were constructed some time after 2011. Four wood square columns support a hipped porch roof with asphalt shingles. Square wood balusters and flat handrails run the length of the ramp and down the front stairs to the walkway. A side deck and rear deck are constructed of similar materials and appear to have been constructed at the same time as the current front porch, though the deck planking on the front porch is narrower. All are in good condition. The side enclosed porch was never finished (photos 121 and 122).

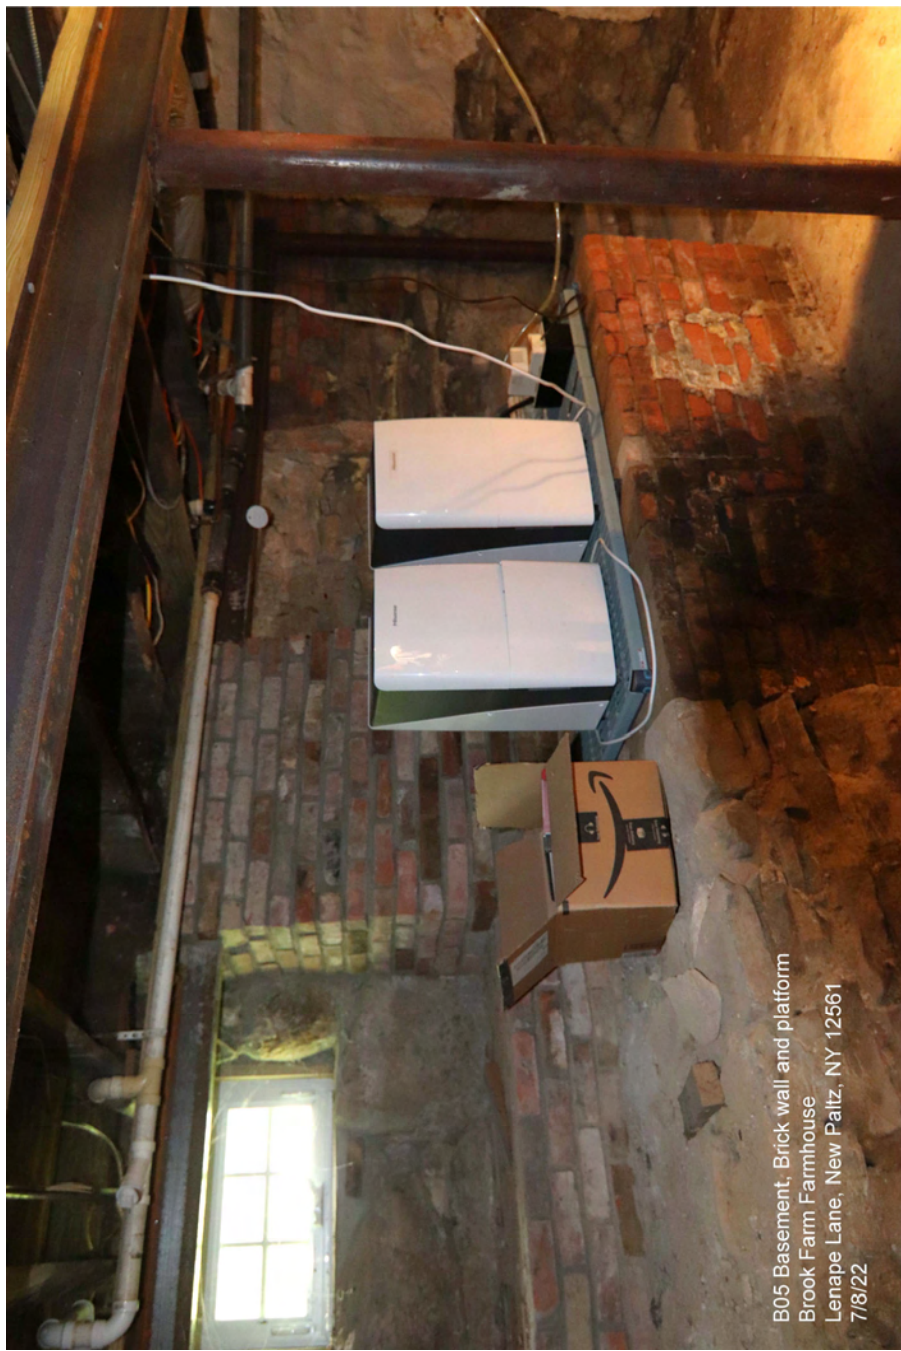
B05 Basement, Brick wall and platform
Brook Farm Farmhouse
Lenape Lane, New Paltz, NY 12561
7/8/22

The basement was enlarged when the house was extended in the 1890s. The foundation walls in both sections are stone, much of it parged. The floor is poured concrete. These areas are in good condition. The older section has a brick platform next to what may have been the original entrance to the basement (photo B05). The brick platform may have been used for cooking or food preparation.

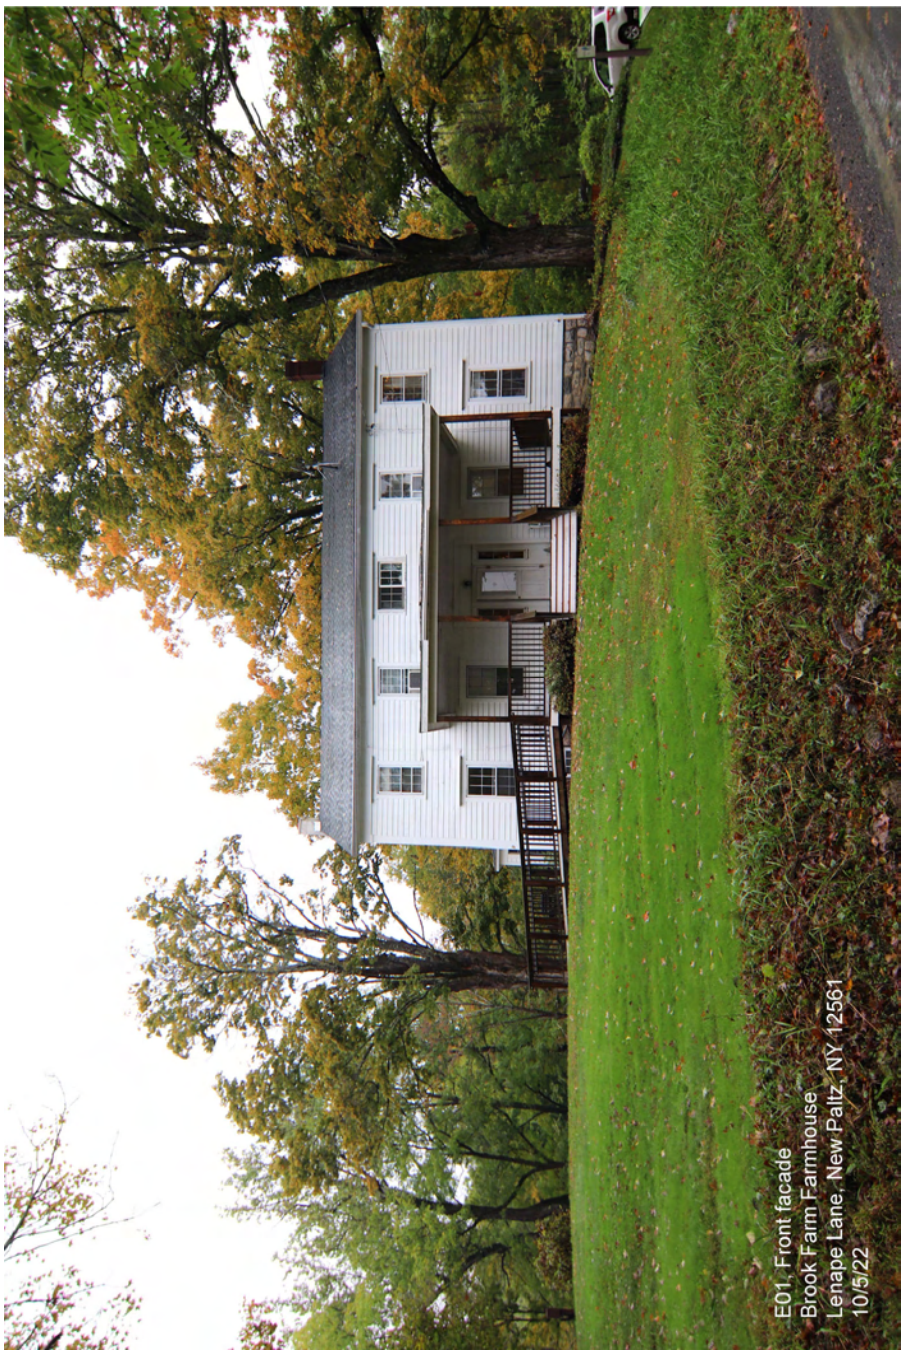
E01, Front facade
Brook Farm Farmhouse
Lenape Lane, New Paltz, NY 12561
10/5/22

A spring-hinged, three-panel wood door with a glass upper panel opens to the front door of the house (photo E01). That door is an historic wood, four-paneled door that opens to the foyer. A contemporary multi-pane glass door on the south-side opens to the enclosed porch (photo E05). Within the enclosed porch, an historic wood, four-paneled door opens to the kitchen (photo 119). Three raised wood panels make up the lower half of the door. One single-glazed glass panel occupies the top half of the door. On the rear elevation, a contemporary aluminum-frame screen door opens to an historic wood door that matches the side door, except that the top panel is multi-paned glass (photos E08 and 116). All doors are in fair to good operable condition.

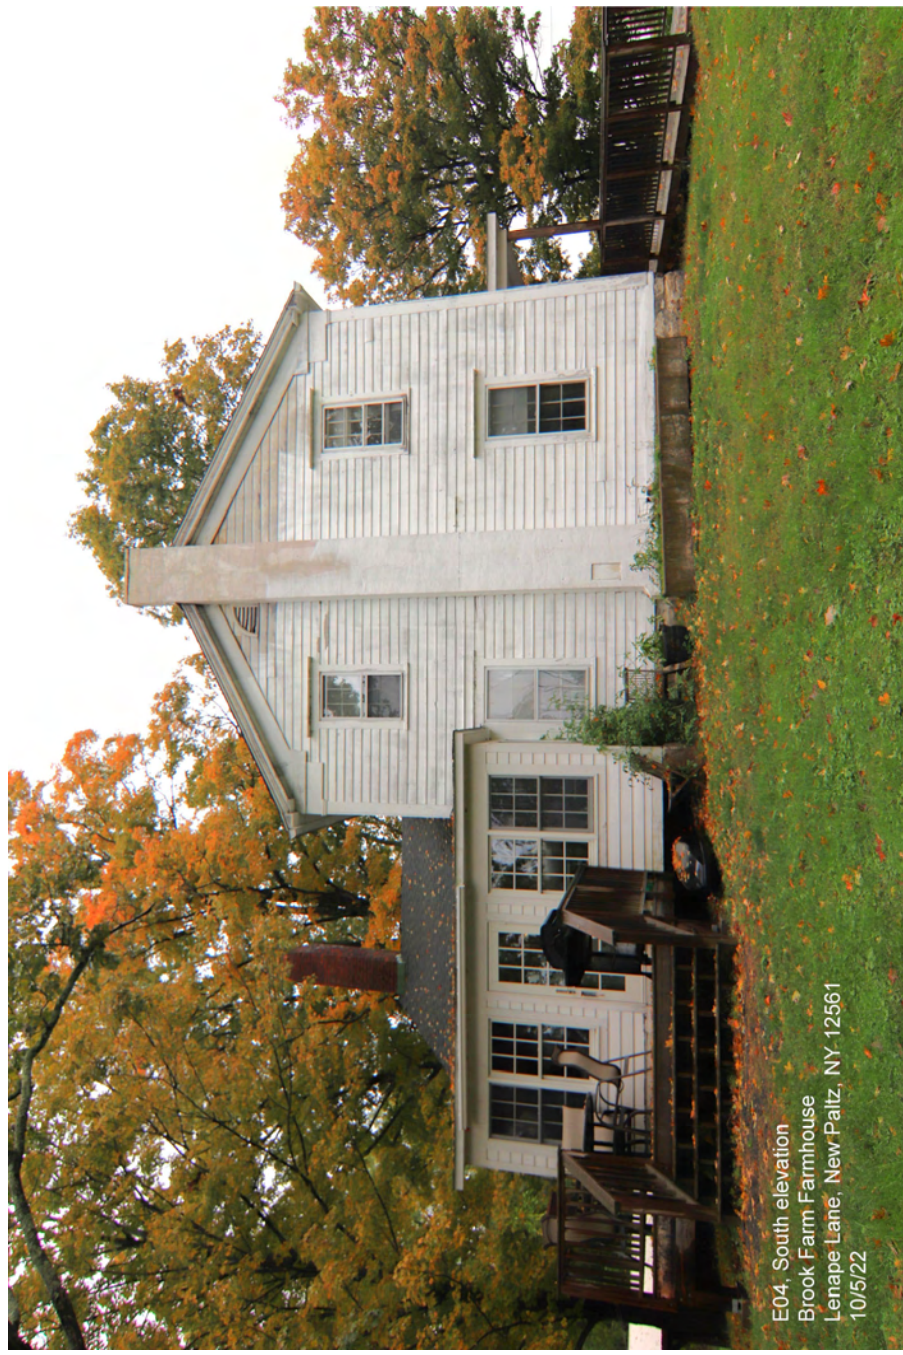
E04, South elevation
Brook Farm Farmhouse
Lenape Lane, New Paltz, NY 12561
10/5/22

The gable roofs in both sections are finished in fiberglass shingles, and are in good condition. Chimneys are constructed on both ends of the large, front section of the house, a red brick one on the north side, and a stucco one on the south end, the latter appearing off center (photo E04). A brick chimney rises above the roof of the west-side kitchen extension (photos E04, E06, and E08). The chimneys appear stable and are not currently used. There are no visible fireplaces in the interior of the house.

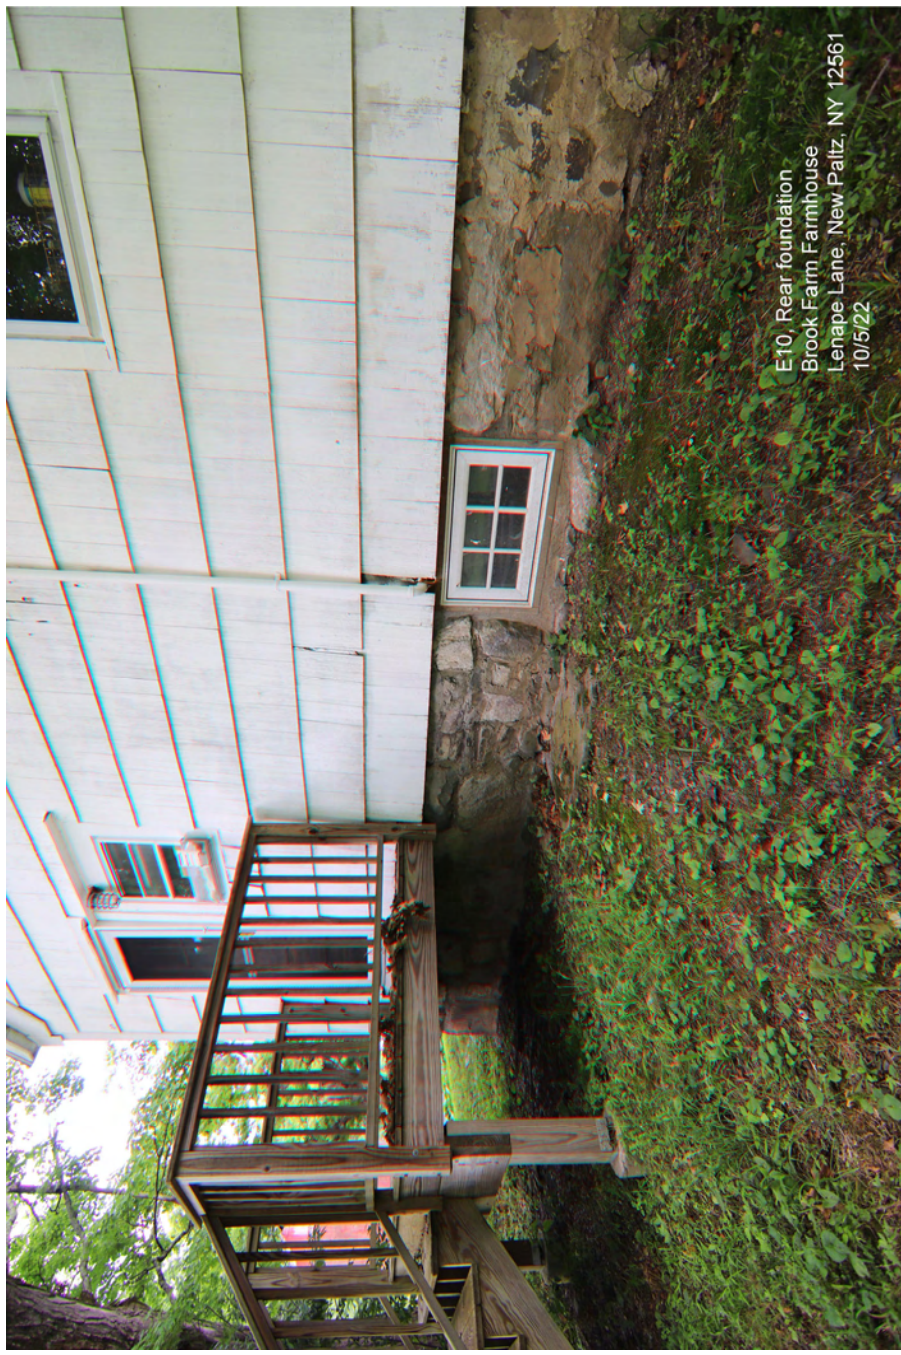
E10, Rear foundation
Brook Farm Farmhouse
Lenape Lane, New Paltz, NY 12561
10/5/22

Most of the house, including the front and main side areas are finished in historic wood clapboard (photos E01-E11). Shingle siding from a later, but undated period, is installed on the rear, kitchen extension and the area above it on the two-story, east-side addition. Both are in good condition. The original siding and construction of the 1865 section may be evident in the enclosed porch on the south side. Here, beaded tongue and groove siding is applied over brick (photo 121). This construction may have been a method of safeguarding against another fire, as two had occurred prior to 1865. The foundation for both sections is stone, with some variation of stone size and construction method evident in the kitchen extension (photos E10, E11, and other exterior photos).
