# Technical Memorandum

**RE: Duck Pond Dam at Mohonk Preserve**

SLR Engineering, Landscape Architecture, and Land Surveying, P.C. (SLR) conducted a visual inspection of the Duck Pond Dam at Mohonk Preserve (NYSDEC Dam 193-5962) on August 20, 2024.

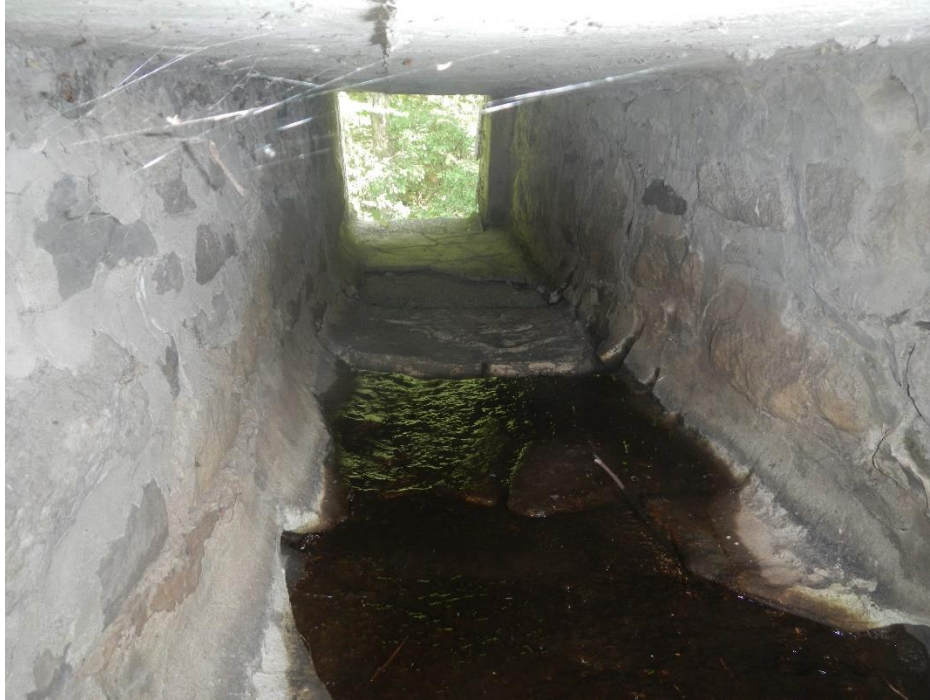
During the inspection, the pond water surface elevation was slightly above the spillway inlet elevation; however, all spilling flow was observed to be entering a lateral crack that extends across all three spillway conduits and not exiting from the spillway outlet (Photo 1). Thus, the water is flowing through the rock and earth embankment. This is an unsafe condition that will cause further deterioration of the dam over time and is a potential mode of failure for the dam as seepage flows can erode the embankment from the inside. Saturation of the structural fill and freeze-thaw action can weaken and/or damage the dam as well. The crack is roughly 4.5" wide and of indeterminate depth and has propagated through the entire concrete and masonry spillway section (base, piers/columns, and top slab). Seeping flows were observed to be flowing out from near the right (southwest) side at the toe of the dam, between about 10 and 20 feet offset from the primary spillway section. No turbidity was observed in the discharging seepage.

**Photo 1** Spilling flows entering lateral crack in base of spillway section (looking downstream through right spillway section)

Because of the apparently unsafe condition of the dam, SLR recommends that Mohonk Preserve close the roadway over the dam to all vehicle traffic and that the impoundment should be drawn down to relieve the hydrostatic pressure on the dam as soon as is practical. Daily and post-rainfall monitoring and visual inspection of the dam and spillway are recommended to assess for any additional damage or change in conditions.

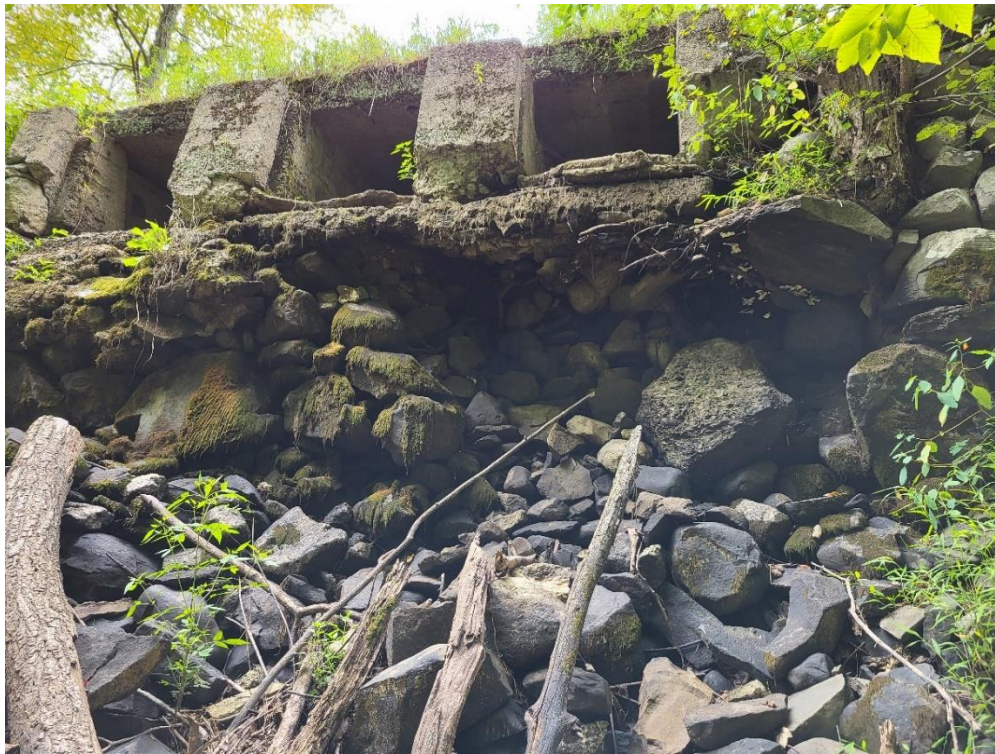
On the downstream face of the dam, the spillway section has been undermined to the point of creating a hazardous condition. A large void has developed underneath the center and left (northeast) spillway conduits that is up to about 3 feet deep, with slightly less severe undermining of the right (southwest) conduit, leaving a significant portion of the spillway structure unsupported on the downstream side (Photo 2). The remaining dry masonry elements under the spillway section are loose. Much of the embankment downstream of the spillway had previously been eroded, and the concrete spillway structure is slumping in the downstream direction.

**Photo 2** Missing masonry, large void, and undermined spillway section (looking upstream at downstream face)
