DUCK POND DAM FEASIBILITY STUDY

Mohonk Preserve

May 2022

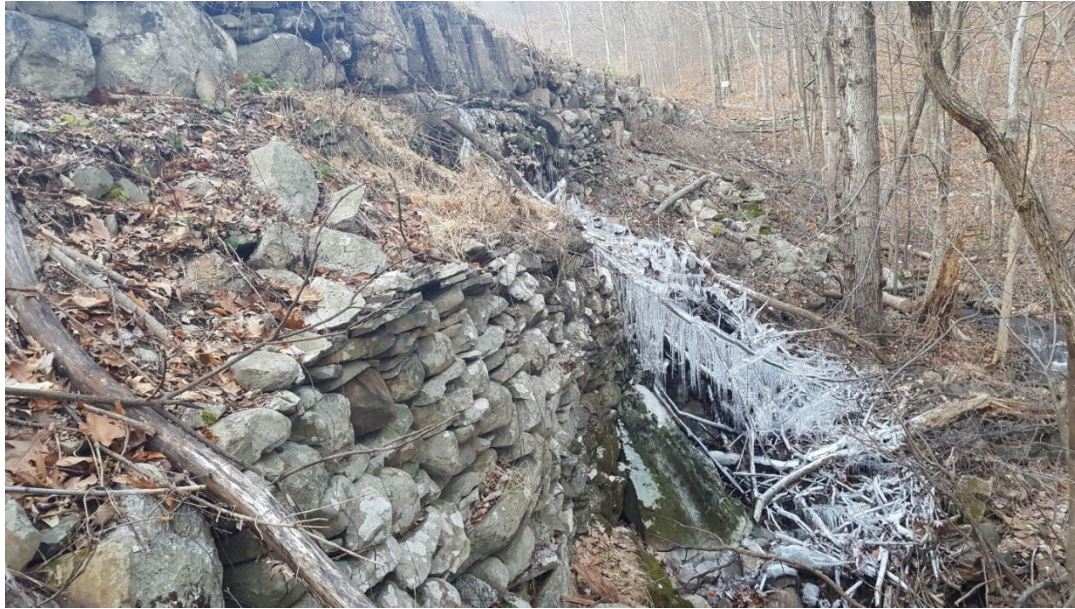
Figure 3-3 View of downstream face of dam, looking north (photo provided by Chuck Reid)

- Trees and shrubs growing below toe of downstream face of dam.
- Downstream face of embankment has many dislodged or missing stones, which have created voids or weak points in the dam structure.
- Significant leakage along right half of embankment from low-level outlet chamber to right abutment.
- Dam crest elevation is uneven.
- Evidence of overtopping (most recently in April 2022).

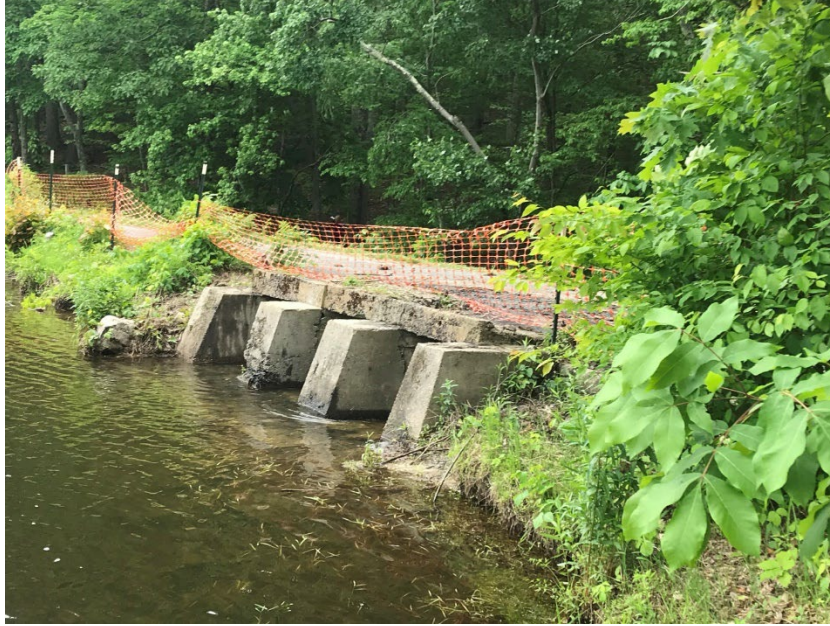
Figure 3-7 Duck Pond Dam spillway inlet

- Spillway inadequately sized to pass spillway design flood; hydraulic modeling indicates that the dam is overtopped during the 100-year flood event.
- Concrete and stone masonry has large cracks, spalling, and deterioration of mortar.
- Spillway slipped or tilted in downstream direction.
- Large transverse cracks present within spillway conduits.
- Erosion at toe due to the spillway flows dropping 15 feet vertically as it discharges through the dam.

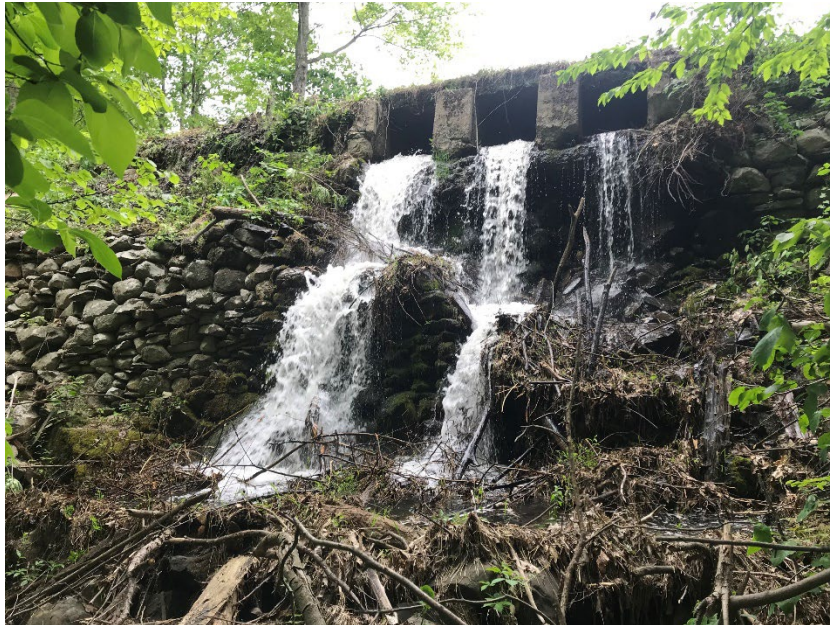
Figure 3-8 Downstream face of dam with spillway outlet (photo by SLR)

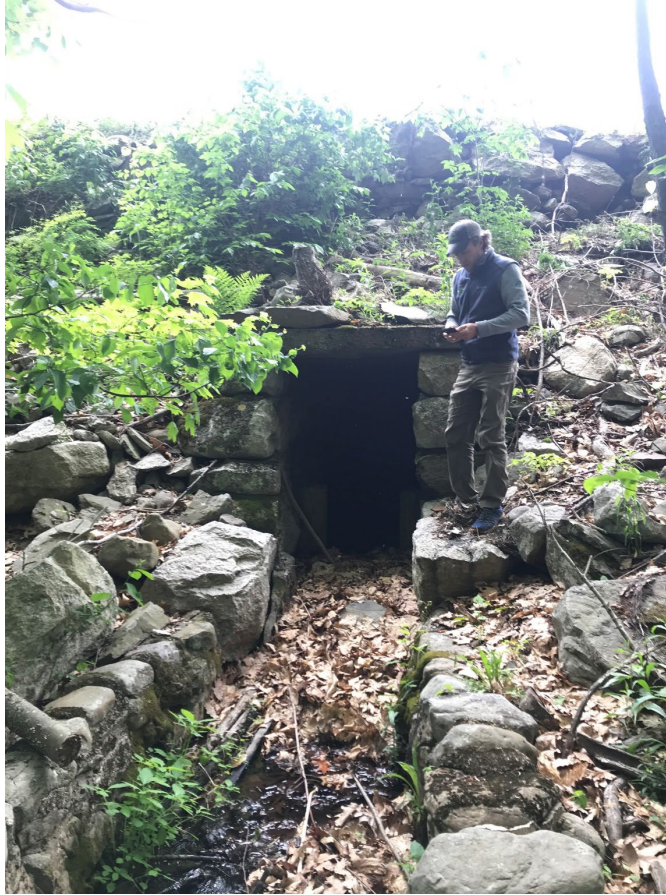
The low-level outlet works are visible in a chamber on the downstream face of the embankment (Figure 3-10 and Figure 3-11). The valves are inoperable, and the outlet pipes are live with water within the earth embankment. The inlet structure is below the surface of Duck Pond and is not visible but can be seen in a historic photo (Figure 3-12).

Figure 3-10 Low-level outlet chamber in downstream face of main dam (photo by SLR)

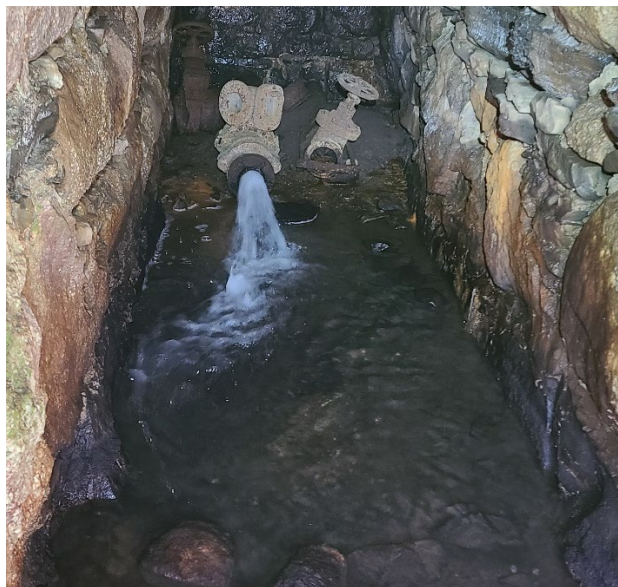
Figure 3-11 Inoperable low-level outlet valves (photo from Mohonk files)

The inspection also revealed two (2) non-functional low-level drain pipes. The valve on one of the pipes is frozen shut and the valve on the second pipe is broken off and unable to close. An open low-level outlet pipe with a non-operable valve creates the risk of creating seepage paths, if the pipe should corrode or joints open, without providing the benefit of having the ability of lowering the pond. The low-level outlet should either be repaired, or the pipe should be filled with grout and an alternate plan using temporary pumps and/or siphons should be developed for inclusion in the Inspection and Maintenance Plan discussed below. Repair or abandonment of the low-level outlet may require a dam safety permit.

- Install new operational gate valve and outlet pipe integrated with the drop inlet spillway.

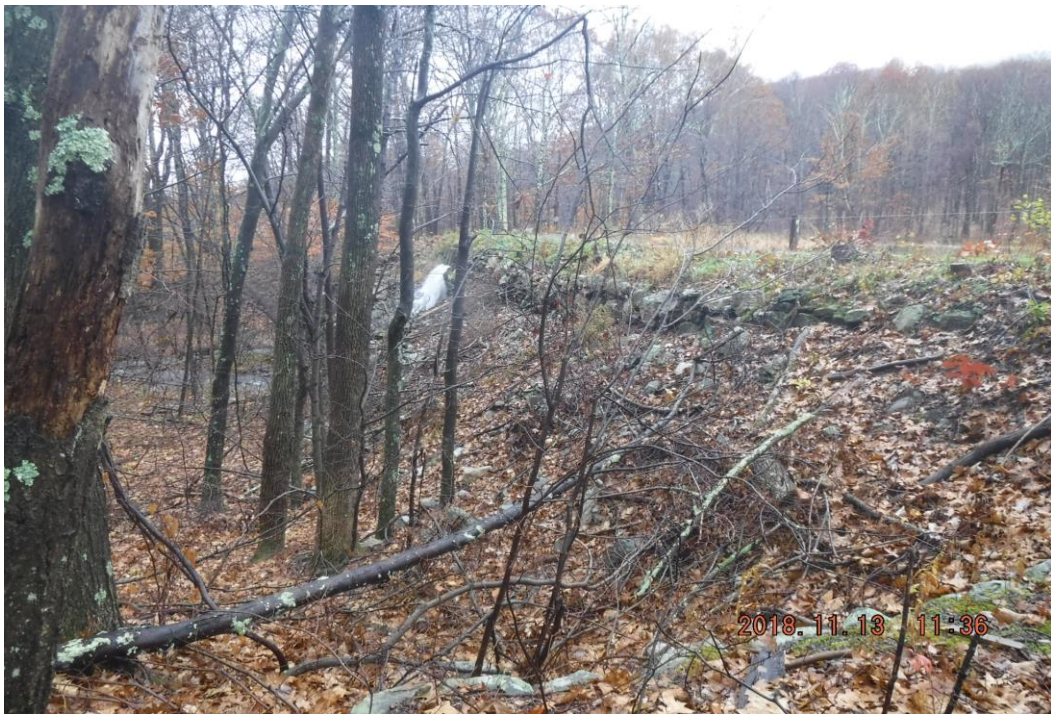
Lastly, it was also noted during the inspection that the downstream laid stone face of the dam and spillway were not uniform with areas/voids of potentially missing stones/material and undercutting of the laid stone in some locations. You should hire a professional engineer (P.E.), registered in New York State and with experience in dam safety, to fully evaluate the structure and recommend alternatives for repair and to bring the dam fully into compliance with applicable safety criteria, as discussed in the Department's Guidelines for Design of Dams.

Photo 4 Dam ID# 193-5962 Duck Pond Dam 11/13/2018
Downstream slope
View looking right from left end of dam

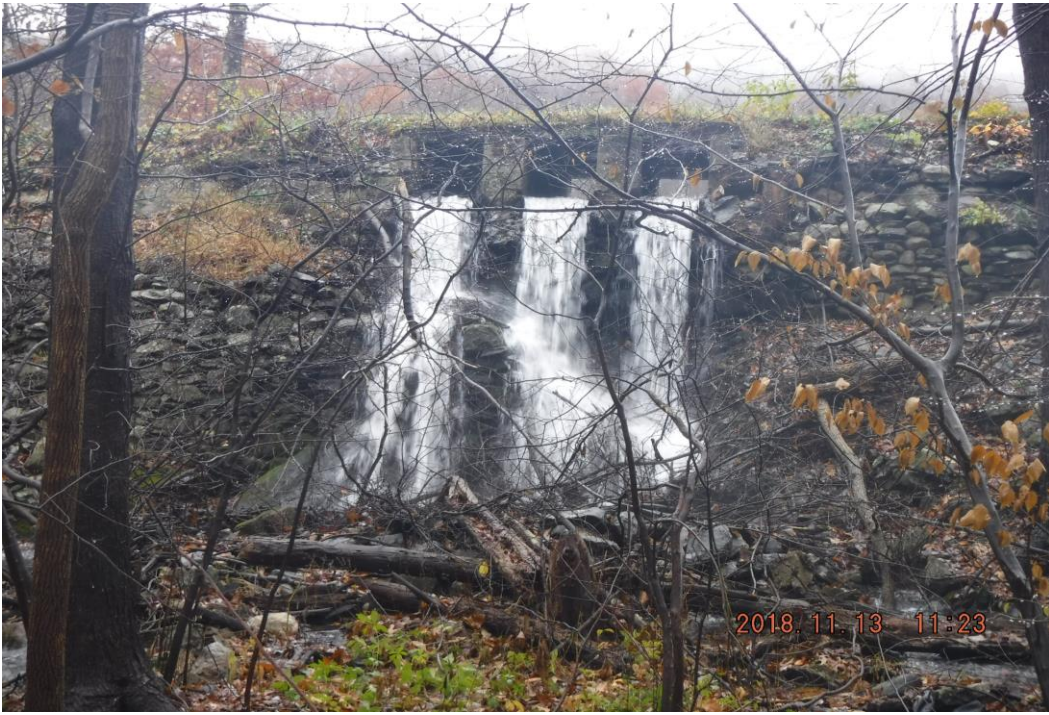
Photo 7 Dam ID# 193-5962 Duck Pond Dam 11/13/2018
Service spillway downstream face
View looking upstream

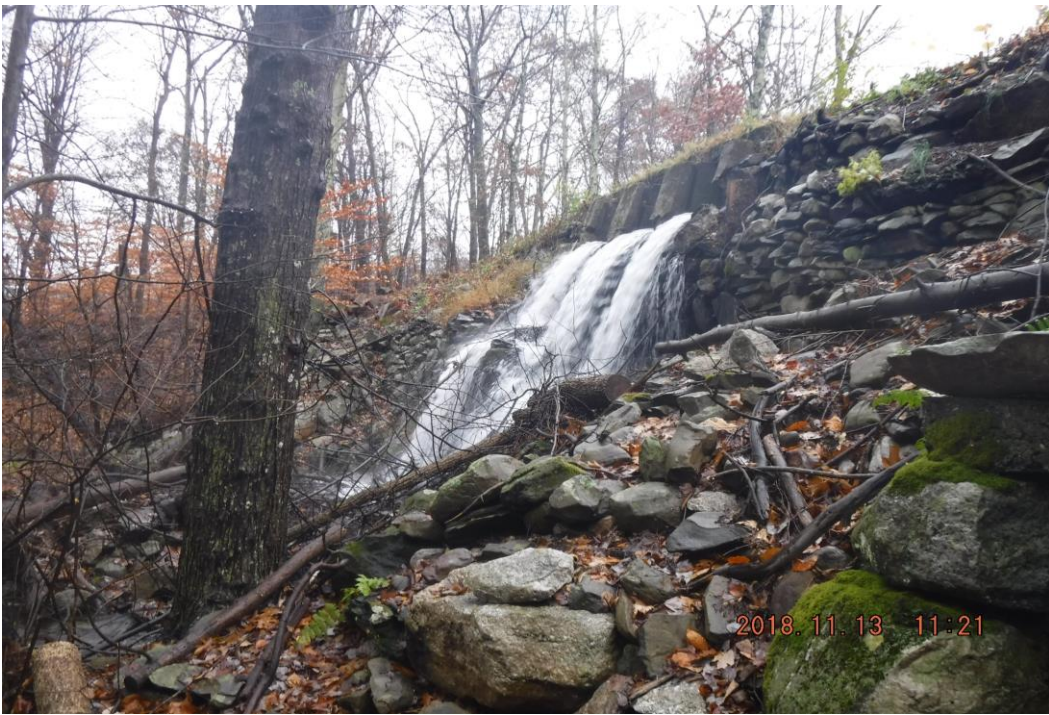
Photo 8 Dam ID# 193-5962 Duck Pond Dam 11/13/2018
Downstream spillway face
View looking right from downstream toe

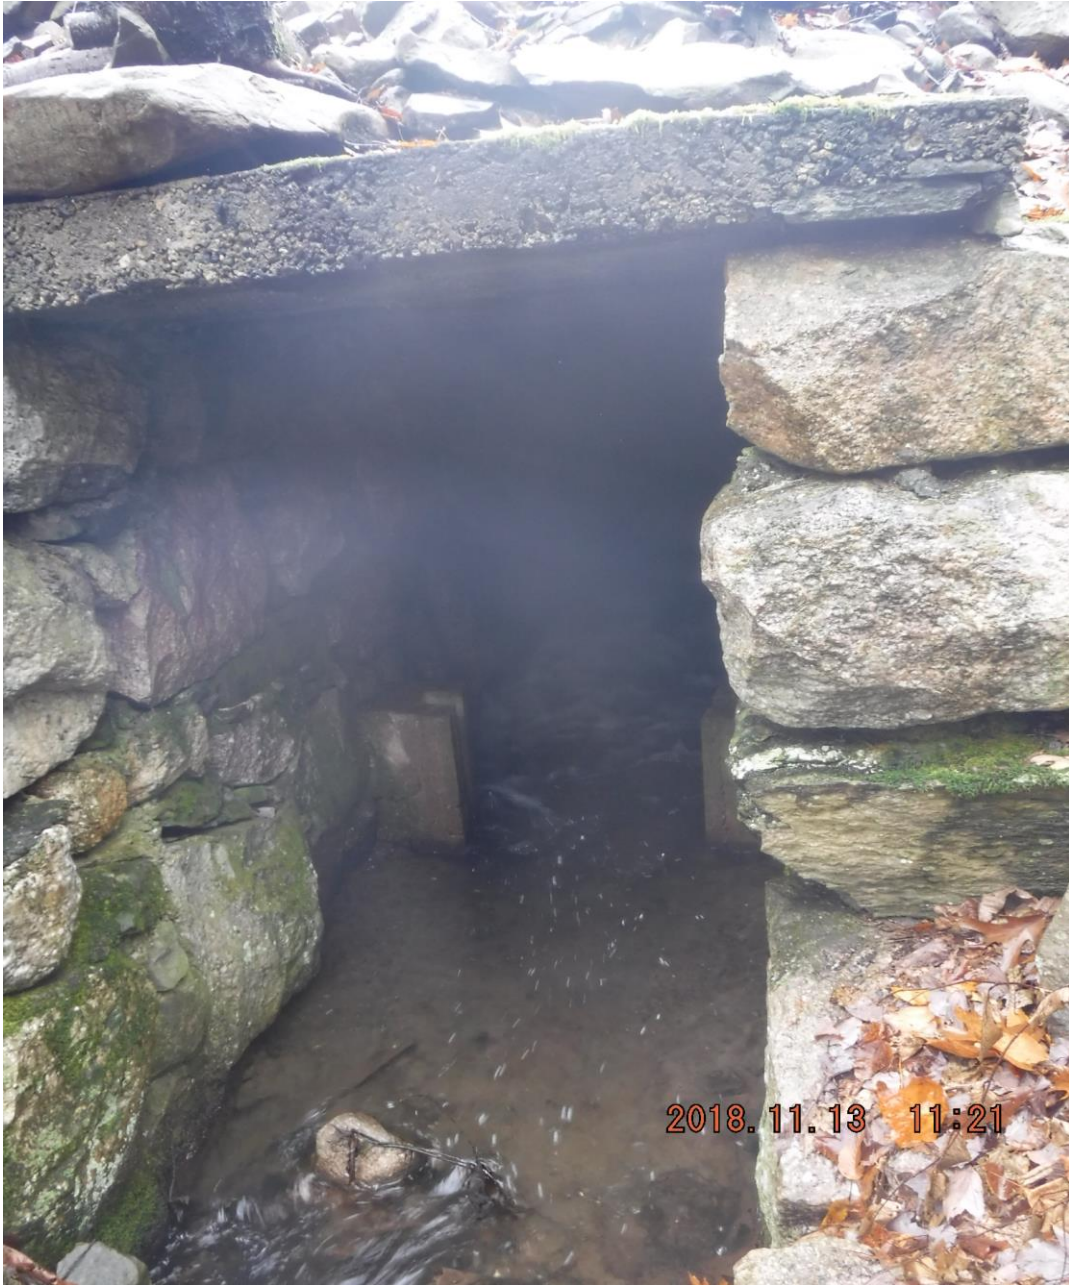
- Low level drains are comprised of two (2) 8-inch pipes.
- The two valves are located on the downstream side of the dam. Reported one valve is seized (frozen) shut, the other valve end is broken off and open. Reported that open outlet pipe flows, becomes clogged then will "let go", flowing full draining the impoundment.
- The low level outlet located at the downstream toe to the left of the service spillway.

Photo 9 Dam ID# 193-5962 Duck Pond Dam 11/13/2018
Low level drain outlet
