Existing Conditions Report

Brook Farm Barn Complex

Lenape Lane, New Platz, NY

June 2024

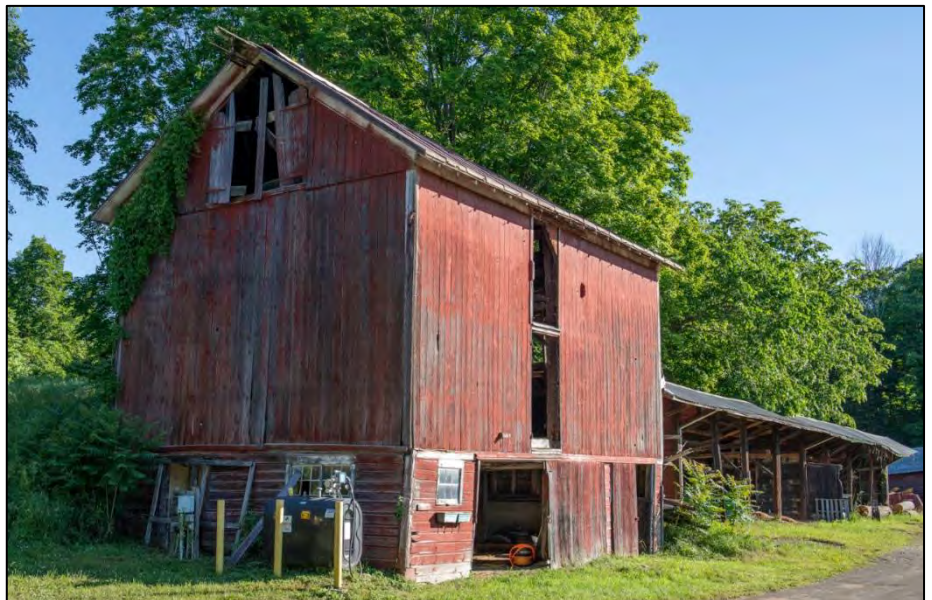
Fig. ##12 Brook Farm Barn 1 built into slope

The building is 24 by 36 feet in size, built into the slope on its western side, supported there by a retaining wall of dry stack mostly conglomerate stone, with an adjacent interior later-poured concrete wall (Fig 12 & 13). The sill on top of this wall, and the adjacent floor above is heavily and extensively decayed due to moisture and ground contact (Fig. 14). The South foundation has a concrete knee wall and sawed wood framing above (Fig 15). The North foundation wall is poured concrete about five feet tall, inside a stone retaining wall, topped by a short wood

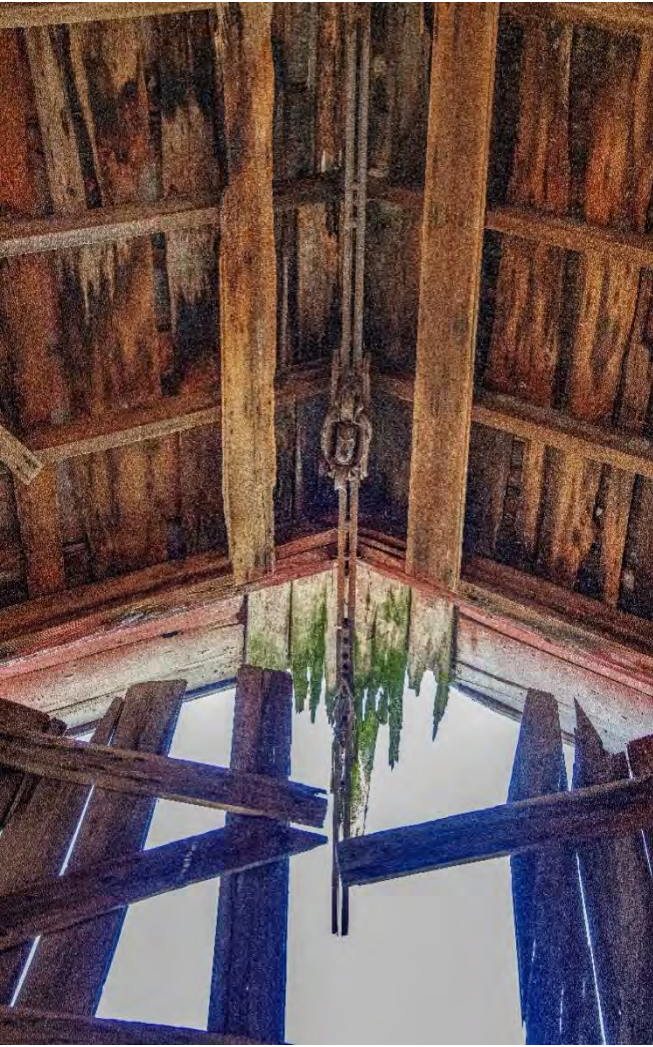
Fig. #27 Brook Farm Barn 1 hay carrier rail

A large hinged ventilation and hay carrier door opening under the roof ridge on the top of the South wall is partly open from deterioration (Fig. 27). Above this roof ridge door are the remains of a hay carrier rail, originally framed and covered over and extending several feet beyond the edge of the building roof overhang.

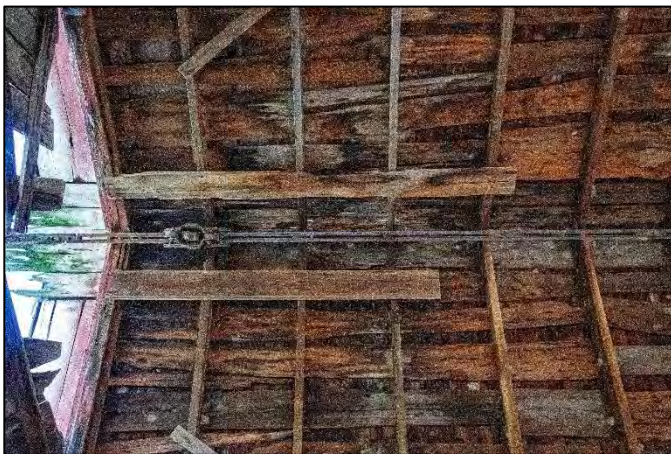
Fig. #28 Brook Farm Barn 1 hay carrier rail system

The patented hay carrier two-rail system was attached from the outside to the underside of the roof ridge across the whole inside top of the barn to the North end (Fig. 28). The hay carrier allowed for loose hay to be efficiently bundled and transported upward and through the roof ridge door into the barn to the hay pile in the mow where it could be spread evenly by hand on the top of the increasing pile. The pulley mechanism of the hay carrier is still on the rails just inside the roof ridge door (Fig. 29). A row of black numbers on the hand-hewn southeast corner post might be a count record of the number of hay carrier loads, although we will never

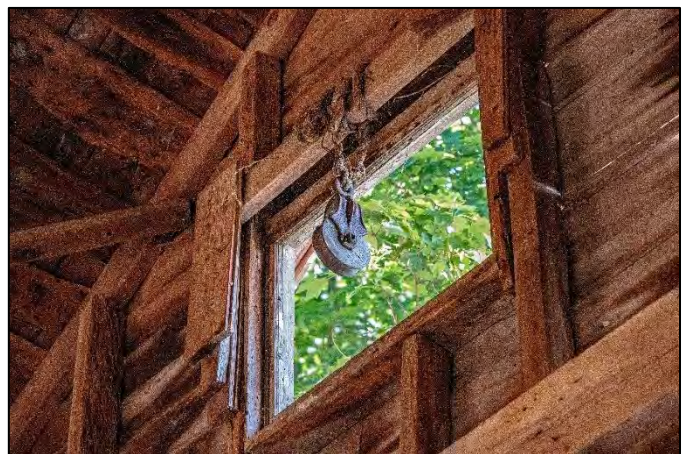
Fig. #32 Brook Farm Barn 1 north wall suspended pulley

know for sure what they record (Fig. 30 & 31). There is a framed window opening on the North wall below the roof ridge with a pulley suspended from its middle top directly below the peak of the roof and the hay carrier rails (Fig. 32). It may have been part of the roping network for pulling the hay carrier in and out of the building for hay distribution.

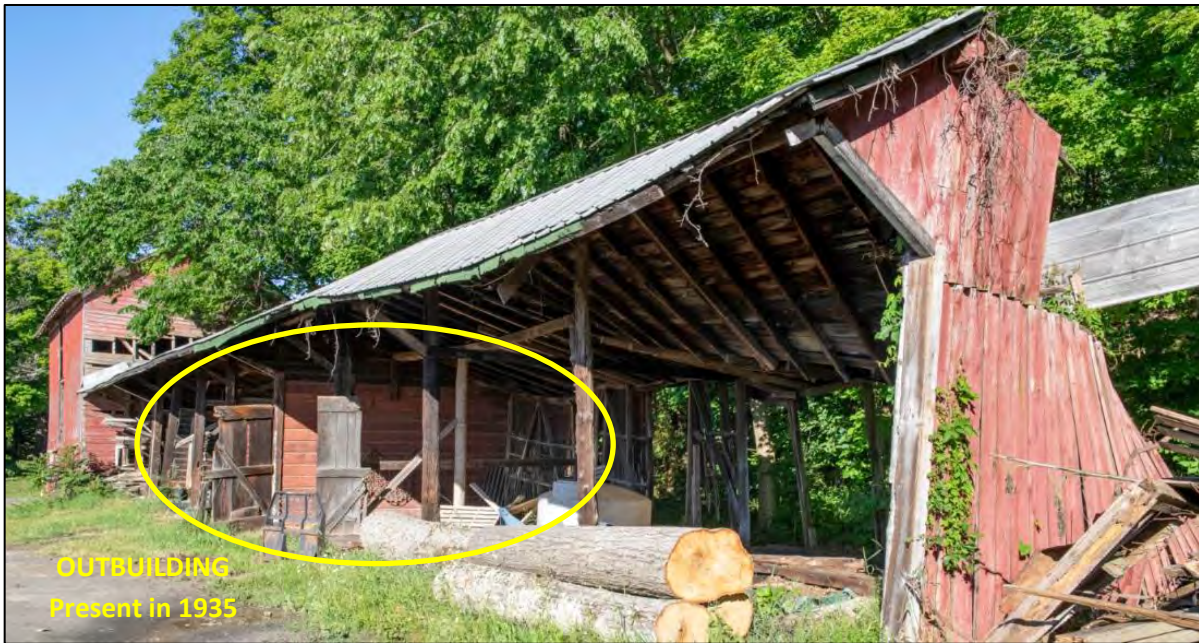
Fig. #43 Outbuilding drive-in sheds

As evidenced from the August 3, 1935, photographs of the major Brook Farm barn fire, an open free-standing shed of four drive-in bays each some 10 feet wide existed about 16 feet North of Barn 1 (Fig. 5). Today that shed is incorporated in the series of eight open drive-in shed-roofed bays for equipment storage (Fig 43).

The main shed shows a framing mix of sawed lumber, tree poles, and a considerable amount of recycled hand-hewn timbers spliced and overlaid together both in roof and vertical support. While set on concrete footings, many vertical support posts are displaced and decayed. The roof sheathing boards of the main shed are placed vertically from roof peak to drip edge across timber rafter framing. Some of the timber rafter framing shows major decay (Fig 47). The shed North of the main shed had a more conventional sawed lumber framing but was very lightly made with support of only two by four-inch roof rafters. Some rafters had been doubled to carry the roof load. Here the sheathing boards are run horizontally (Fig. 44). Originally, all the sheds were roofed with green mineral surfaced rolled 90lb. tar paper roofing. At some time a sheet metal roof was added over the tar paper. These combined sheds are in a major state of deterioration, the structures very weak with many decayed, loose, and broken framing members and timbers, pulling away from attachment to Barn 1.

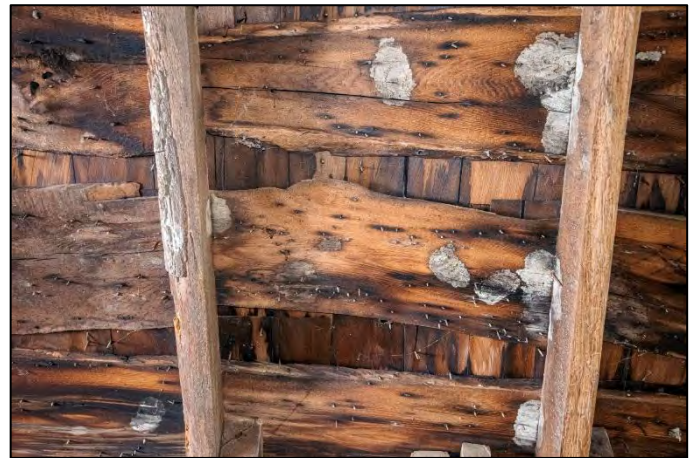
Fig. #69 Brook Farm Barn 2 Roof Cladding

The roof of Barn 2 was constructed with its peak running approximately north to south, draining the roof surface directly over the two front doors (Fig. 48). The roof was clad with irregularly shaped and spaced broad boards topped with cedar shakes. Two layers of asphalt shingles were added on top of the cedar shakes. The roof shows extensive deterioration and rotting from leaking as evidenced by staining and missing sheathing inside. The undersized and widely spaced rough sawed roof rafters, some with bark still on, were reinforced in places to help support the roof load. Many show deflection and decay (Figs. 69 & 70). The roof was covered over with corrugated metal roofing (Fig. 48).

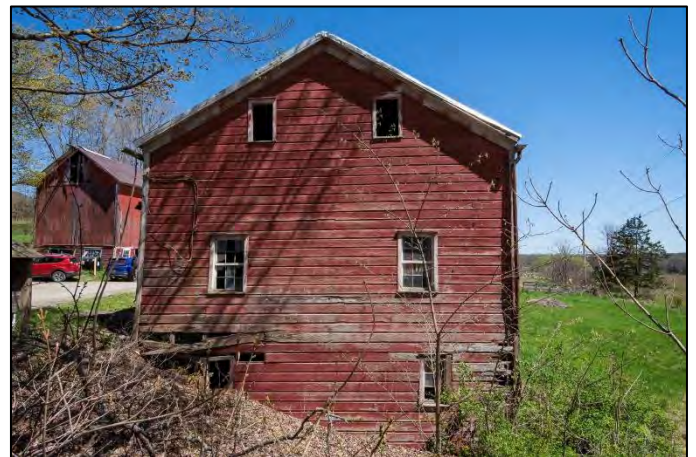
Fig. #67 Brook Farm Barn 2 Six over Six Windows

The upstairs floor joists are supported by a large repurposed hand-hewn beam (Fig. 62). Many of the joists are rough sawed tree poles with the bark still on (Fig. 63). Upstairs in the north corner wire caging was used to confine domestic fowl, probably chickens (Fig. 64). Outside access to the barn yard was made by two front doors both supported by top rollers on a continuous single rail across the front of the barn (Fig. 65). Sheathing is shiplap of two different sizes and is heavily weathered. In some places the sheathing has holes or is missing, thus allowing for considerable outside exposure causing rotting of the wall studs (Fig. 66). Some standard size windows were installed with six over six glass panes, while others were just six panes installed both vertical in the basement and horizontal in the attic (Fig. 67). One single vertical four pane window was installed near the east corner of the main room (Fig. 68).

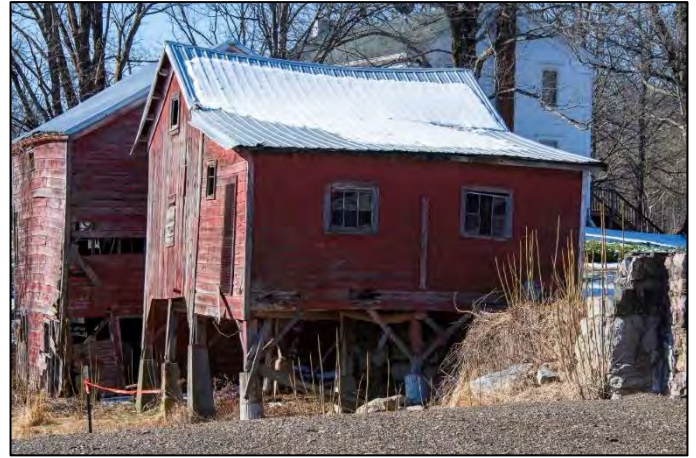
Fig. #85 Brook Farm Barn 3 Weathered Siding

Wooden sills are extremely deteriorated. On the barn yard level of the front of the building the sills on top of the retaining wall are significantly compromised causing settling of the front of the building (Figs. 82, 83). A tree pole added on top of the wall under the front of the building is rotted and broken (Fig. 84). Shiplap siding is heavily weathered especially at the base of the walls (Fig. 85).

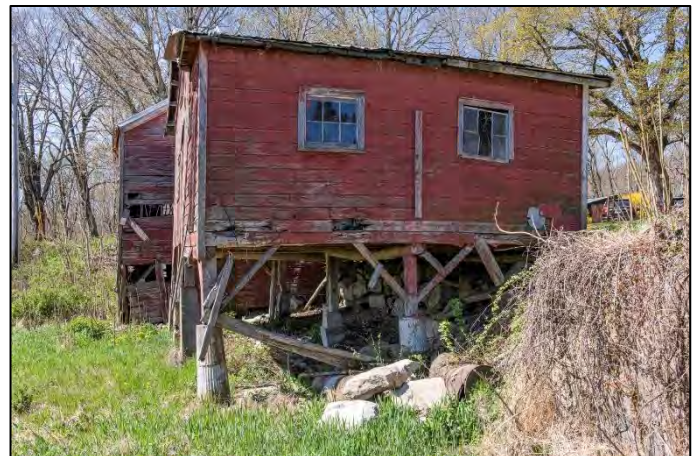
Fig. #74 Brook Farm Barn 3 Support Piers

The foundation of both the original section and a shed addition are supported by tapered concrete piers. Most of the piers are tipped from vertical as a result of being open to weather exposure and frost movement. Two piers under the north side of the shed addition were formed by garbage can forms (Fig. 74). For extra support, tree poles were added under the floor joists. The lower level of the original building, on the east side, has tapered openings for wider access (Fig. 75).

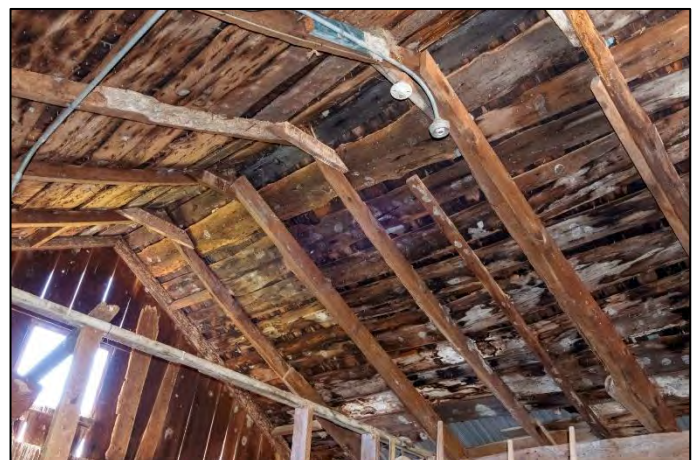
Fig. #86 Brook Farm Barn 3 Roof Cladding

The original roof was constructed of irregularly shaped and spaced broad board sheathing topped by visible cedar shakes (Fig. 86). At some time, asphalt shingles were added over the shakes. Some roof rafters were reinforced to support the roof load. The roof was not maintained and the building suffered heavy leakage, severely damaging the roof structure (Fig. 87). It was covered at an unknown time with corrugated metal roofing.

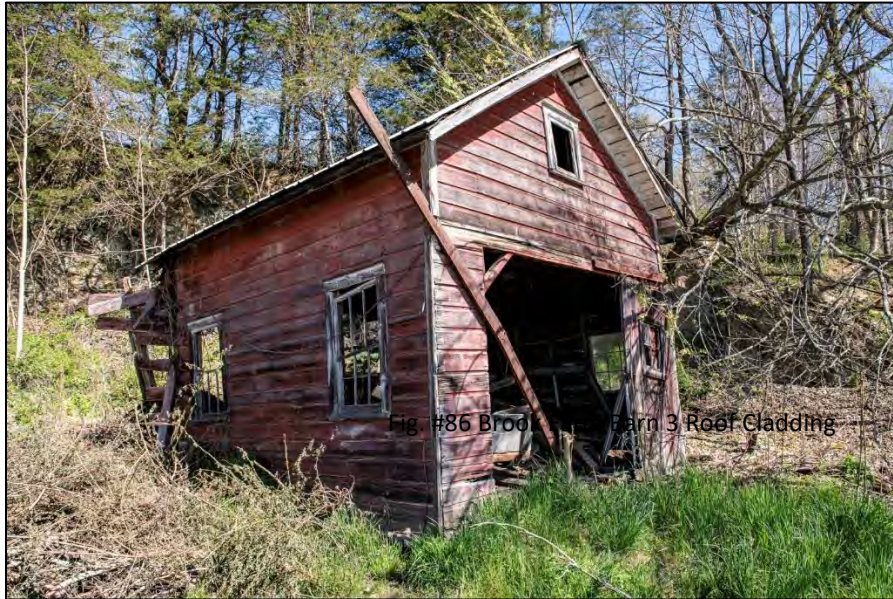
Fig. #88 Brook Farm Barn 4

This, the smallest barn building, is a non-contributing structure. Photographs taken during the August 3, 1935 barn fire reveal Barn 4 absent at that time (Fig. 6).

When constructed, it was framed with rough cut sawed lumber and built directly on the ground (Fig. 90). With no conventional foundation under the building, the wooden sills are seriously deteriorated and crumbling. The bottom of the wall uprights is also compromised leaving the barn settling into the ground and unsafe. A small wooden framed lean-to shed addition on the back of the building collapsed and its remains lay in a rotting mass (Fig. 91).

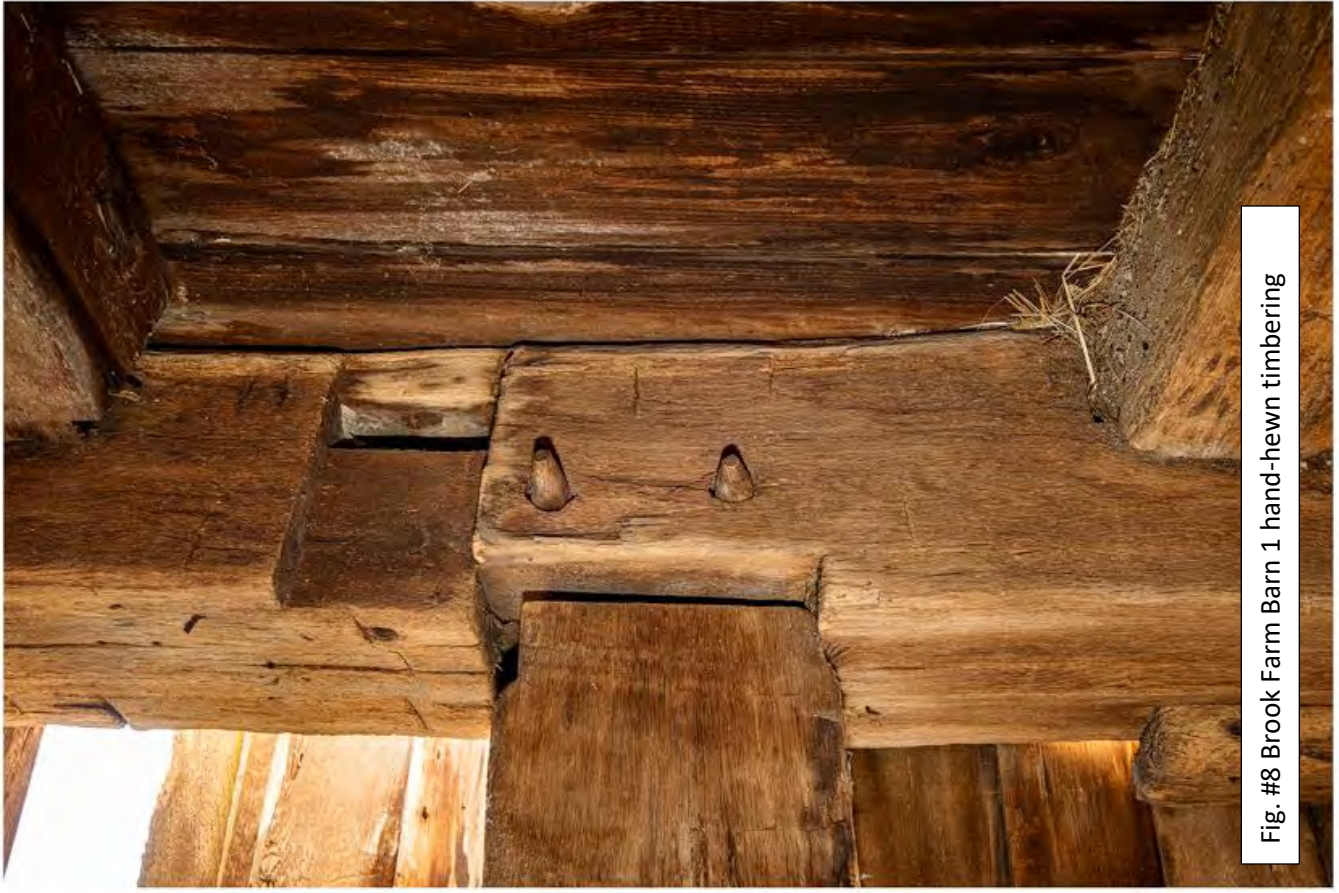
Fig. #8 Brook Farm Barn 1 hand-hewn timbering

The building date for this large tall hay barn along Lenape Lane, on the West side of the Brook Farm barnyard, is unknown. It appears in the 1915 photograph from the New York State Archives (Fig 4). It's original framing, consisting of hand-hewn timbering and mortise and tenon joinery, indicates a building date in the 19th century (Fig. 8 & 9). Many of the vertical hand-hewn timbers show unused framing slots indicating possible reuse from some earlier building frame. Ladders are built on the East wall and partially on the South wall below the hay carrier roof peak door on the main floor level. One is built mostly into the wall framing on the North corner extending from the eaves through an opening in the floor to the foundation level (Fig. 10). Major floor and roof reframing with domestic sawed lumber likely occurred after Mohonk took ownership of Brook Farm in 1906 (Fig 11).

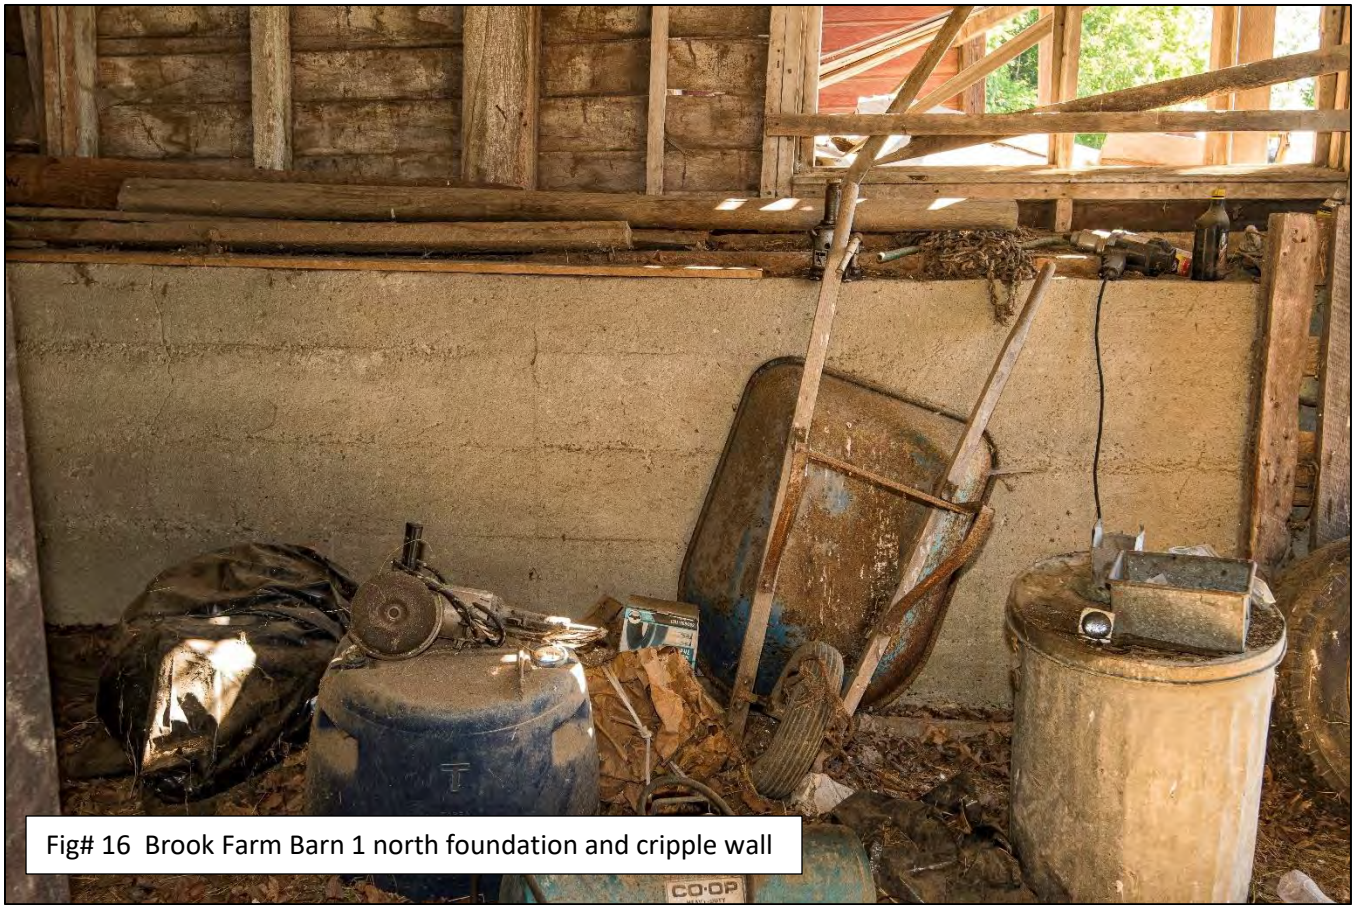
Fig# 16 Brook Farm Barn 1 north foundation and cripple wall

framed “cripple” wall (Fig 16). The “cripple” wall is crowned by a large hand-hewn timber. In the “cripple” wall were two horizontal window frames (Fig 17). The North/South oriented floor joists are of two inches by ten inch sawed lumber supported by large tree pole supports some with the bark still on and additional vertical posts extending to the floor. At some time the floor joists and adjacent flooring was whitewashed (Fig 18). All of the foundation sills show deterioration due to moisture and ground contact. The North wall has sustained major sideways movement as a result of tension placed on it by the attached open front long shed and lack of foundation depth and stability (Fig 19). In the back half of the basement ground level room are the remains of four roughly constructed stalls (Fig 20).

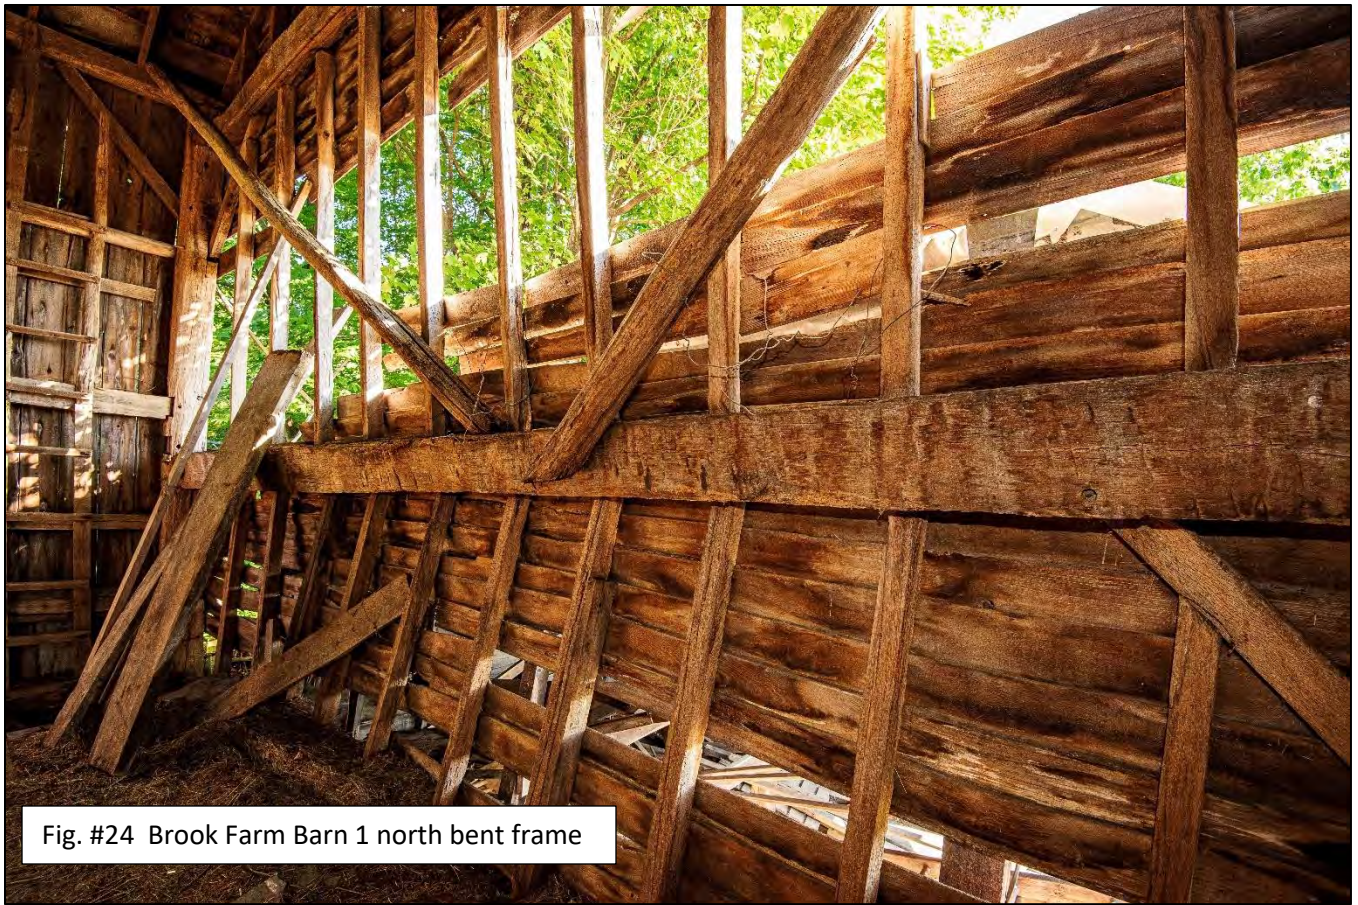
Fig. #24 Brook Farm Barn 1 north bent frame

The large single floor to roof peak main room is fully open for loose hay storage, with three original bents (Fig. 21 & 22). The large upright hand hewn central bent support posts, especially the Eastern post, show major cracking and mortise and tenon failure (Fig 23). A large single hand-hewn timber that is part of the North bent supporting the whole North wall and attached sawed lumber wall framing is broken near its middle and pulled outward by at least a foot (Fig 24).

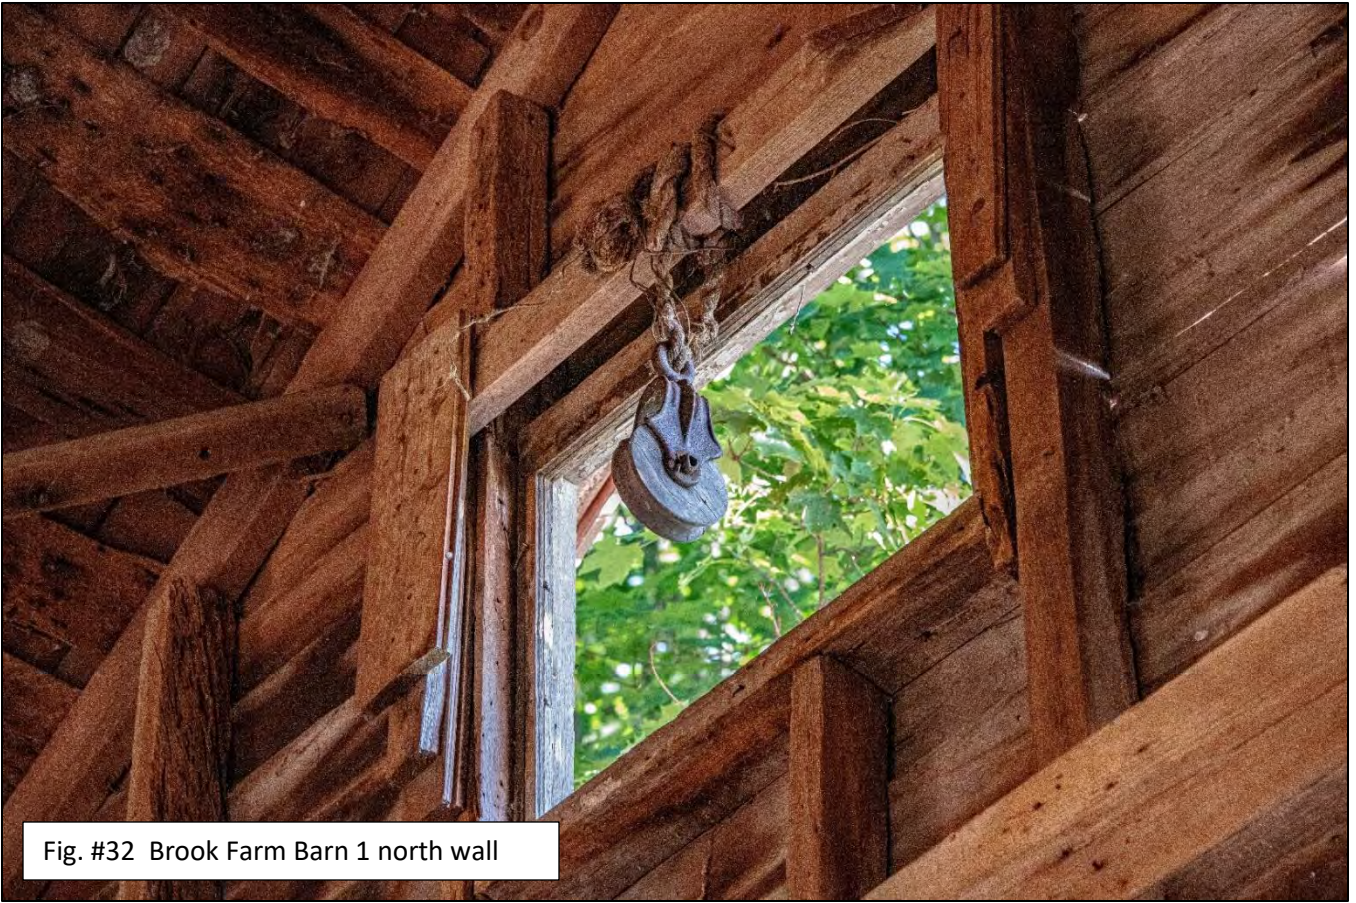
Fig. #32 Brook Farm Barn 1 north wall

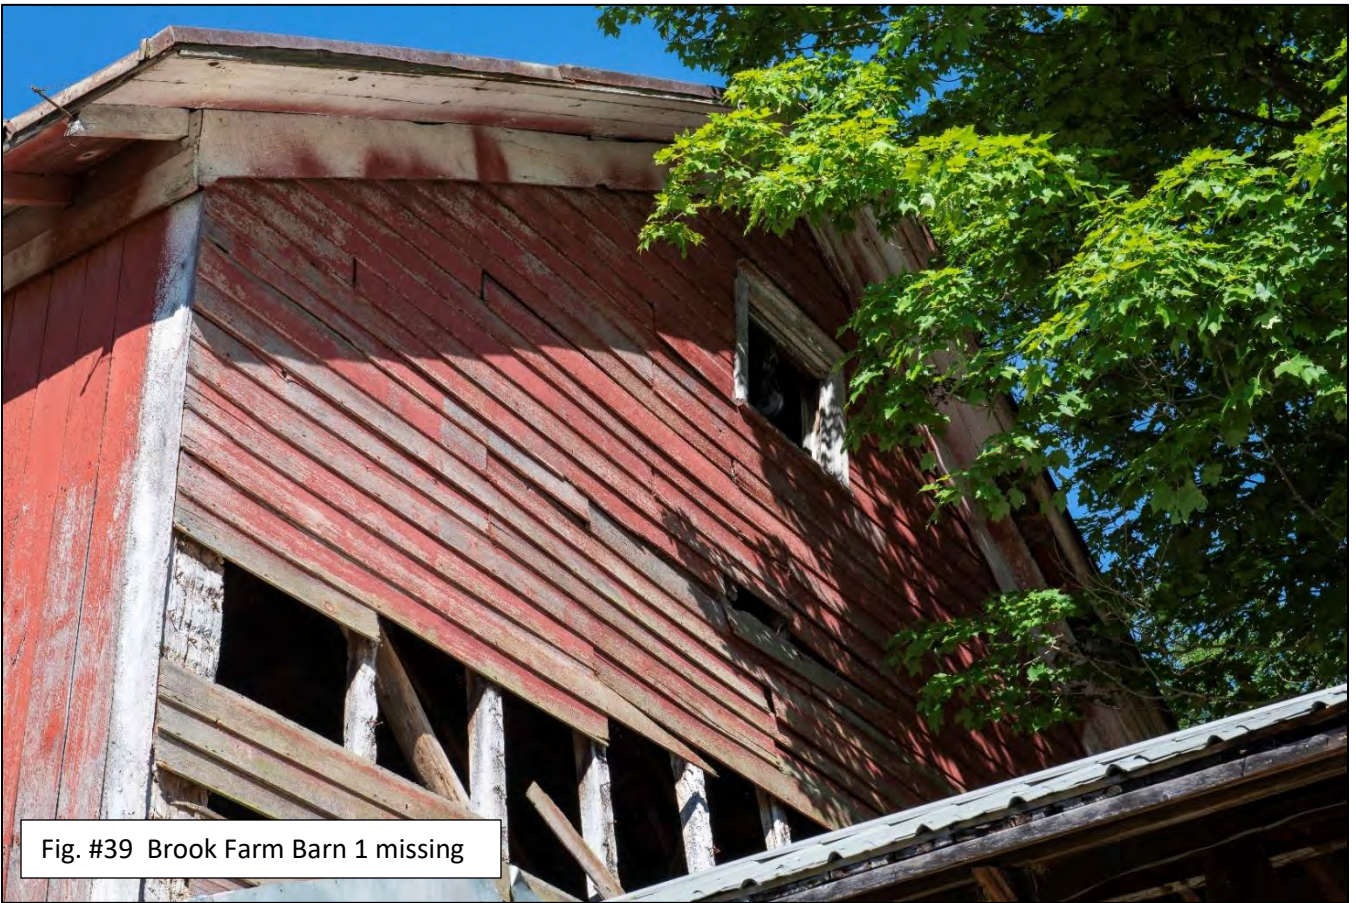
Fig. #39 Brook Farm Barn 1 missing

The siding of the barn consists of two types. Long vertical tongue and groove boards make up the siding on the East, South, and West sides of the main hay mow room (Fig. 37). On the barnyard foundation level on the South wall is horizontal shiplap siding, as well as on the whole North wall attached to sawed framing (Fig. 38). Above the shed roof attached to the North wall considerable siding is missing the large opening allowing for major weather penetration causing extensive frame and floor deterioration (Fig 39). The exposed barn wall framing and siding at the shed attachment shows significant breakage and deflection outward from the large broken main hand hewn North bent beam support failure (Fig 24). The upper bent beam is mostly out of the weather and looks still intact (Fig. 40)

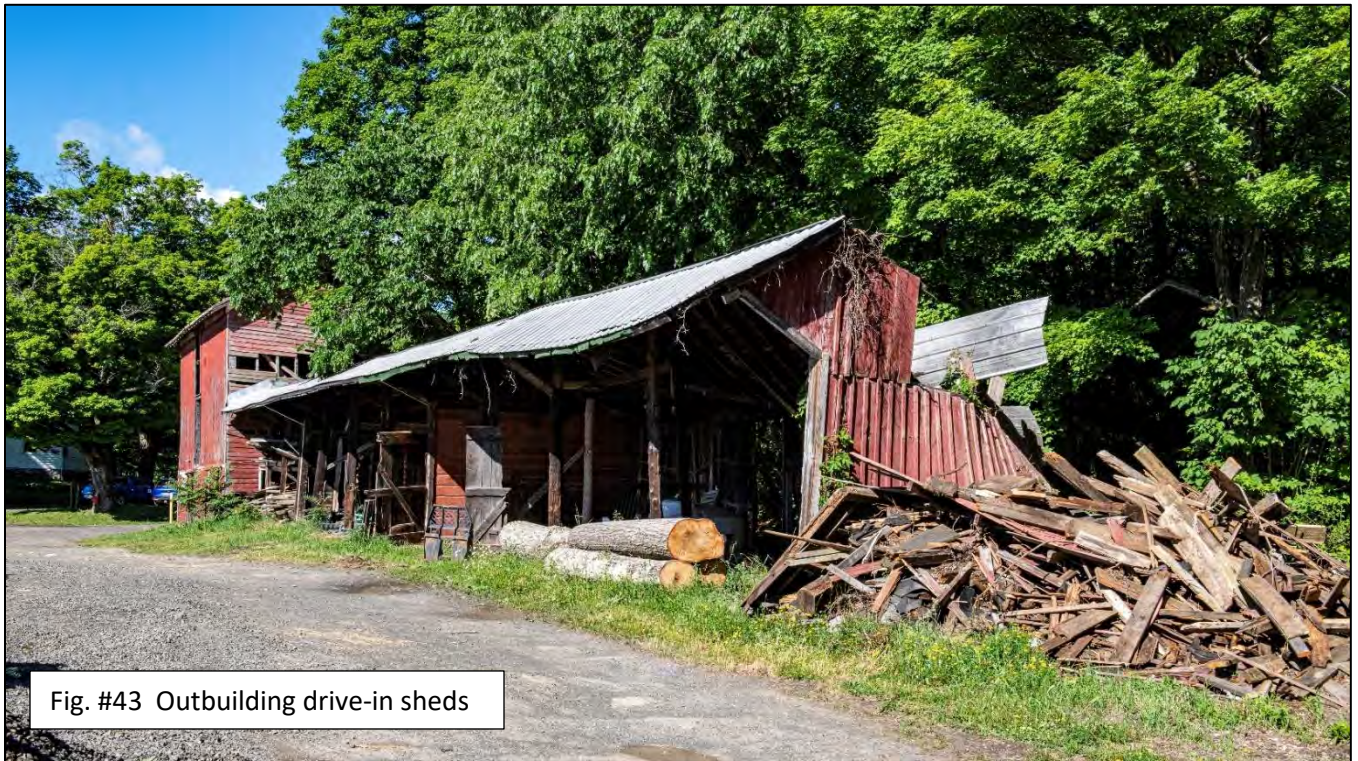
Fig. #43 Outbuilding drive-in sheds

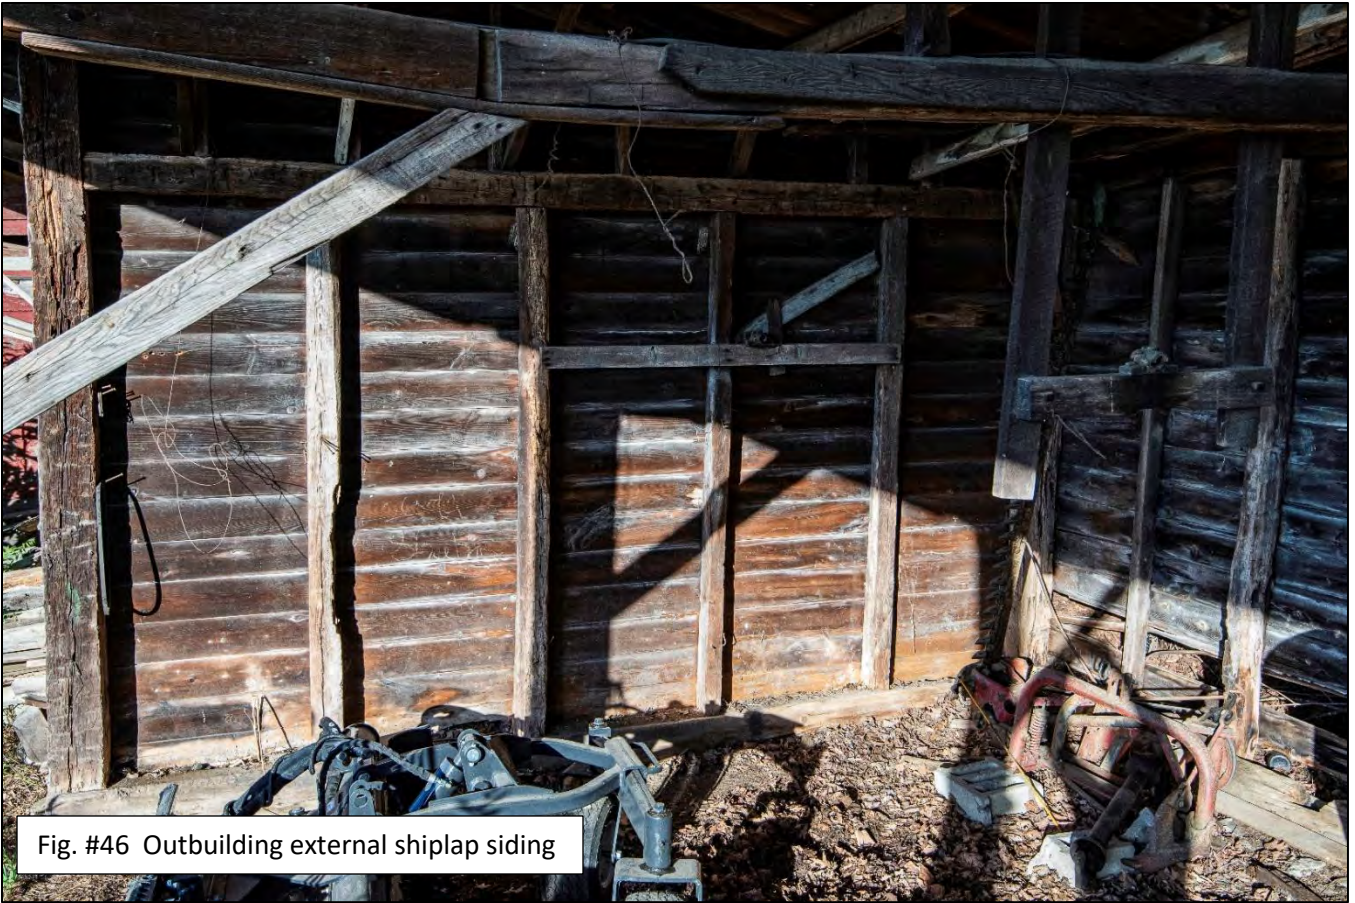
The additional four bays to the North of the main shed, attached to the former exterior red-painted shiplap siding of the main shed, were built with inferior framing and materials and is seriously deteriorated and collapsing on its North end (Fig. 44). Its North end siding consisted of vertical board and batten painted red. A small building the once stood beyond the North end of the sheds has collapsed and is in a pile (Fig. 43). At some time the space between the main shed and Barn 1, about 16 feet to its South, was closed in by an additional and similarly constructed shed used for lumber storage (Fig. 45). Its frame is attached to the former exterior red painted shiplap siding of the main shed facing South to Barn 1 (Fig. 46). The main shed did not appear in the 1915 New York State Archives photograph showing Brook Farm.

Fig. #46 Outbuilding external shiplap siding

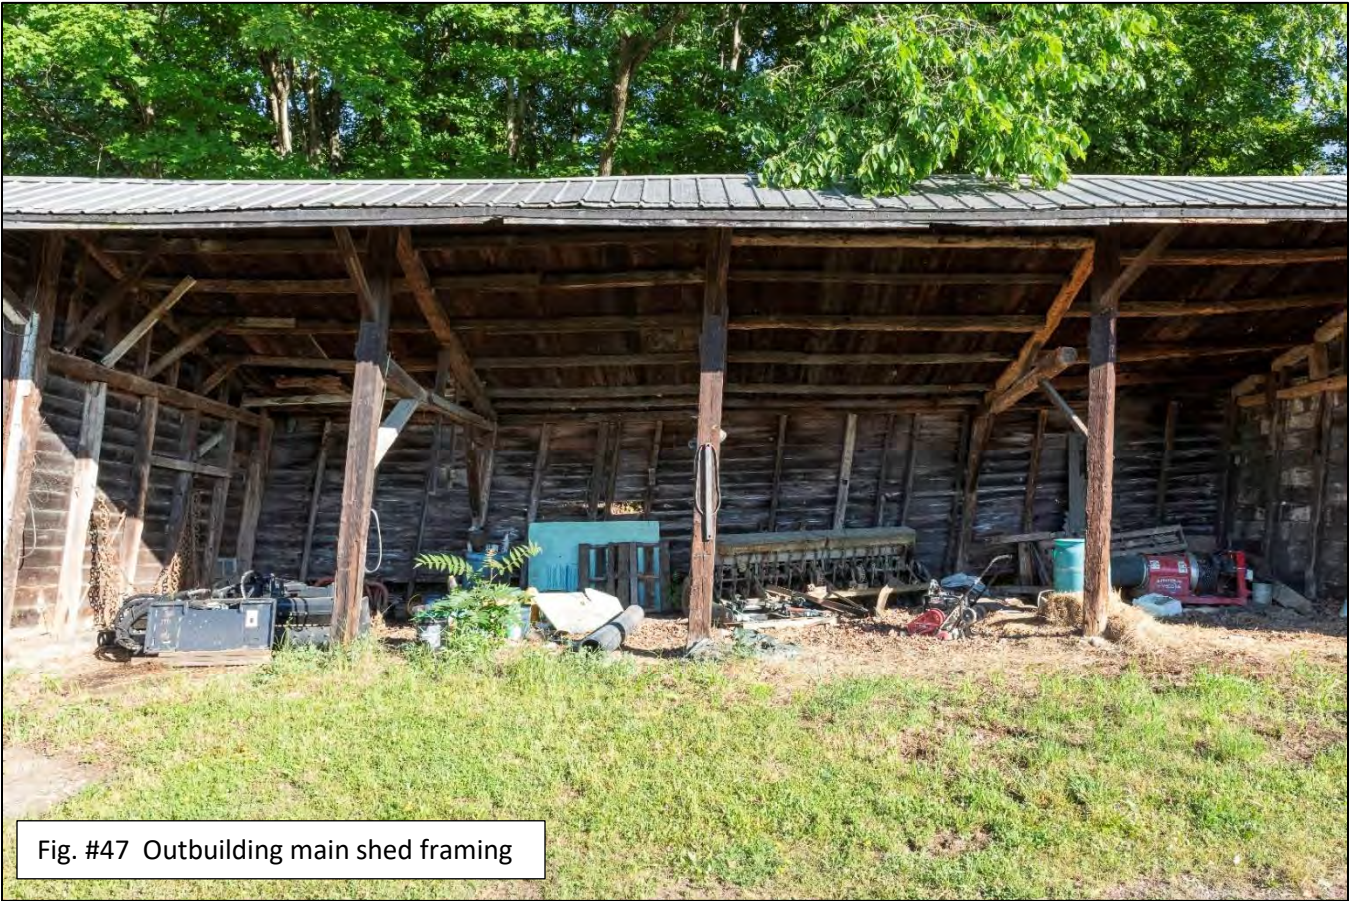
Fig. #47 Outbuilding main shed framing

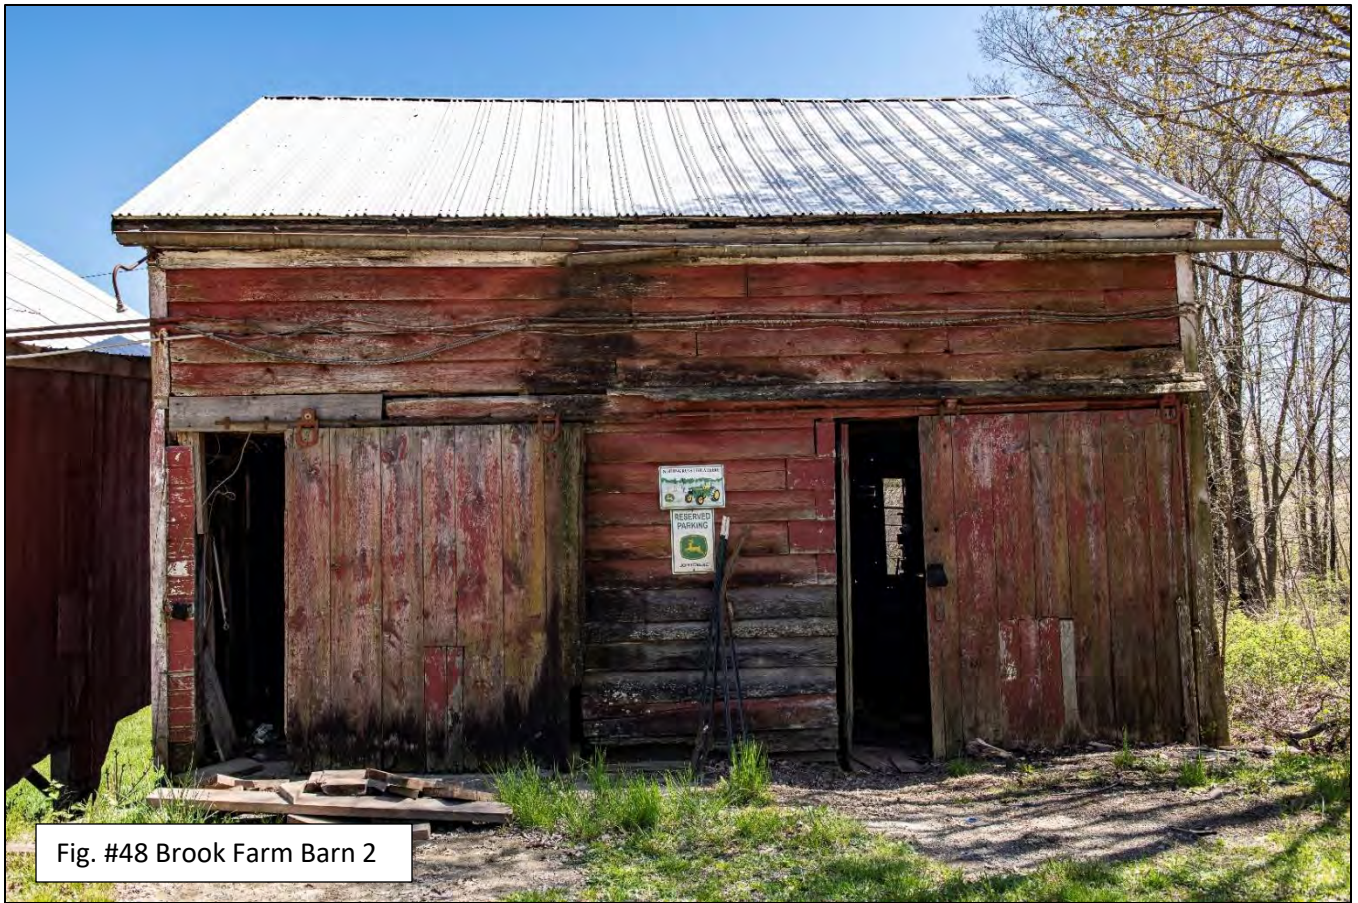
Fig. #48 Brook Farm Barn 2

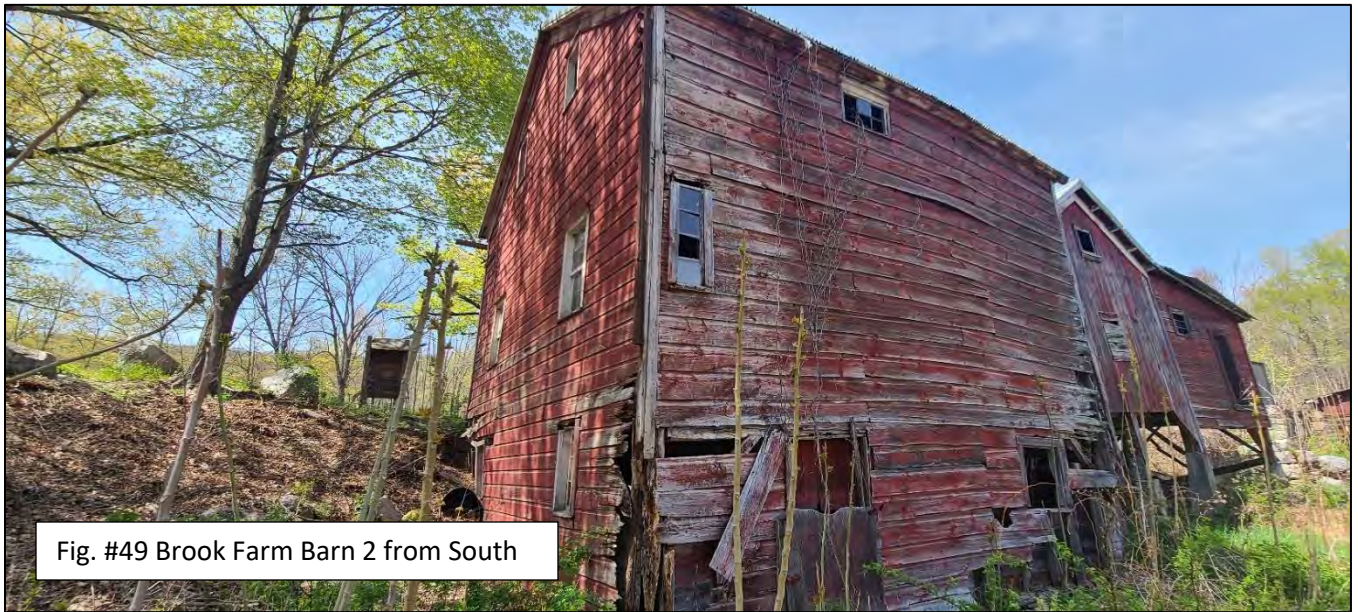
The building date of this small barn, closest to Lenape Lane, is unknown (Fig. 49). It is located within 10 feet of the adjacent Barn 3 (Fig. 50). It appears in the 1915 photograph from the New York State Archives. It is a single-story wood frame building, 24 feet by 24 feet in size, built into the slope on its western side, where it is supported by a dry stack retaining wall of native conglomerate stones (Fig. 51). It has an upstairs under roof storage area, and a basement beneath with a low ceiling whitewashed area with stalls on a concrete floor. The basement by its low height, was possibly used for pigs, young cows, or goats, as it was far too low for use by standard horses. These bottom stalls were accessed by two different doors, the existing one on the northeast corner supported outside by two top rollers on a track, the rollers labelled Myers Sure Grip, made in Ashland, Ohio (Figs. 52, 53, 54, 55).

Fig. #49 Brook Farm Barn 2 from South

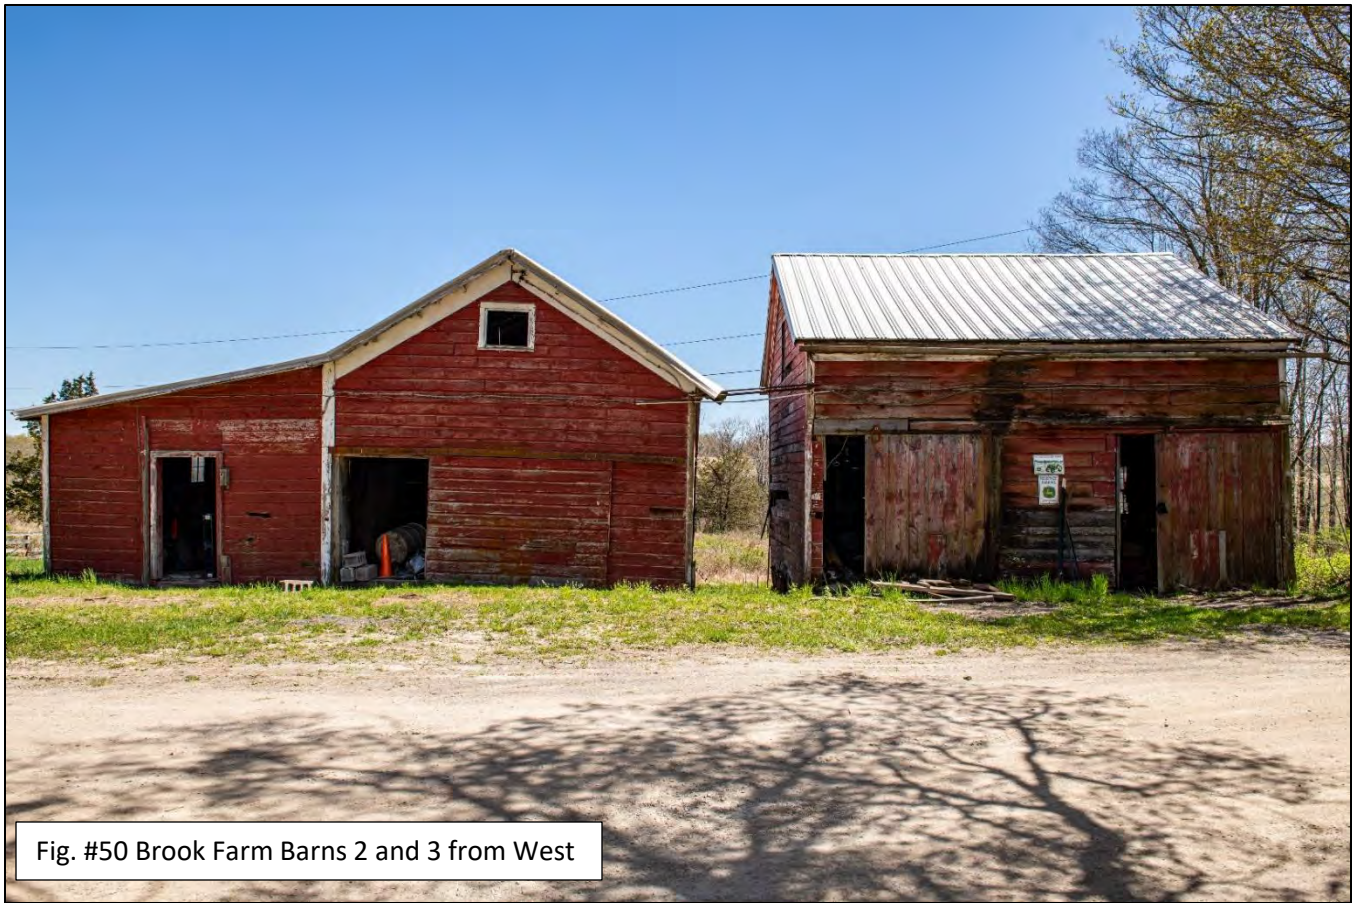
This barn is located adjacent to Barn 2 (Fig. 50). Its construction date is unknown. It is shown in the 1915 New York State Archives photograph. It is a single-story wood frame barn, 33 feet by 20 feet in size, with a small partial walk up attic area (Fig. 72). It is built into the slope on its western side, supported by the same retaining wall. The wall has had major settlement and movement, the north end now collapsed allowing for sinking and settlement of the building (Fig. 73).

Fig. #50 Brook Farm Barns 2 and 3 from West

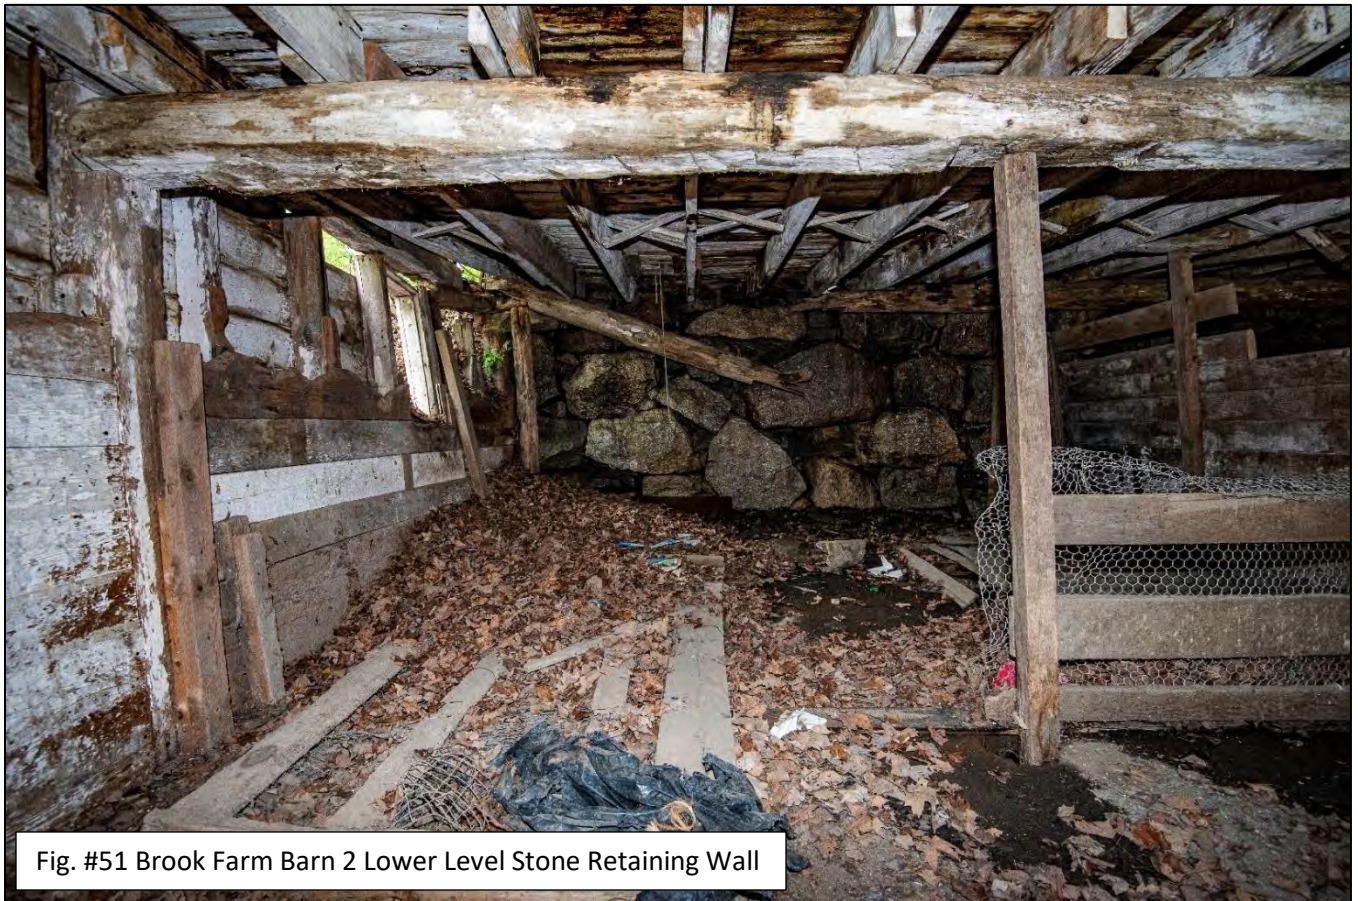
Fig. #51 Brook Farm Barn 2 Lower Level Stone Retaining Wall
