Existing Conditions Report

Brook Farm Barn Complex

Lenape Lane, New Platz, NY

June 2024

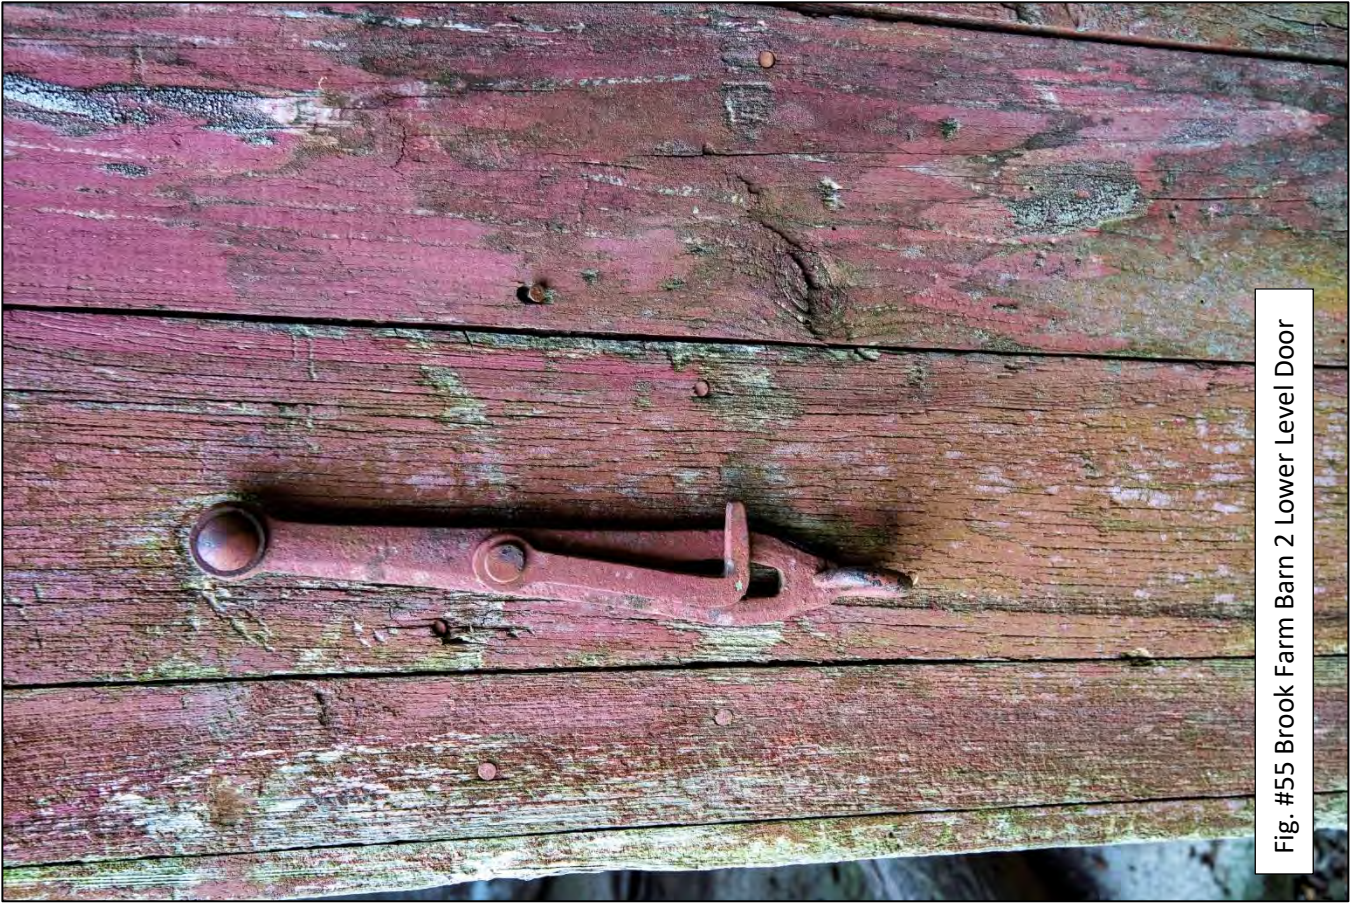
The building date of this small barn, closest to Lenape Lane, is unknown (Fig. 49). It is located within 10 feet of the adjacent Barn 3 (Fig. 50). It appears in the 1915 photograph from the New York State Archives. It is a single-story wood frame building, 24 feet by 24 feet in size, built into the slope on its western side, where it is supported by a dry stack retaining wall of native conglomerate stones (Fig. 51). It has an upstairs under roof storage area, and a basement beneath with a low ceiling whitewashed area with stalls on a concrete floor. The basement by its low height, was possibly used for pigs, young cows, or goats, as it was far too low for use by standard horses. These bottom stalls were accessed by two different doors, the existing one on the northeast corner supported outside by two top rollers on a track, the rollers labelled Myers Sure Grip, made in Ashland, Ohio (Figs. 52, 53, 54, 55).

Fig. #55 Brook Farm Barn 2 Lower Level Door

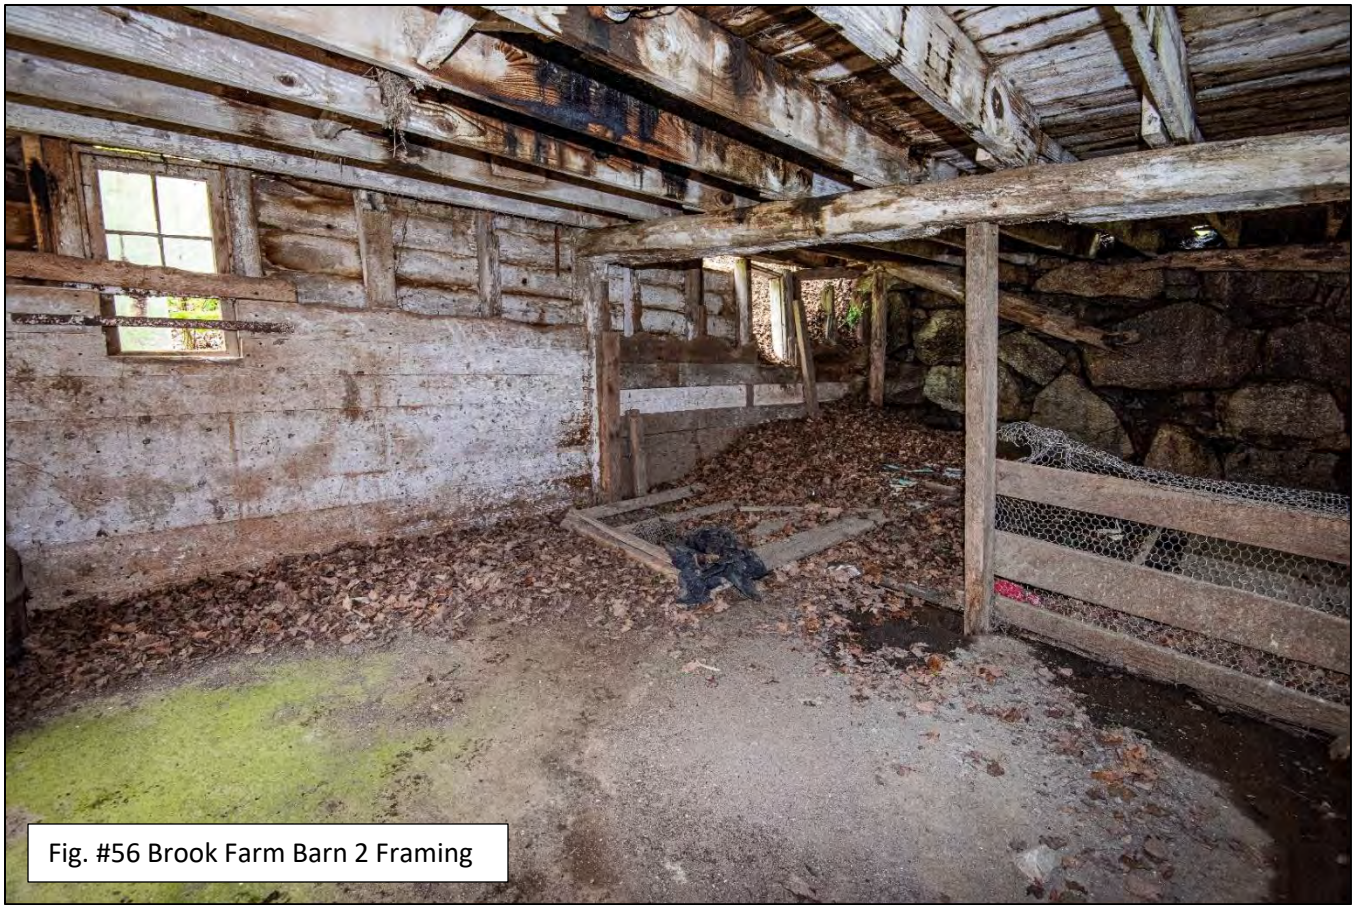
The framing of the barn is a mix of mostly rough cut domestic sawed lumber, with older and larger hand-hewn timbers repurposed and used in key support positions. Domestic rough sawed main floor joists are supported by native tree pole supports below (Figs. 56, 57, 58, 59). This mix of lumber indicates a build likely after Mohonk took ownership of Brook Farm in 1906.

Fig. #56 Brook Farm Barn 2 Framing

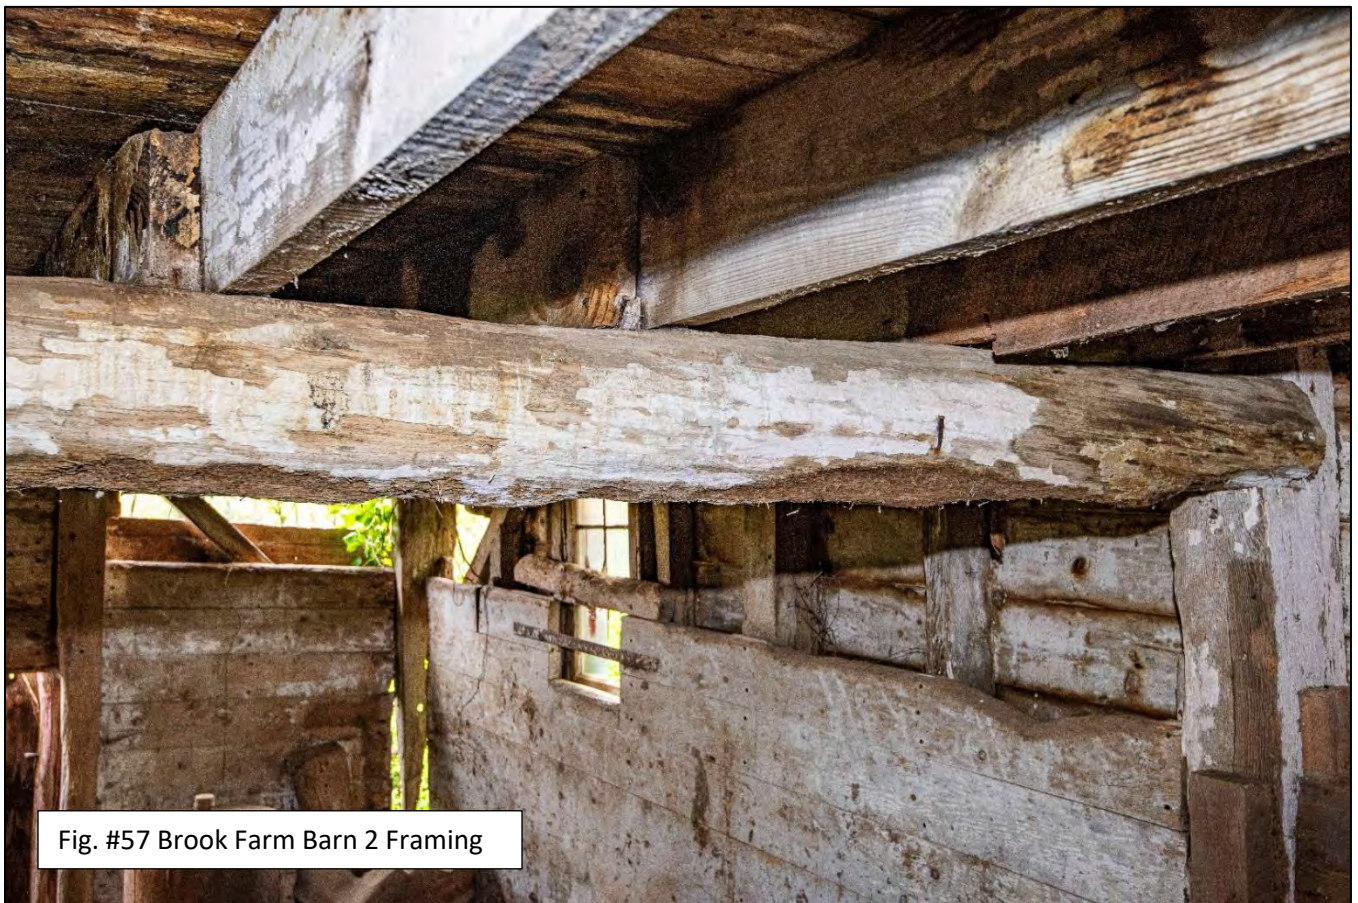
Fig. #57 Brook Farm Barn 2 Framing

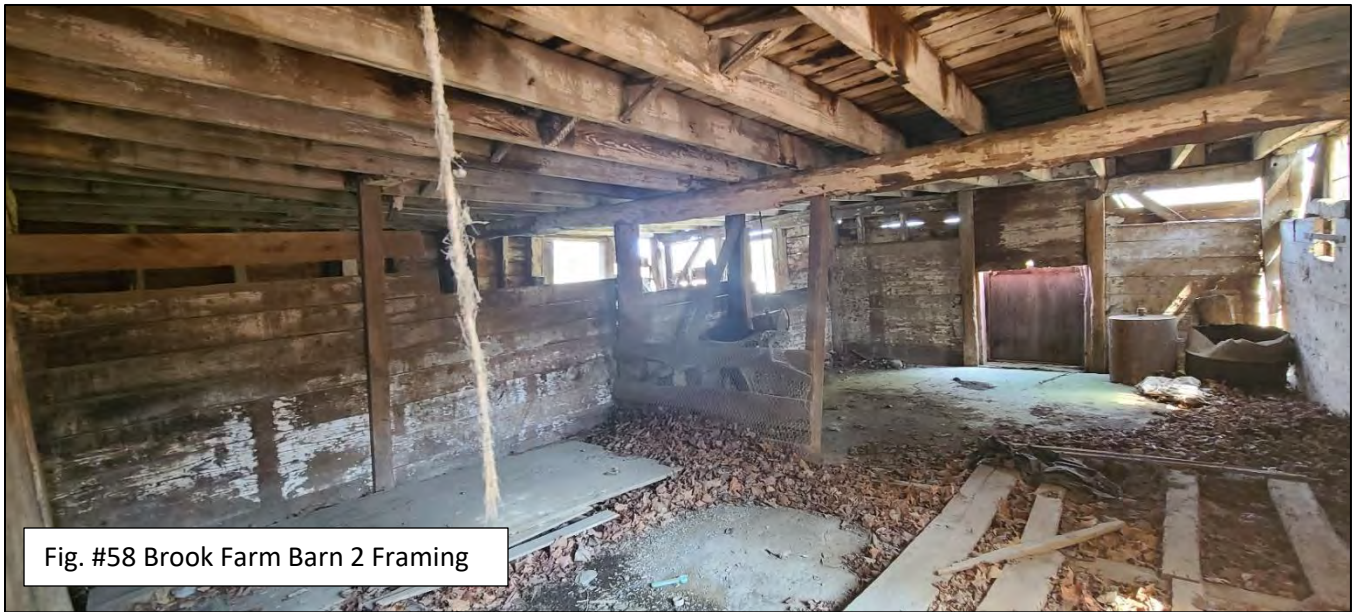
Fig. #58 Brook Farm Barn 2 Framing

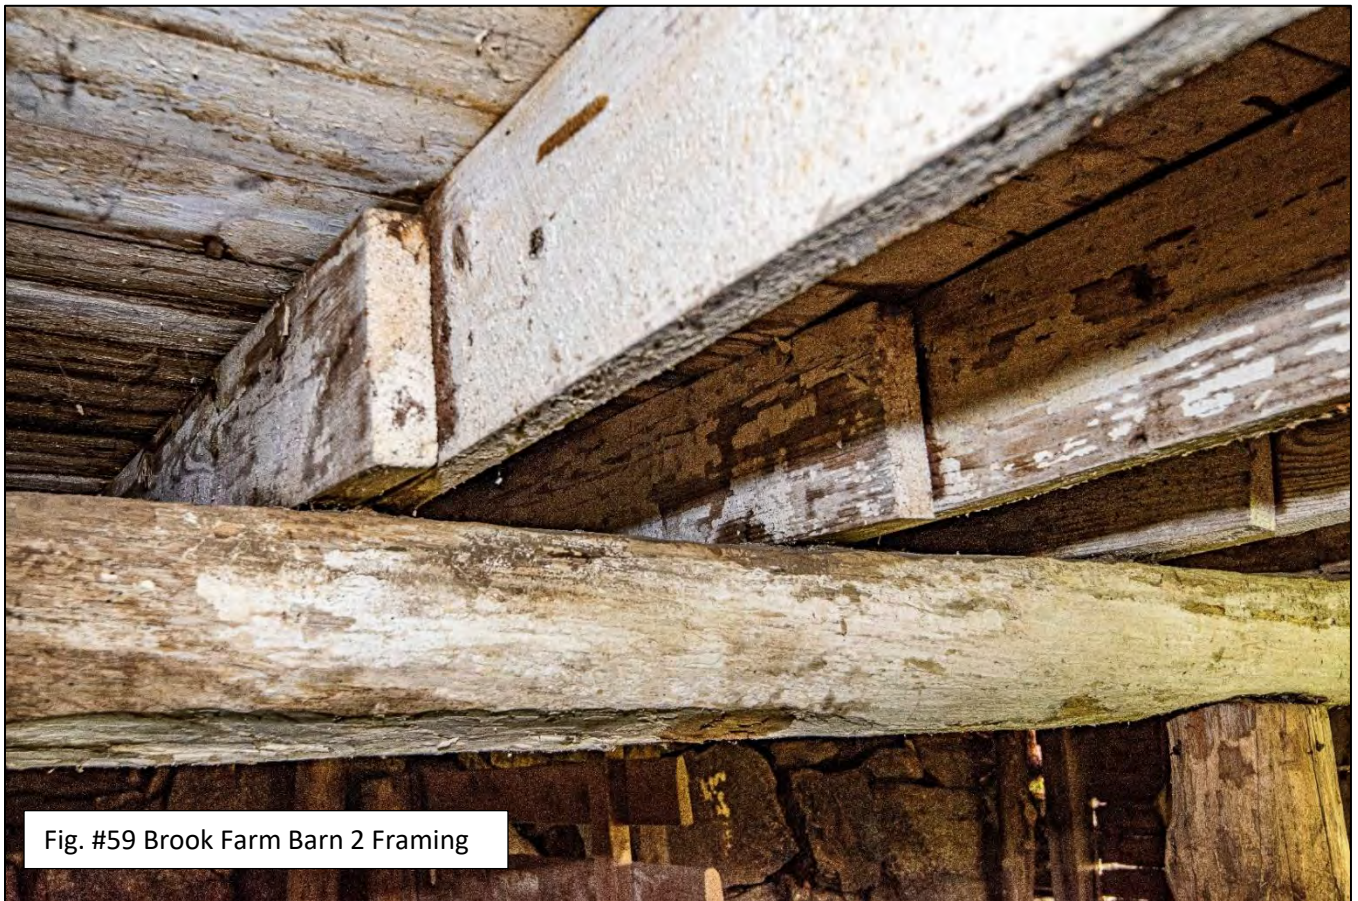
Fig. #59 Brook Farm Barn 2 Framing

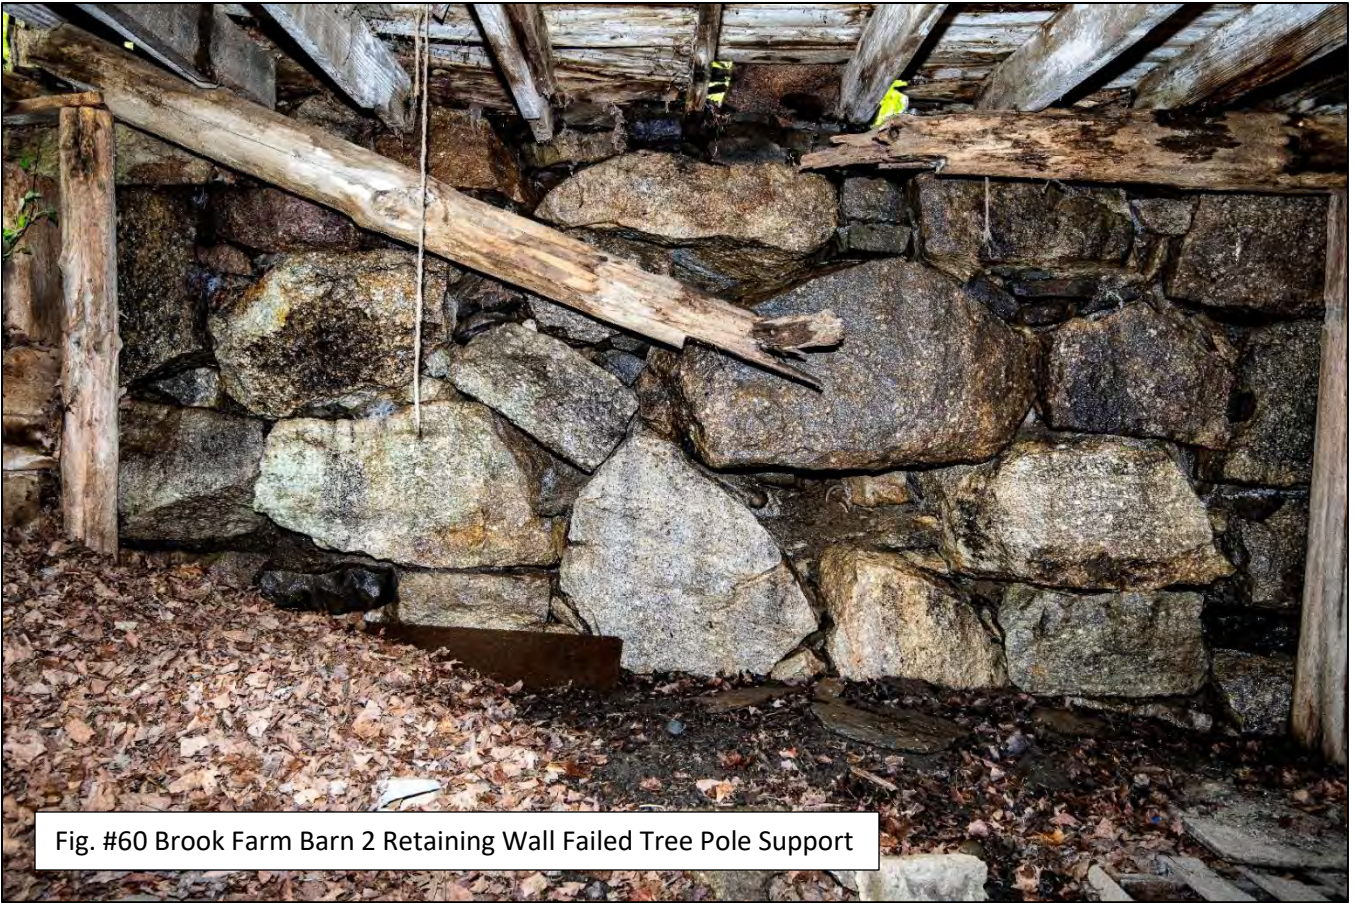
Fig. #60 Brook Farm Barn 2 Retaining Wall Failed Tree Pole Support

The supporting six-foot-tall stone foundation retaining wall on the west side shows heavy deterioration from the annual freeze/thaw cycle, and settlement. A tree pole support beam added adjacent to the top of the stone wall inside has broken and completely failed (Fig.60). Wood pole foundation support posts in contact with the ground, have failed, rotted, or settled (Fig. 61).

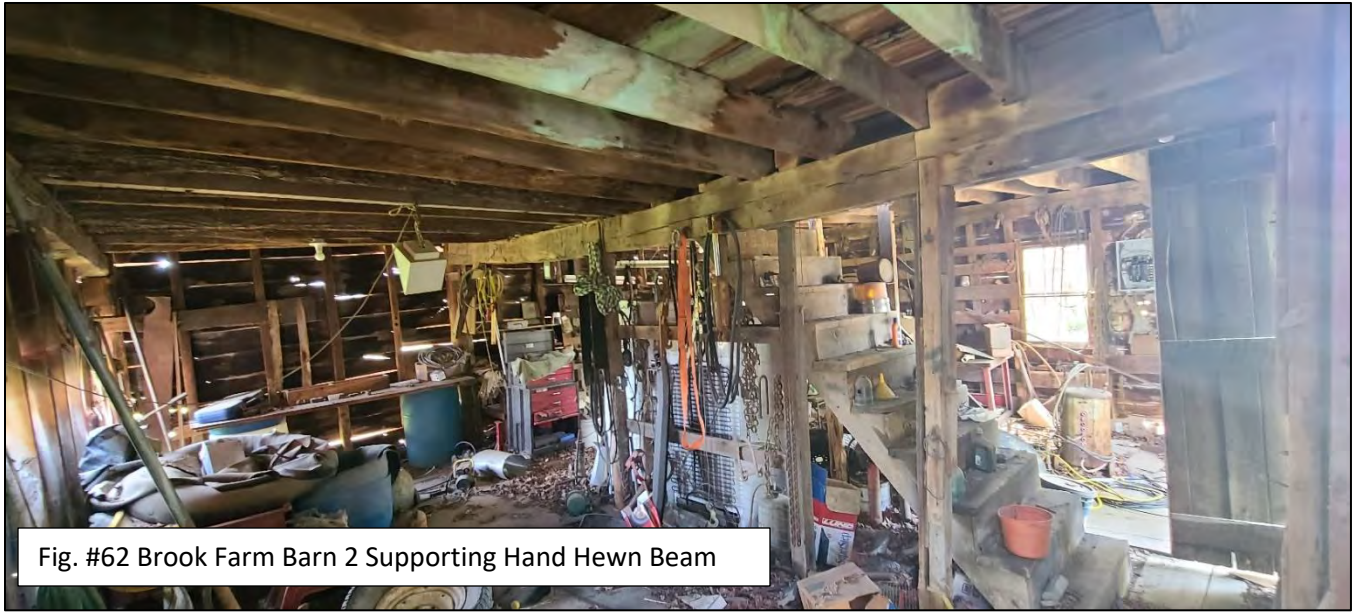
The upstairs floor joists are supported by a large repurposed hand-hewn beam (Fig. 62). Many of the joists are rough sawed tree poles with the bark still on (Fig. 63). Upstairs in the north corner wire caging was used to confine domestic fowl, probably chickens (Fig. 64). Outside access to the barn yard was made by two front doors both supported by top rollers on a continuous single rail across the front of the barn (Fig. 65). Sheathing is shiplap of two different sizes and is heavily weathered. In some places the sheathing has holes or is missing, thus allowing for considerable outside exposure causing rotting of the wall studs (Fig. 66). Some standard size windows were installed with six over six glass panes, while others were just six panes installed both vertical in the basement and horizontal in the attic (Fig. 67). One single vertical four pane window was installed near the east corner of the main room (Fig. 68).

Fig. #62 Brook Farm Barn 2 Supporting Hand Hewn Beam

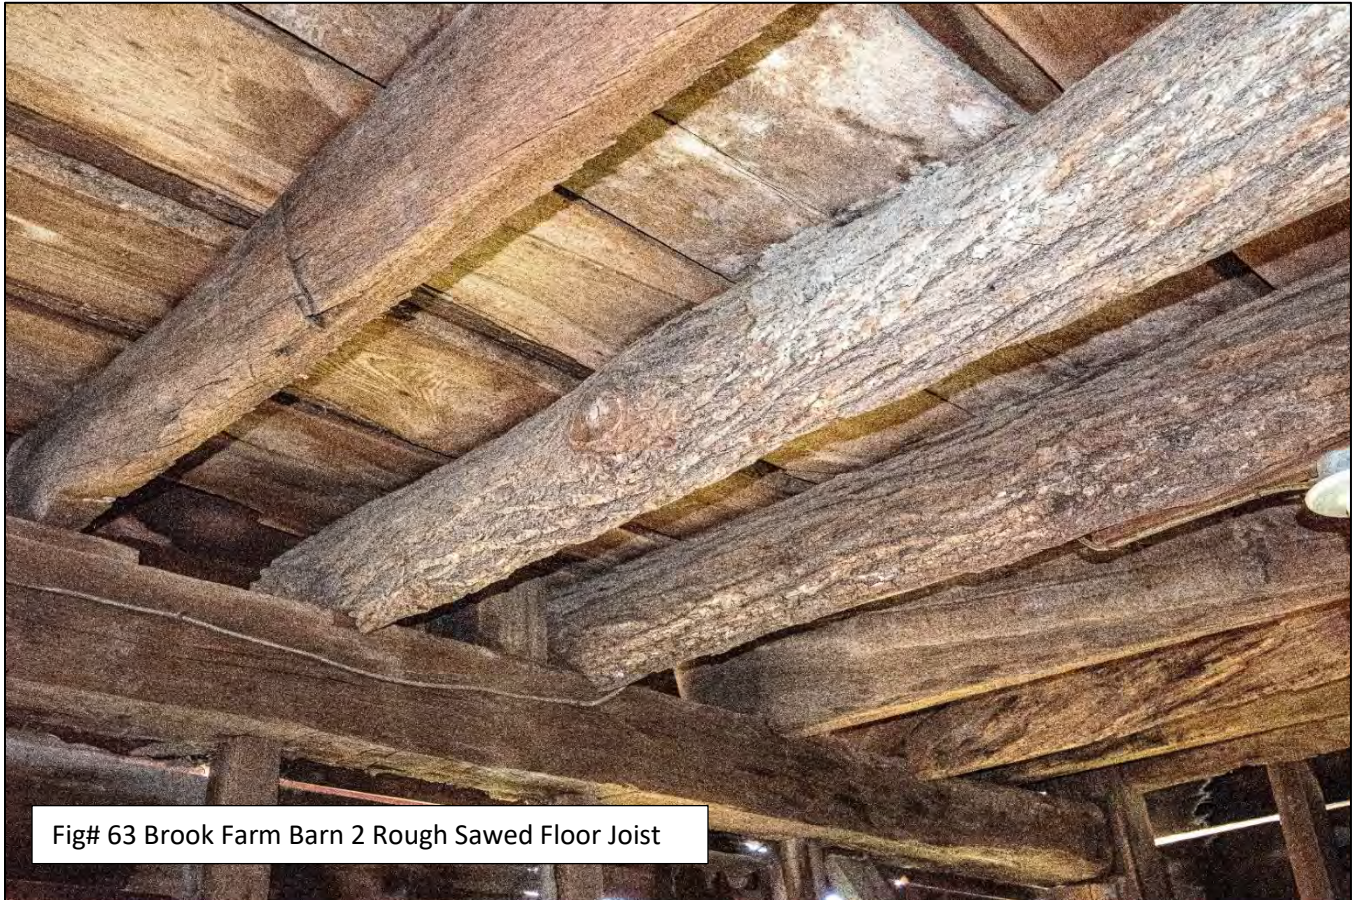
Fig# 63 Brook Farm Barn 2 Rough Sawn Floor Joist

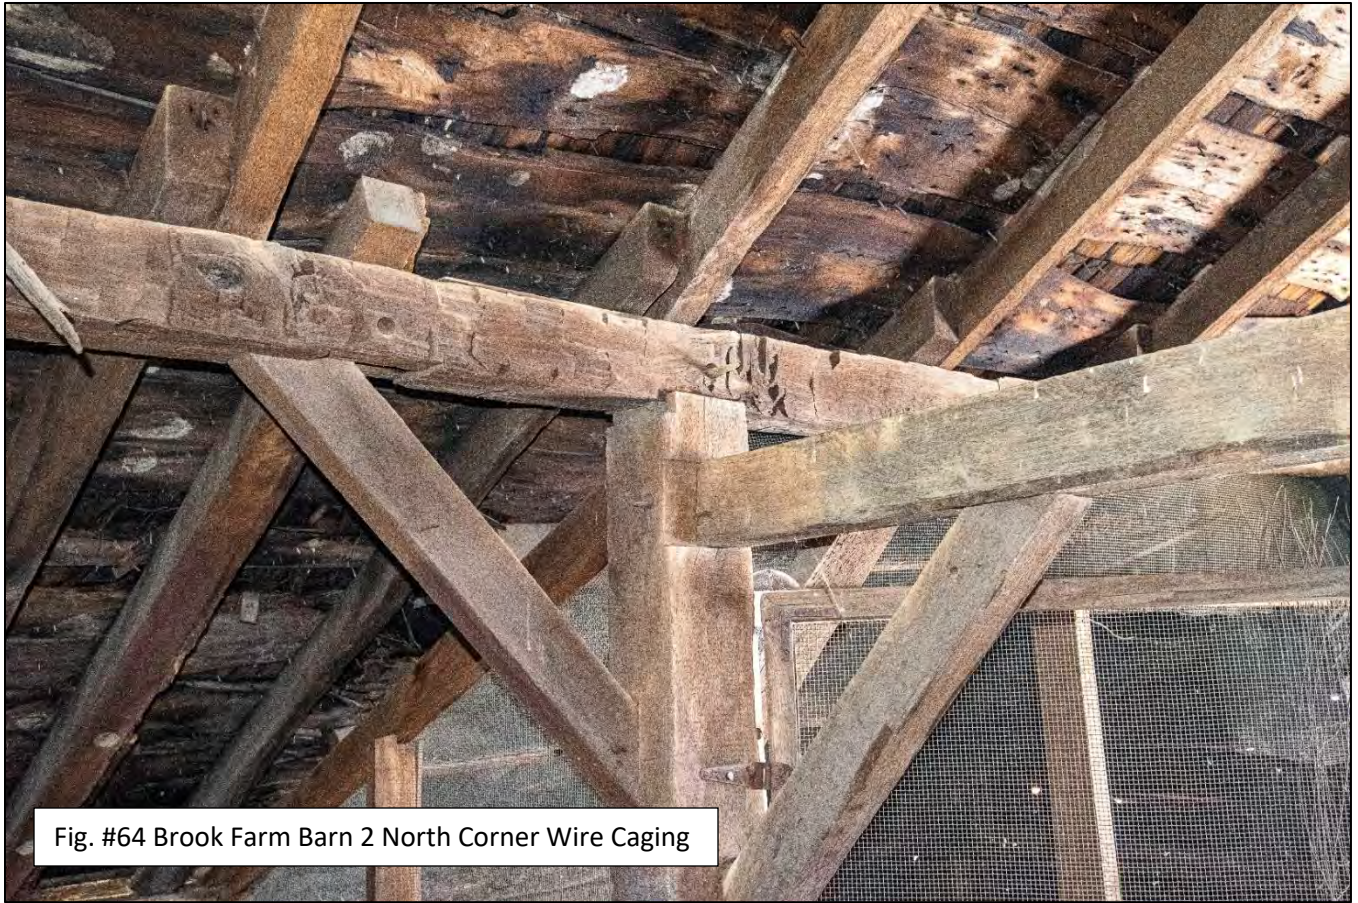
Fig. #64 Brook Farm Barn 2 North Corner Wire Caging

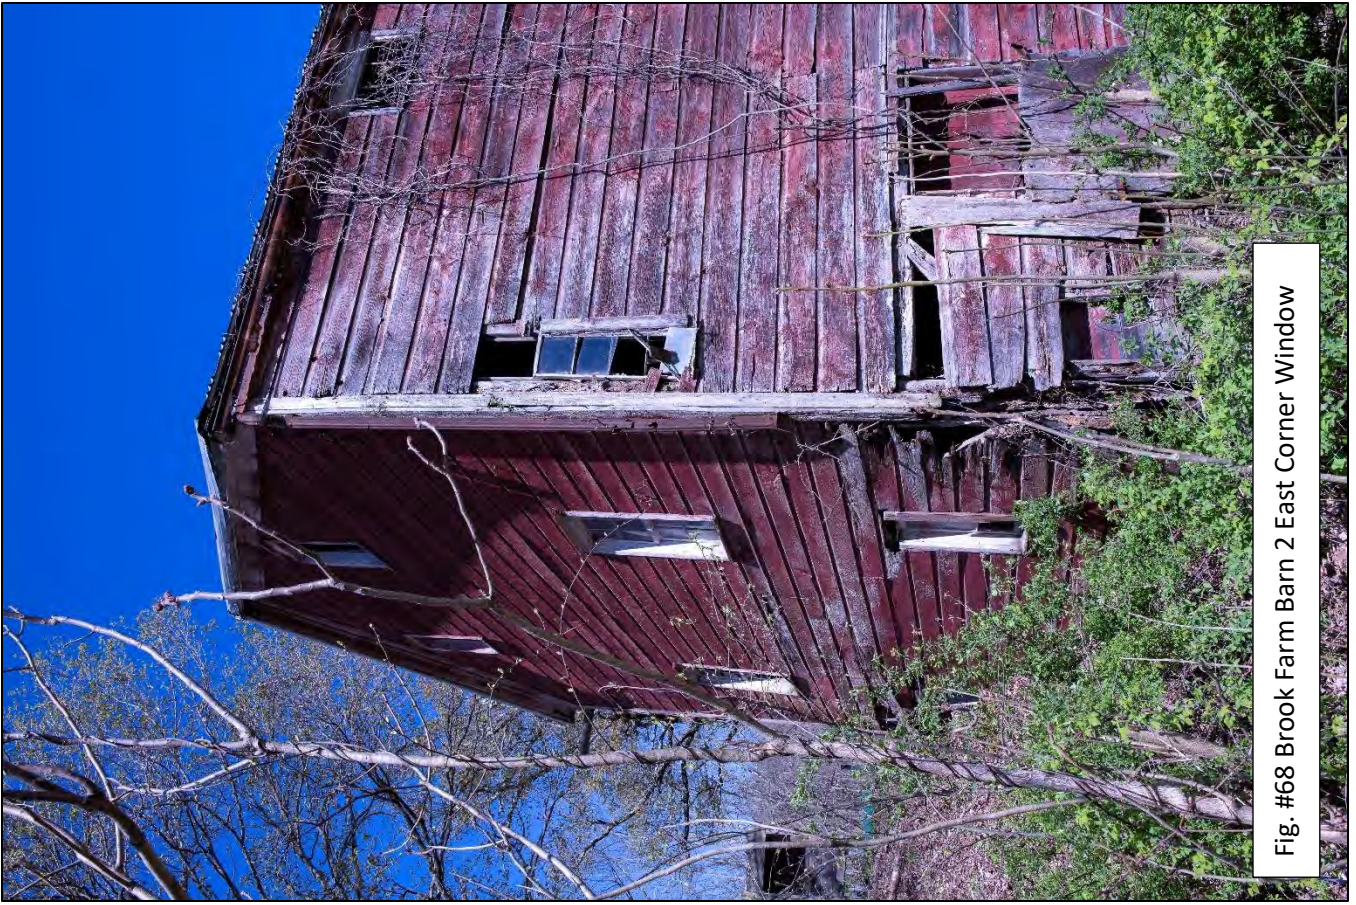
Fig. #68 Brook Farm Barn 2 East Corner Window

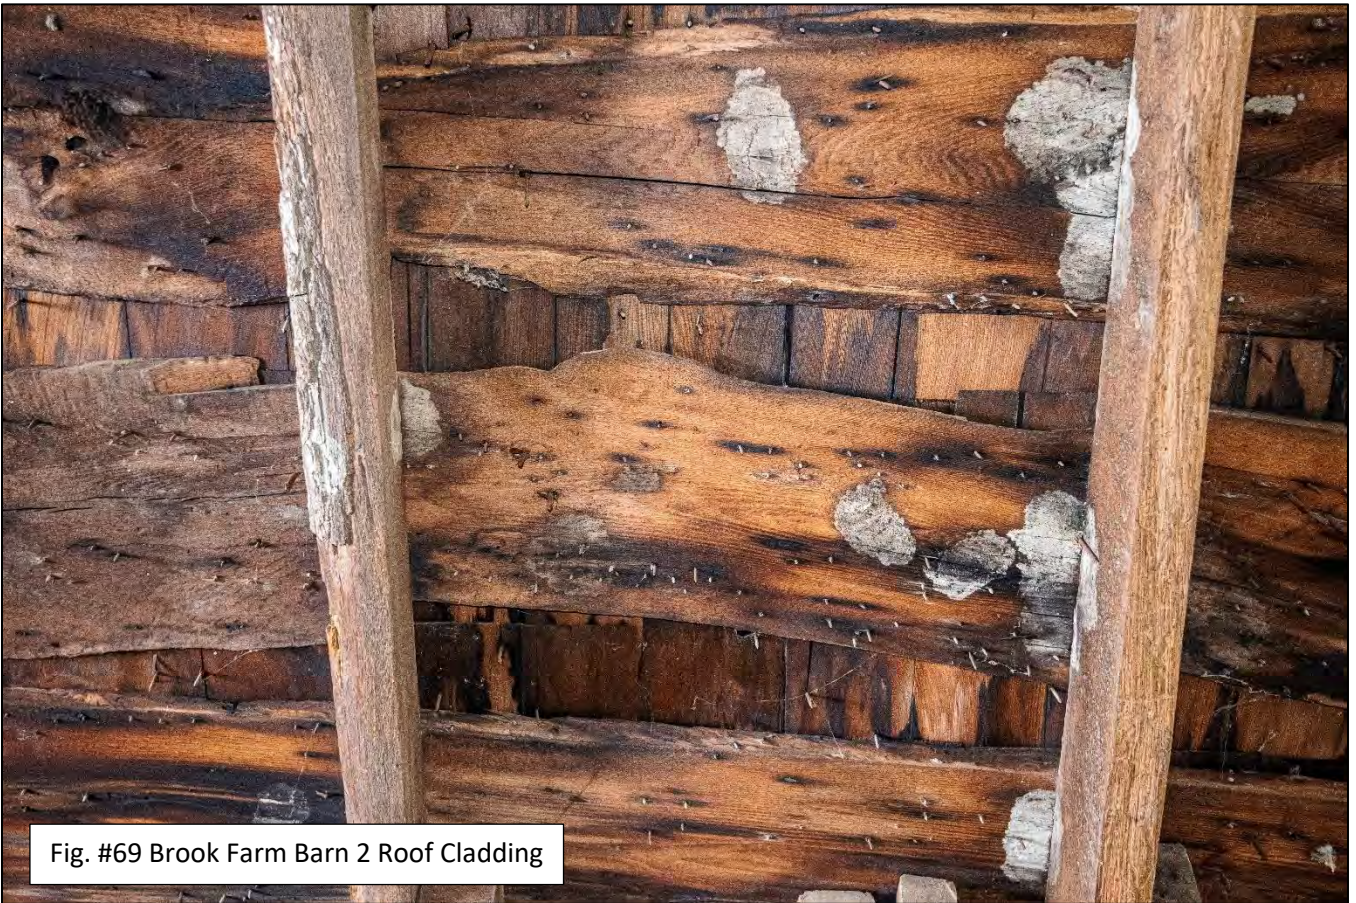
The roof of Barn 2 was constructed with its peak running approximately north to south, draining the roof surface directly over the two front doors (Fig. 48). The roof was clad with irregularly shaped and spaced broad boards topped with cedar shakes. Two layers of asphalt shingles were added on top of the cedar shakes. The roof shows extensive deterioration and rotting from leaking as evidenced by staining and missing sheathing inside. The undersized and widely spaced rough sawed roof rafters, some with bark still on, were reinforced in places to help support the roof load. Many show deflection and decay (Figs. 69 & 70). The roof was covered over with corrugated metal roofing (Fig. 48).

Fig. #69 Brook Farm Barn 2 Roof Cladding

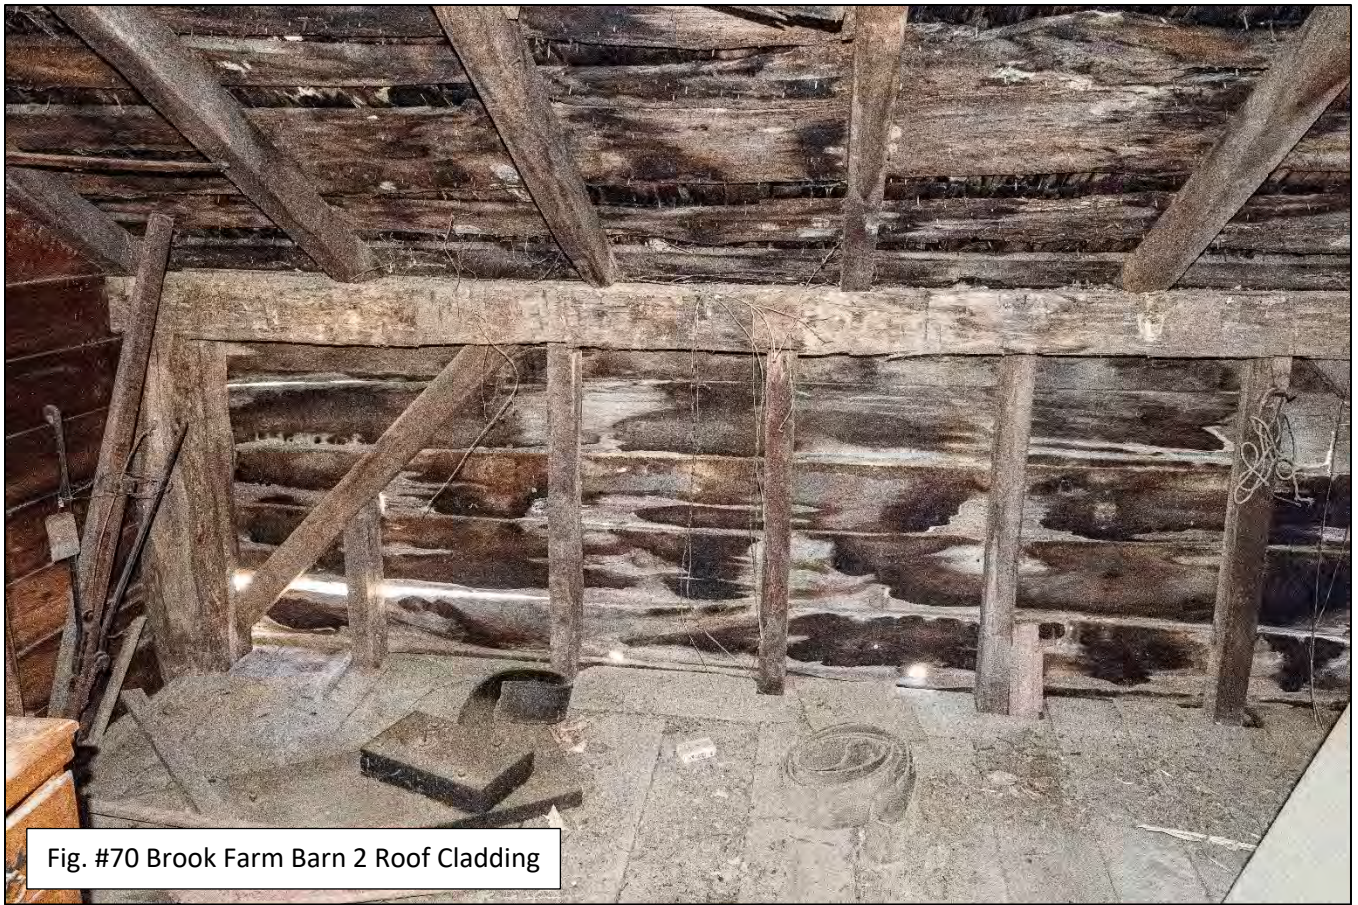
Fig. #70 Brook Farm Barn 2 Roof Cladding

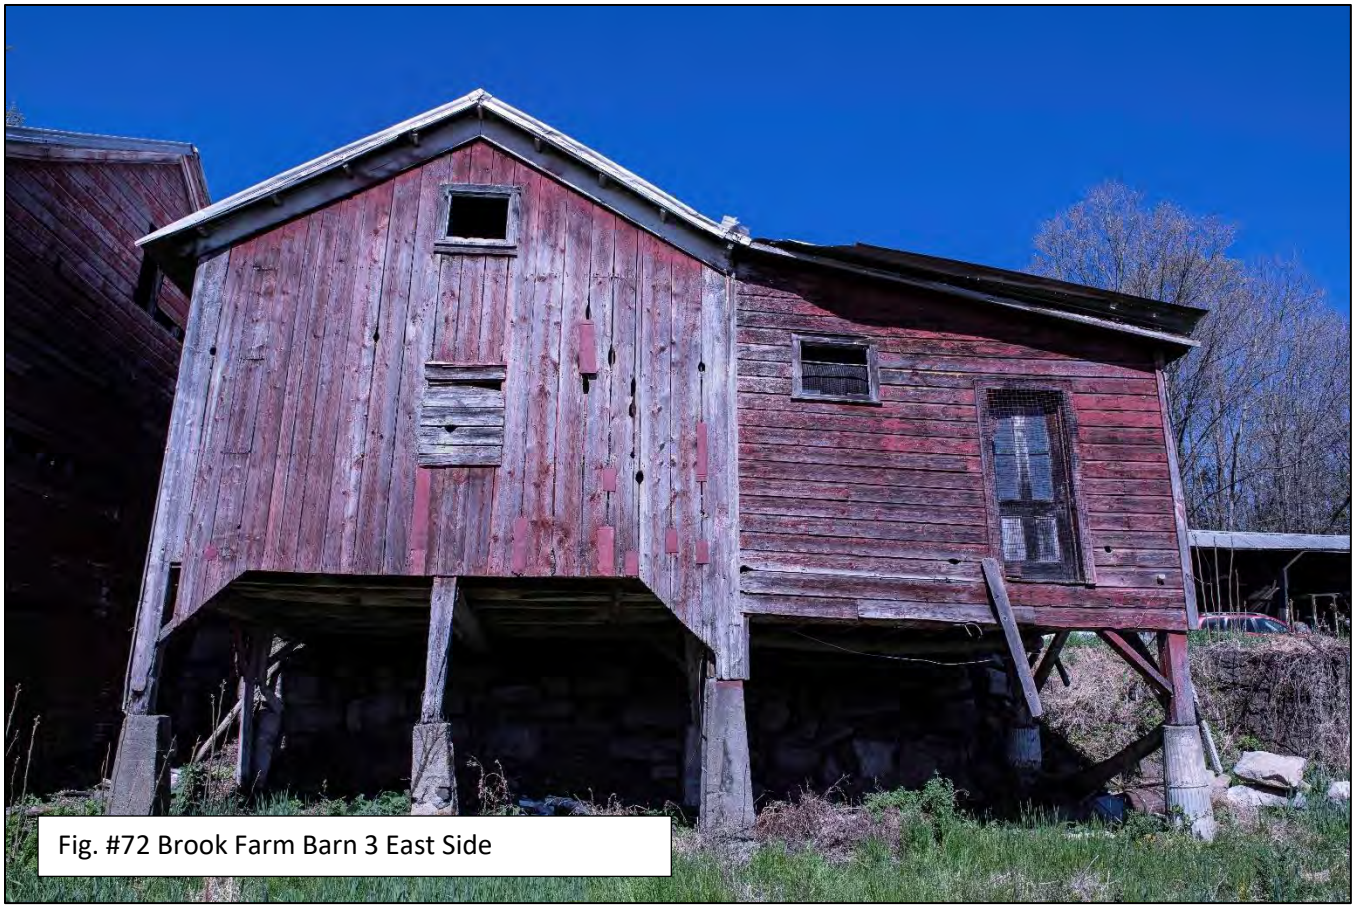
Fig. #72 Brook Farm Barn 3 East Side

77, 78). At an unknown date, an open one room shed-roofed addition was added to the original building on its north side (Figs. 72, 79). A six-panel door opened on the east side from the main floor level of the shed addition, its use unknown. The original building had its roof ridge-oriented east to west. The roof of the shed addition faces north. The shed has a layer of sheathing on the inside of the vertical framing up to just under the roof rafters (Fig. 80). Hardware wire covers the inside of the shed windows. Part of the exterior red painted outside wall of the original building is exposed inside the shed (Fig. 81).

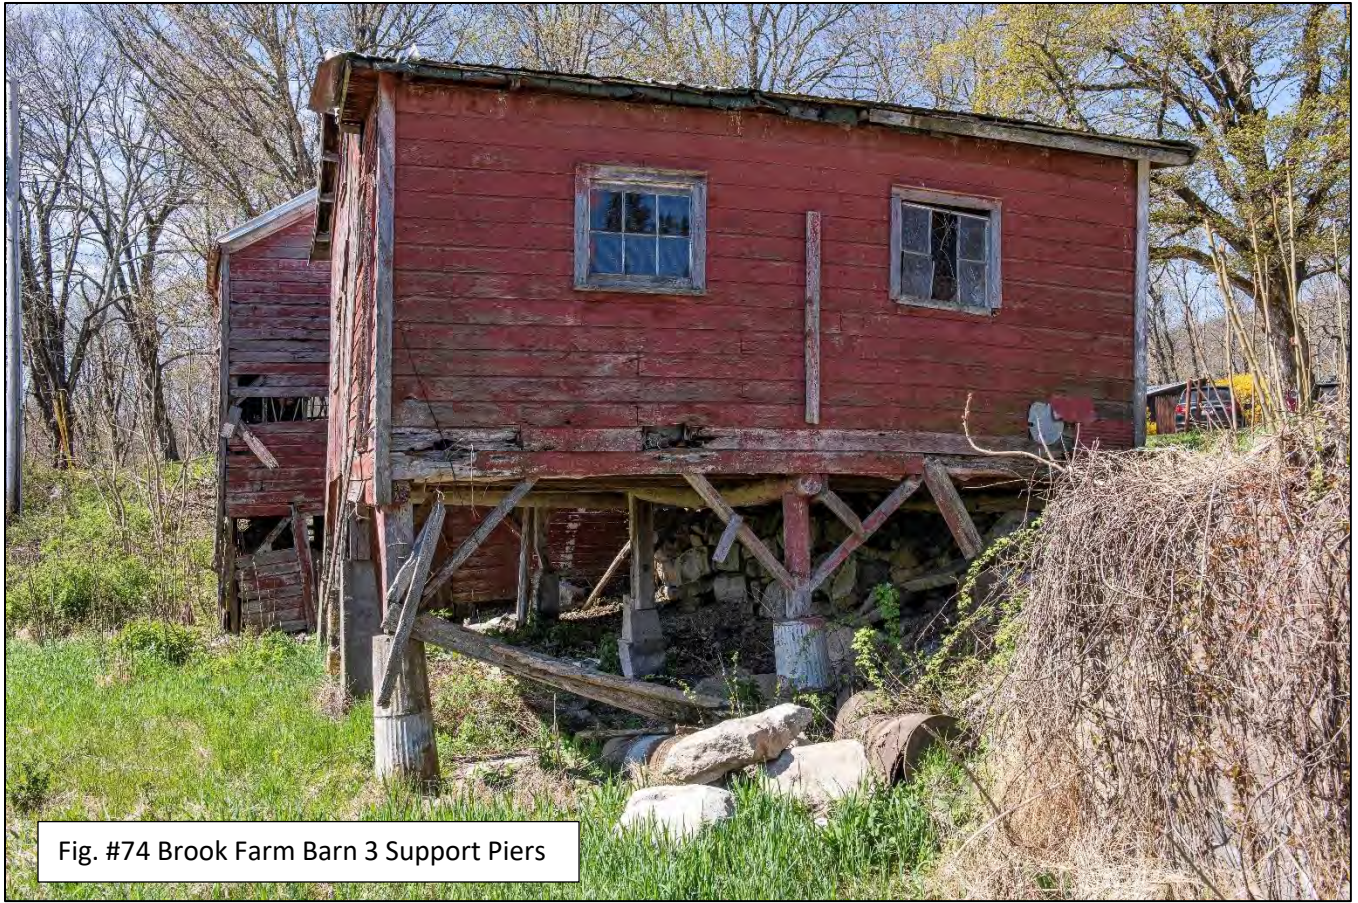
Fig. #74 Brook Farm Barn 3 Support Piers

The foundation of both the original section and a shed addition are supported by tapered concrete piers. Most of the piers are tipped from vertical as a result of being open to weather exposure and frost movement. Two piers under the north side of the shed addition were formed by garbage can forms (Fig. 74). For extra support, tree poles were added under the floor joists. The lower level of the original building, on the east side, has tapered openings for wider access (Fig. 75).

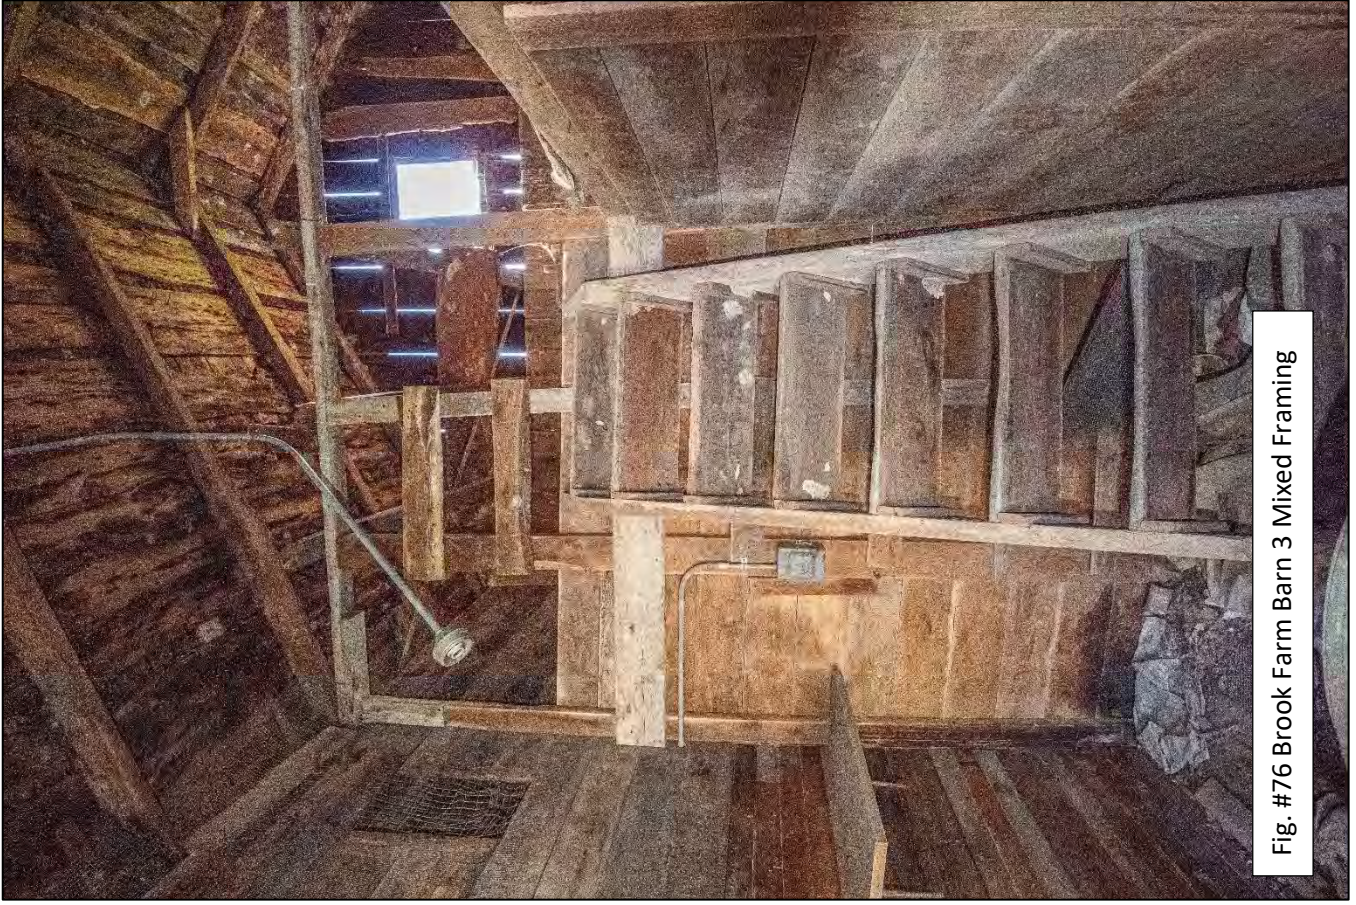
Fig. #76 Brook Farm Barn 3 Mixed Framing

Framing is mostly of rough cut domestic sawed lumber, some still with the bark on, including the upstairs floor joists and roof rafters. A few pieces of large old repurposed hand-hewn support timbers are mixed in (Figs. 76,

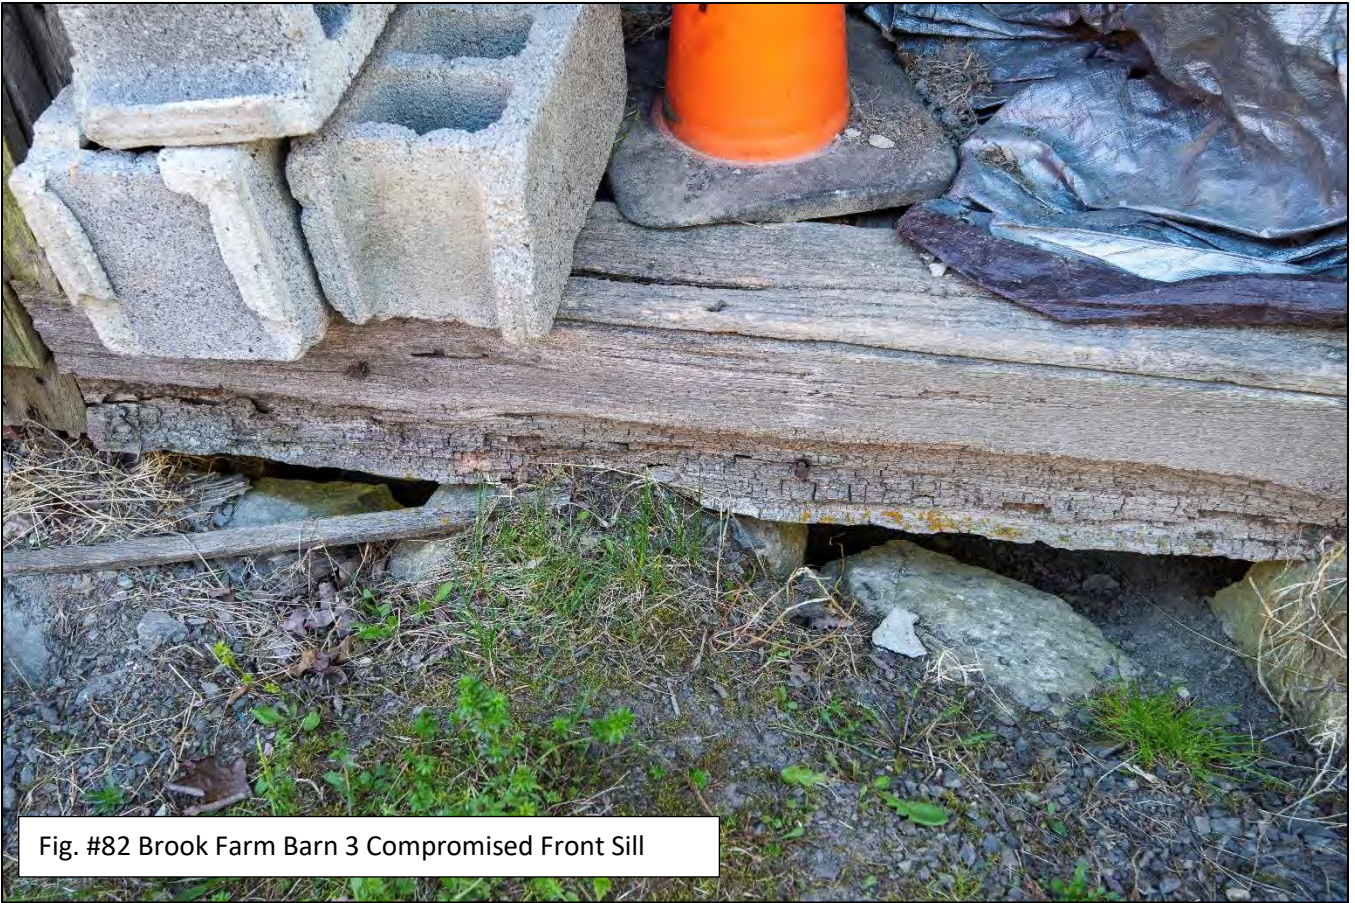
Fig. #82 Brook Farm Barn 3 Compromised Front Sill

Wooden sills are extremely deteriorated. On the barn yard level of the front of the building the sills on top of the retaining wall are significantly compromised causing settling of the front of the building (Figs. 82, 83). A tree pole added on top of the wall under the front of the building is rotted and broken (Fig. 84). Shiplap siding is heavily weathered especially at the base of the walls (Fig. 85).

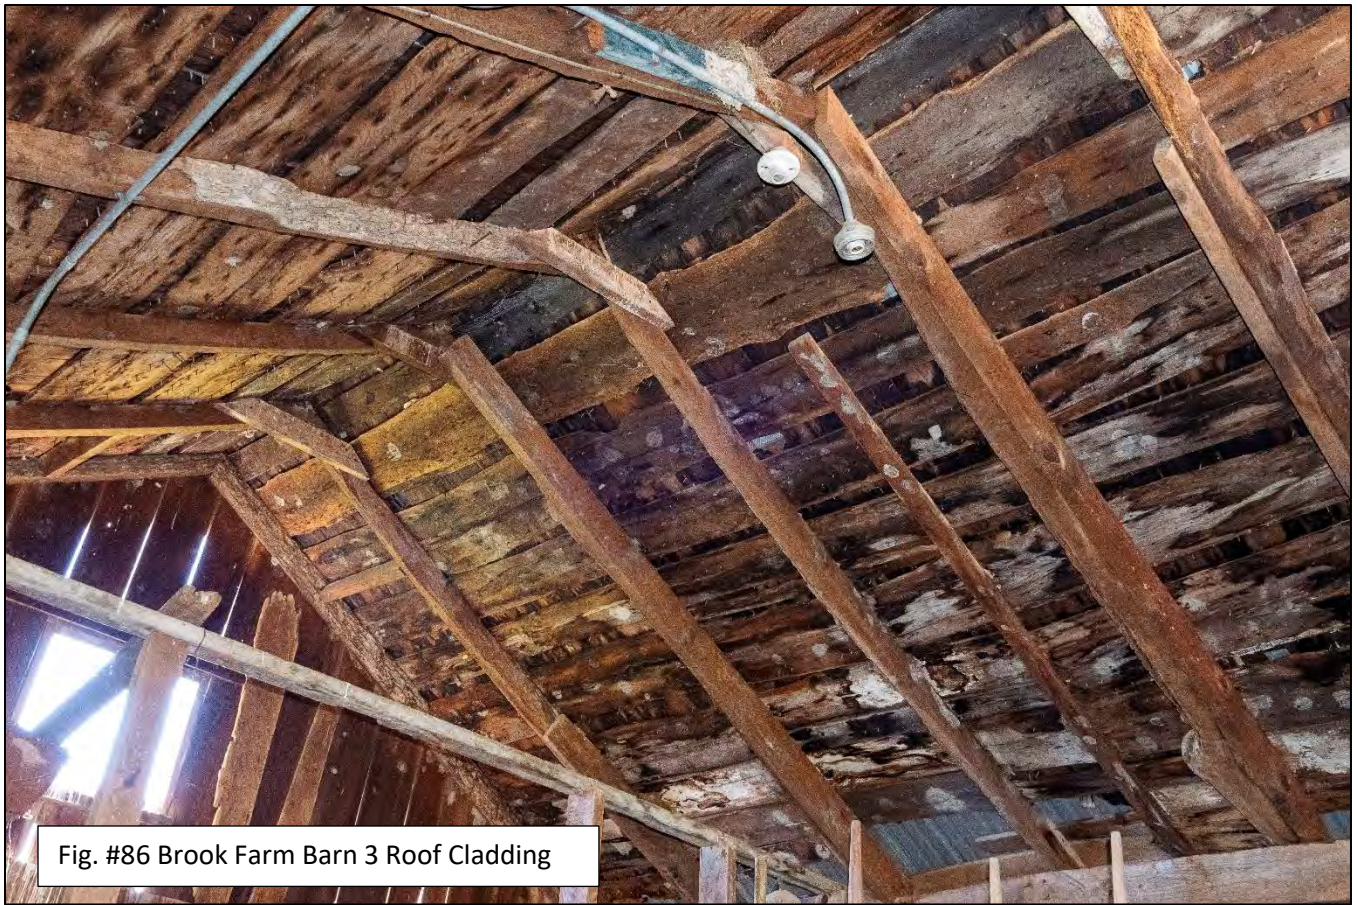
Fig. #86 Brook Farm Barn 3 Roof Cladding

The original roof was constructed of irregularly shaped and spaced broad board sheathing topped by visible cedar shakes (Fig. 86). At some time, asphalt shingles were added over the shakes. Some roof rafters were reinforced to support the roof load. The roof was not maintained and the building suffered heavy leakage, severely damaging the roof structure (Fig. 87). It was covered at an unknown time with corrugated metal roofing.

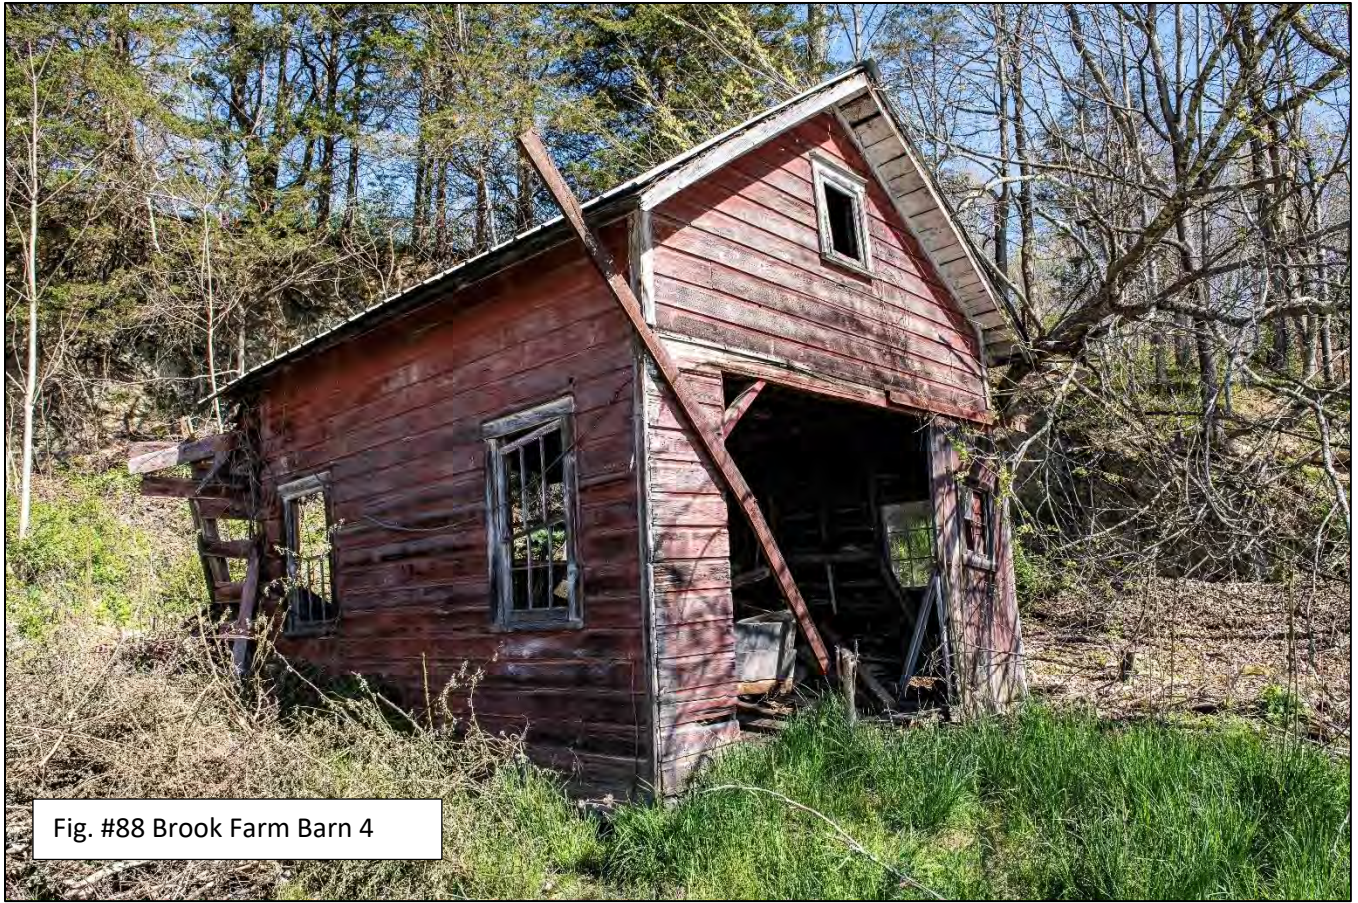
Fig. #88 Brook Farm Barn 4

BARN 4 (Figs. 88, 89)
