Existing Conditions Report

Brook Farm Barn Complex

Lenape Lane, New Platz, NY

June 2024

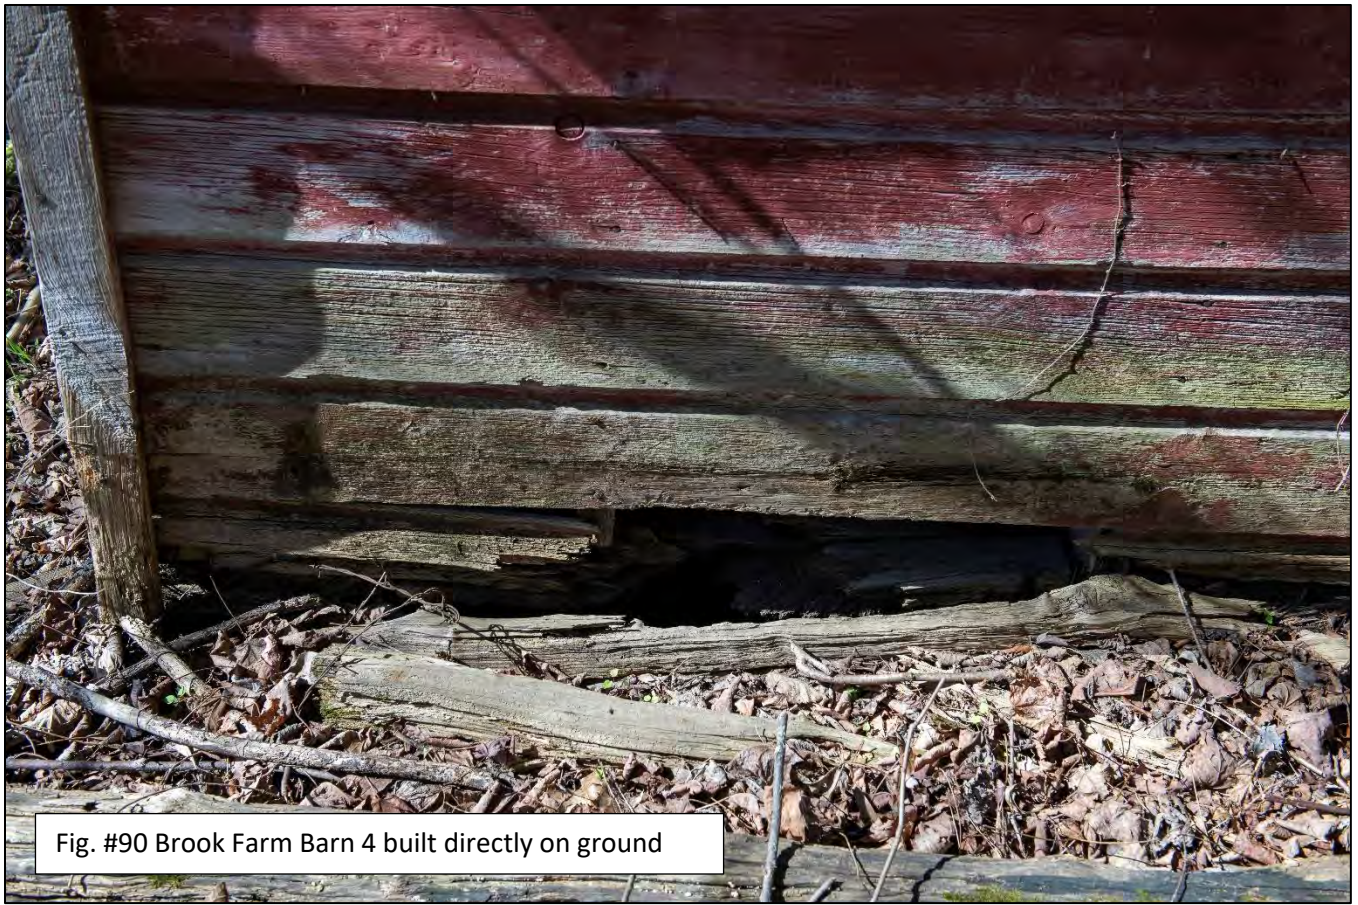
Fig. #90 Brook Farm Barn 4 built directly on ground

When constructed, it was framed with rough cut sawed lumber and built directly on the ground (Fig. 90). With no conventional foundation under the building, the wooden sills are seriously deteriorated and crumbling. The bottom of the wall uprights is also compromised leaving the barn settling into the ground and unsafe. A small wooden framed lean-to shed addition on the back of the building collapsed and its remains lay in a rotting mass (Fig. 91).

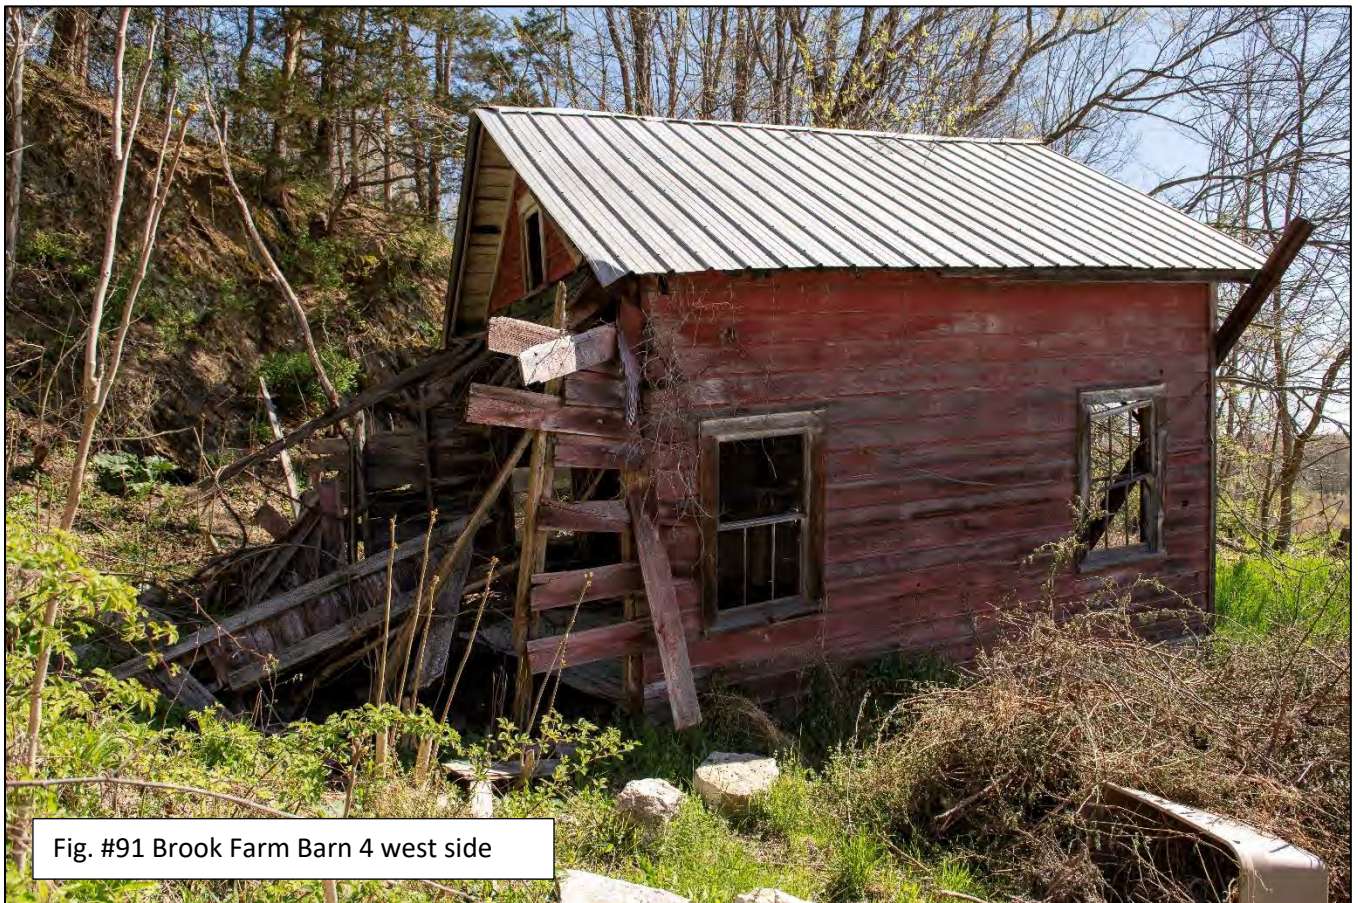
Fig. #91 Brook Farm Barn 4 west side

The roof sheathing of this barn is more accurately cut lumber and is less stained and deteriorated from leaking. Outside overhanging roof sheathing show holes and moderate deterioration. The roofing is corrugated metal over two layers of asphalt shingles (Fig. 91).

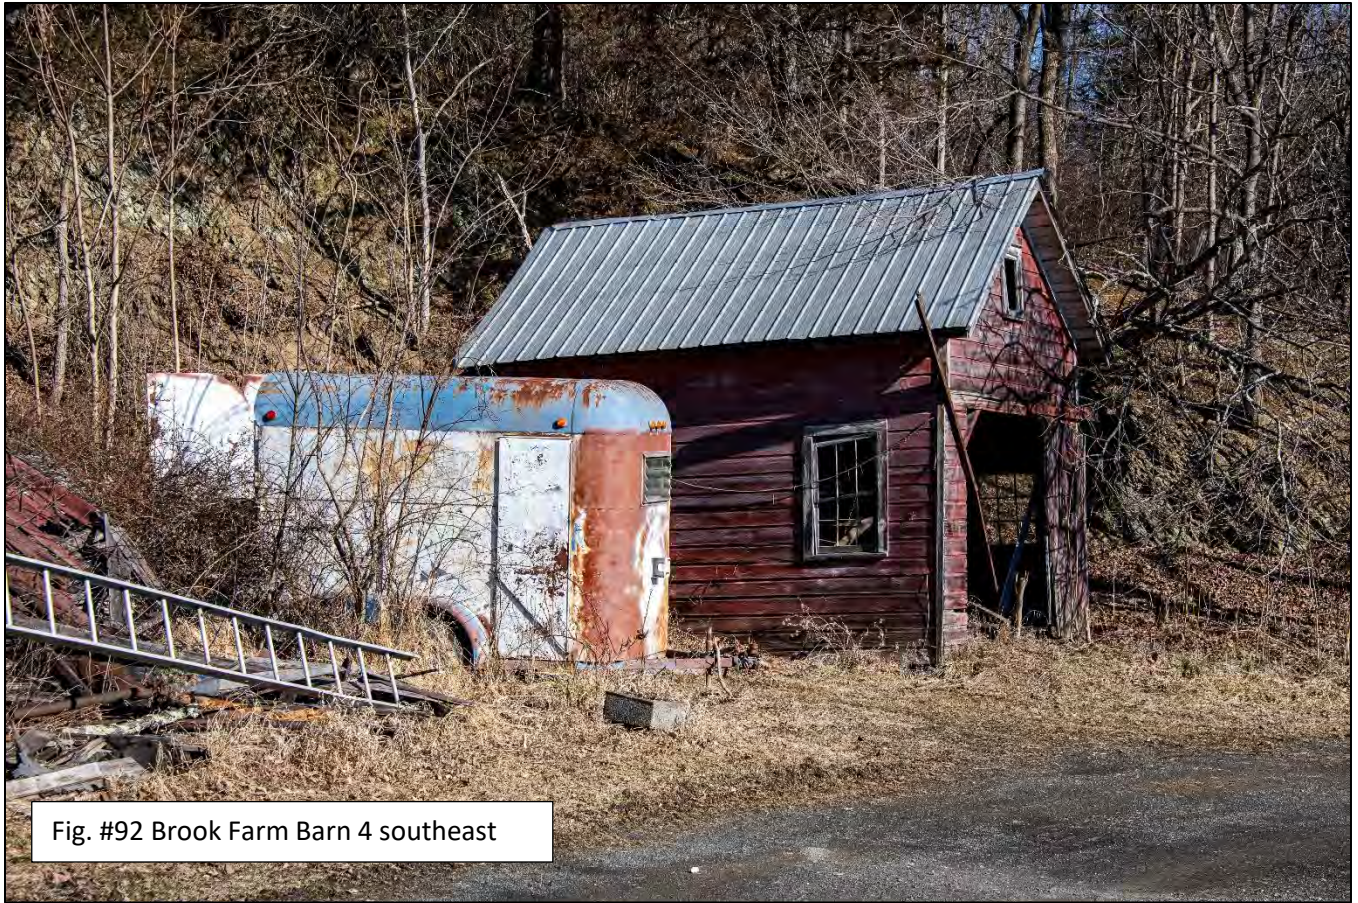
Fig. #92 Brook Farm Barn 4 southeast

The roof ridge faces east to west, with a gable window centered under the peak of the roof front and back (Fig. 92). Top rolling front doors could be opened outward both ways on a rail which extended beyond the sides of the building. There are two windows in the north and south walls (Figs. 93 & 94). Inside there is a partial loft floor supported on joists from the top of the walls on either side with six additional supports extending up to the roof rafters, the loft area filling about half of the interior space.
