Existing Conditions Report

Brook Farm House
Lenape Lane, New Paltz, NY

Carolyn M. Coppola
Coppola Preservation Consulting LLC
8 Haviland Street
Bluffton, SC 29910

July 19, 2023

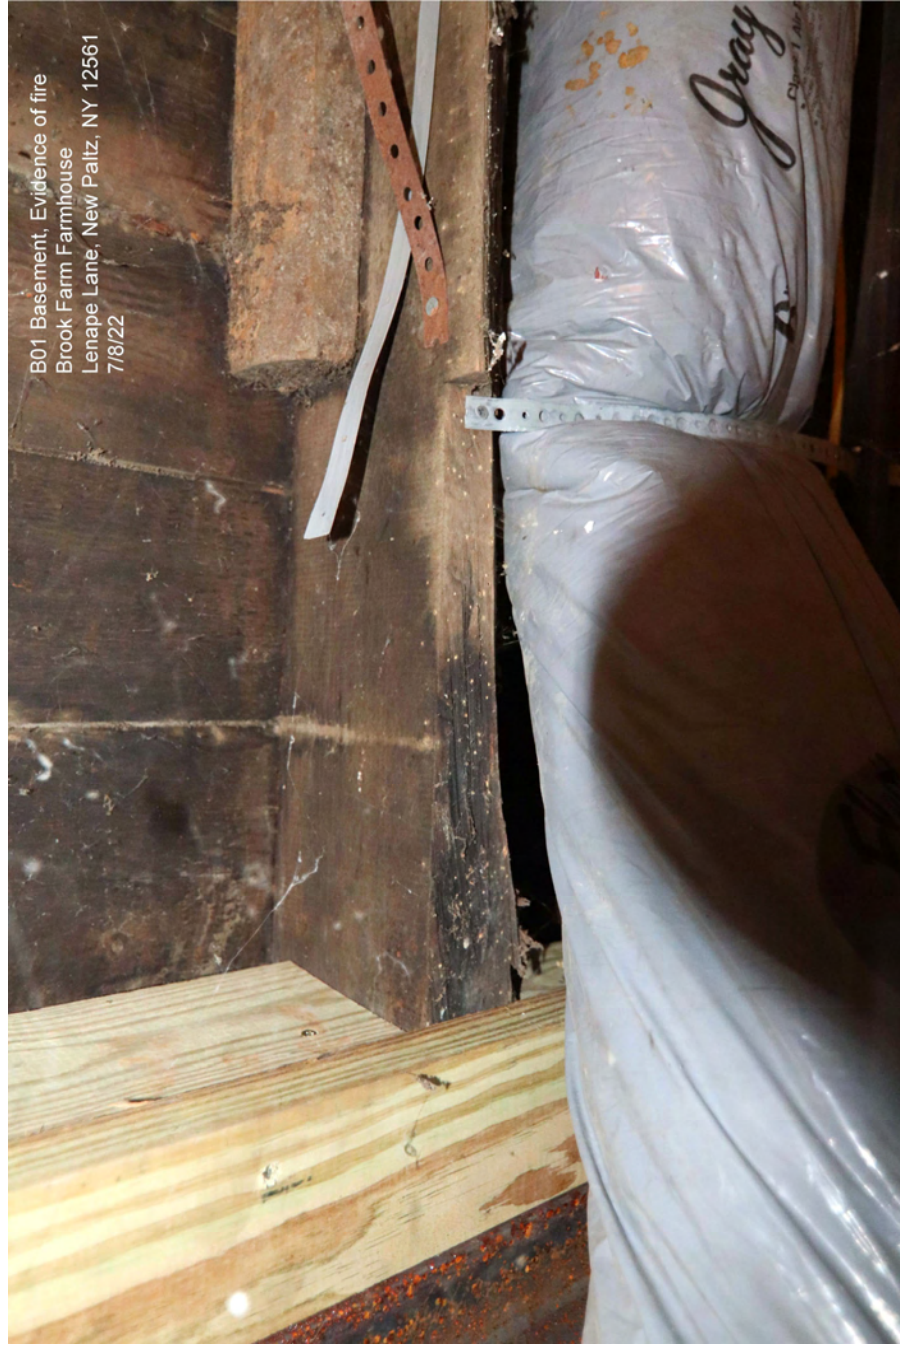
B01 Basement, Evidence of fire
Brook Farm Farmhouse
Lenape Lane, New Paltz, NY 12561
7/8/22

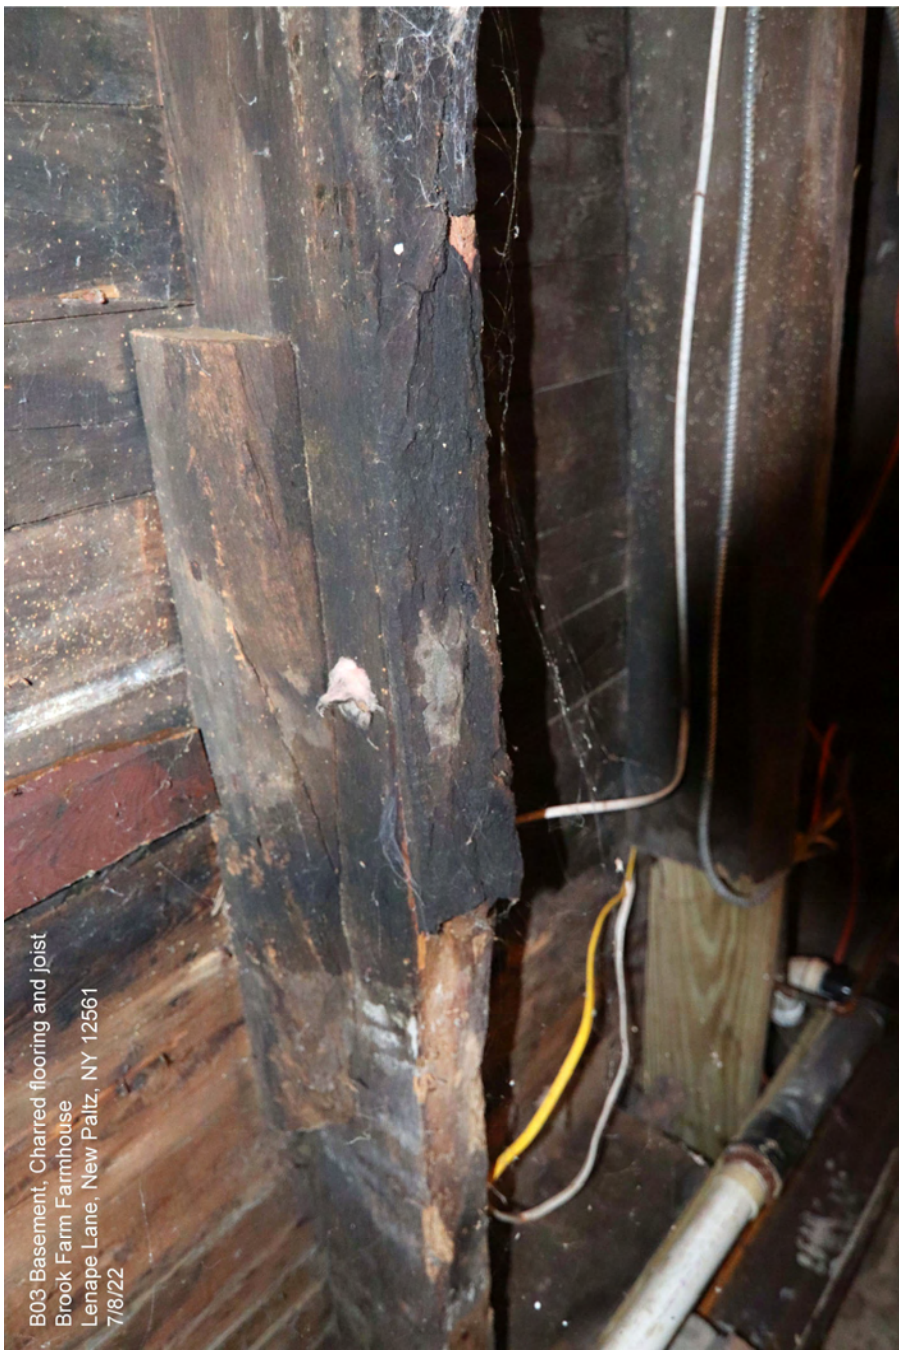
B03 Basement, Charred flooring and joist
Brook Farm Farmhouse
Lenape Lane, New Paltz, NY 12561
7/8/22

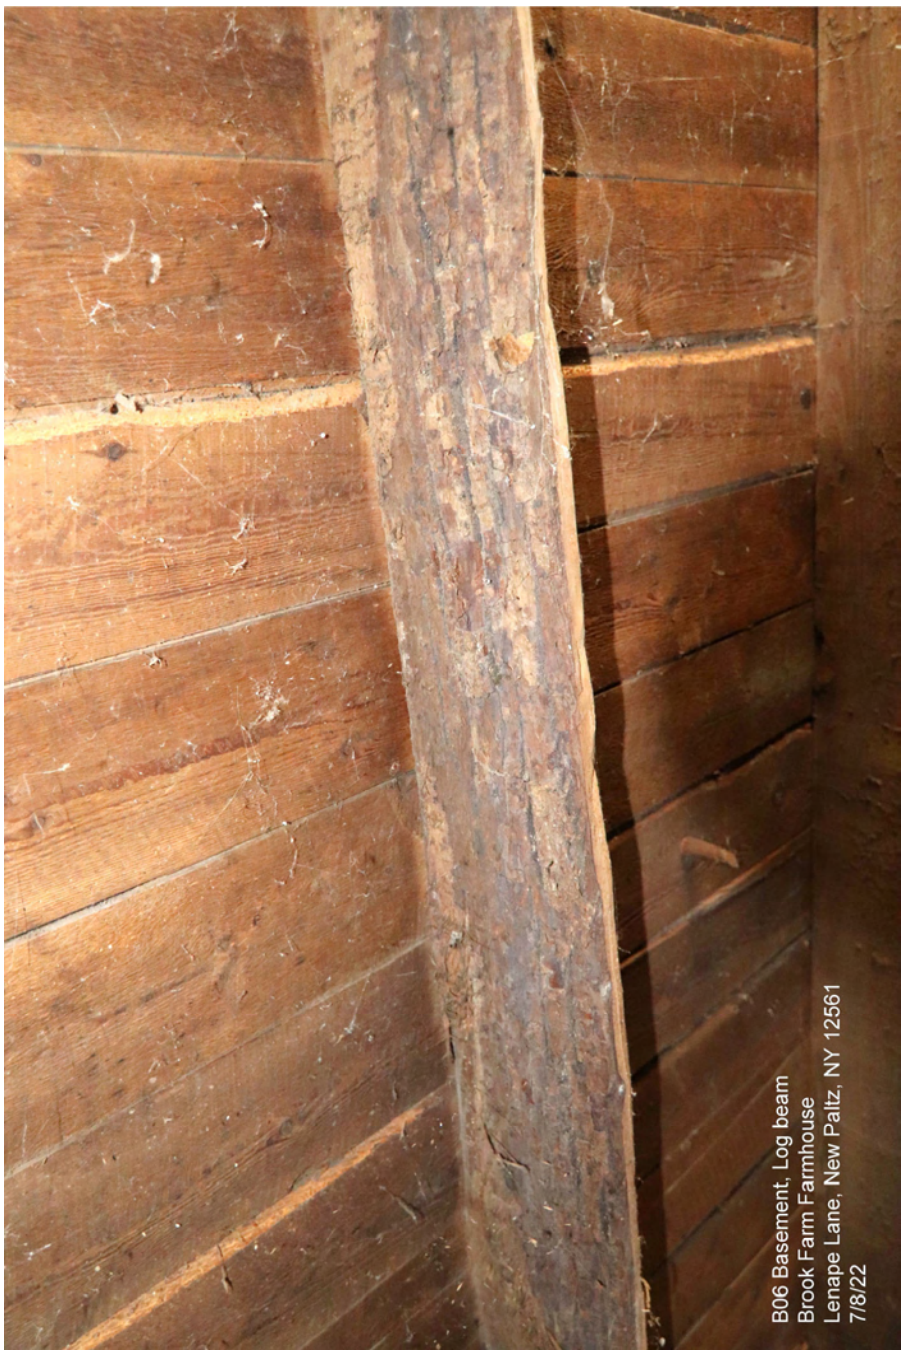
B06 Basement, Log beam
Brook Farm Farmhouse
Lenape Lane, New Paltz, NY 12561
7/8/22

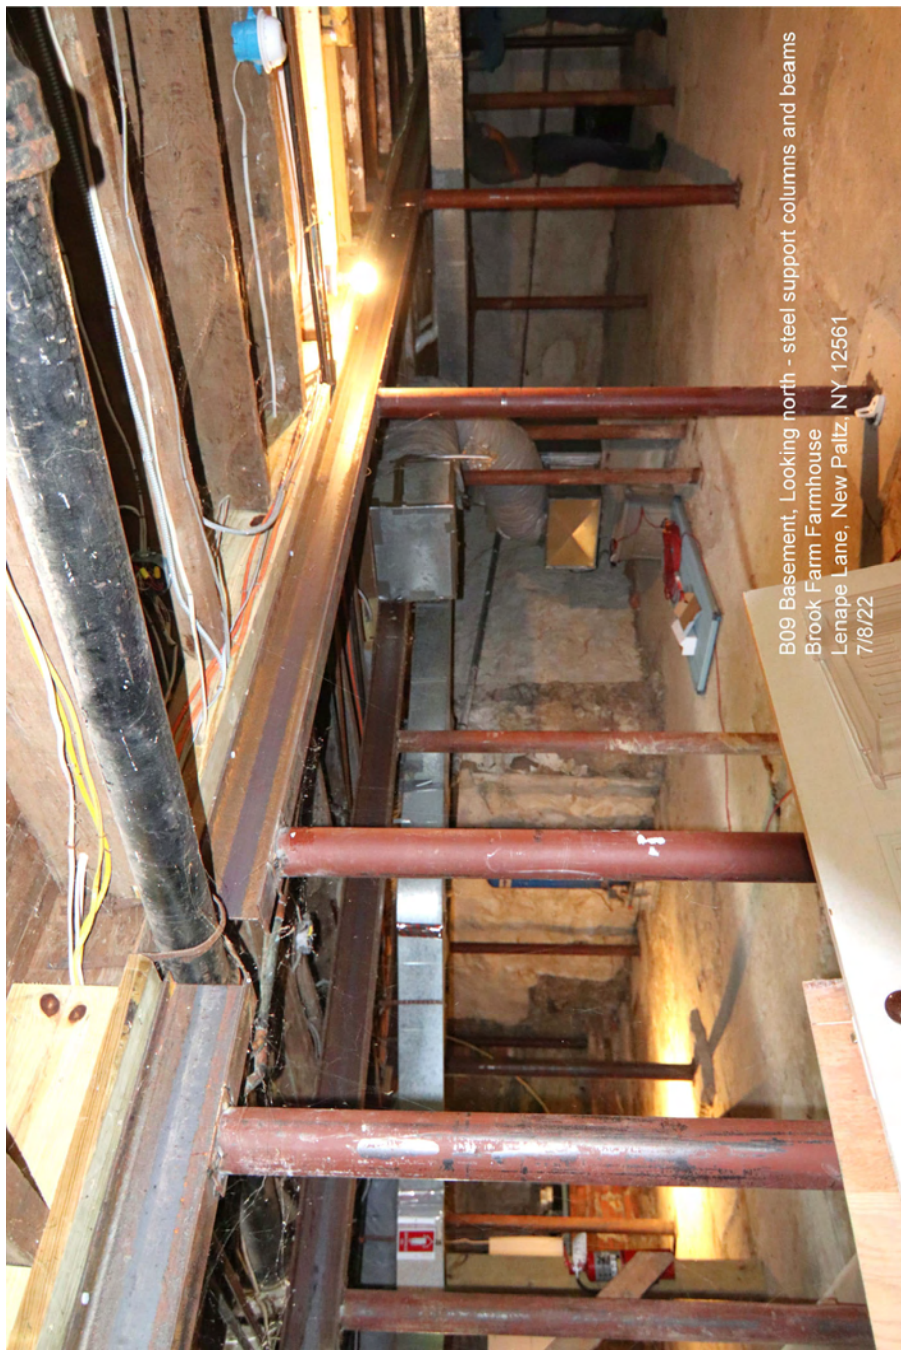
B09 Basement, Looking north - steel support columns and beams
Brook Farm Farmhouse
Lenape Lane, New Paltz, NY 12561
7/8/22

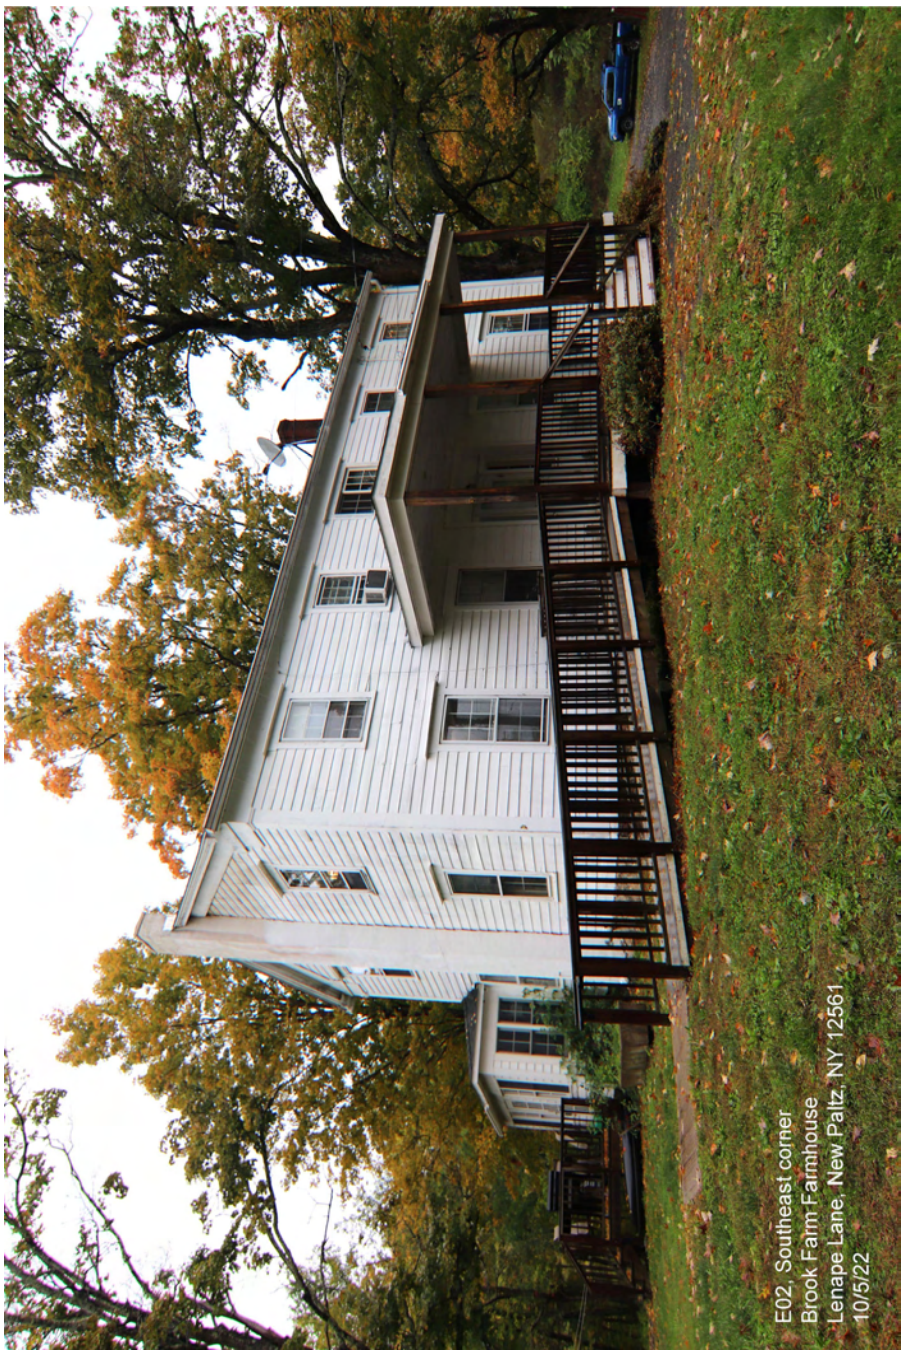
E02, Southeast corner
Brook Farm Farmhouse
Lenape Lane, New Paltz, NY 12561
10/5/22

Most of the house, including the front and main side areas are finished in historic wood clapboard (photos E01-E11). Shingle siding from a later, but undated period, is installed on the rear, kitchen extension and the area above it on the two-story, east-side addition. Both are in good condition. The original siding and construction of the 1865 section may be evident in the enclosed porch on the south side. Here, beaded tongue and groove siding is applied over brick (photo 121). This construction may have been a method of safeguarding against another fire, as two had occurred prior to 1865. The foundation for both sections is stone, with some variation of stone size and construction method evident in the kitchen extension (photos E10, E11, and other exterior photos).
