DUCK POND DAM FEASIBILITY STUDY

Mohonk Preserve

May 2022

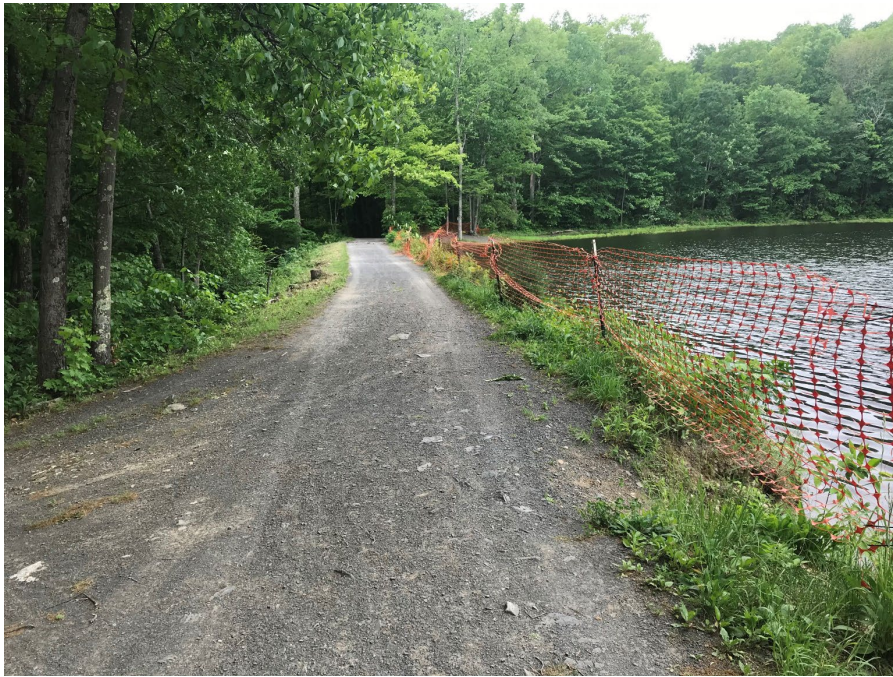
Figure 3-2 View along carriage road on crest of dam, looking south (photo by SLR)

along the eastern edge of pond for approximately 180 feet, ranging in height from 15 to 20 feet. The dam crest is approximately 13 feet wide and consists of the 10-foot-wide gravel carriage road centered on the earth embankment (Figure 3-2). The upstream (west) face of the dam slopes at 2:1 horizontal to vertical slope into the pond while the downstream (east) face slopes at 1:1 for approximately 5 feet before transitioning to a 5-foot vertical section consisting of larger stacked boulders. The lower embankment slope consists of a riprap face constructed at a 1.6:1 horizontal to vertical slope (Figure 3-3). Figure 3-4 is a sketch of a typical cross section of the dam.

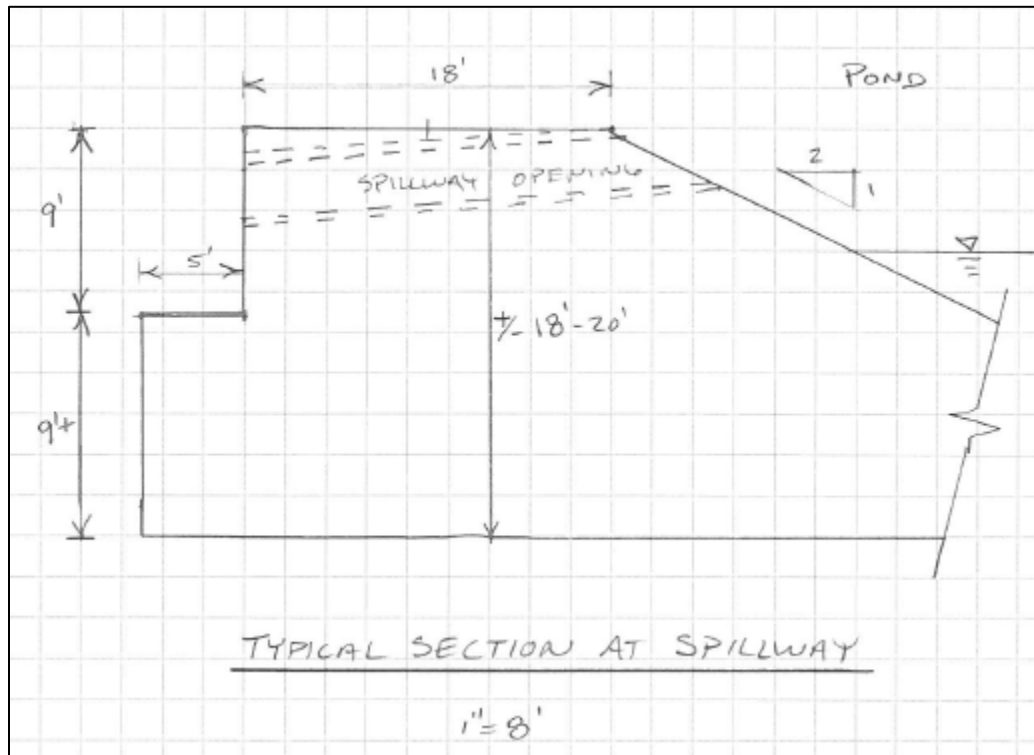
Figure 3-9 Engineer's sketch of spillway

The spillway is located at the southeastern corner of Duck Pond. The spillway consists of three rectangular concrete and stone masonry culverts that convey flow under the carriage road (Figure 3-7). Very little cover fill is present on the top slab. The three culverts are approximately 2.5 feet high and range in width from 2.65 feet to 2.95 feet. The culverts slope at 8.5 percent from upstream to downstream. It is unknown if this slope has increased due to a drop or settlement at the outlet side of the spillway. The top concrete slab that carries the carriage road across the spillway was presumably level when constructed but is now visibly inclined in the downstream direction. Downstream of the spillway the earth embankment consists of two sections of vertical stepped dry-laid stone masonry below the spillway discharge. Water flowing through the spillway drops straight down almost 15 feet to toe of dam (Figure 3-8). The spillway culverts' openings occasionally become clogged with debris, sometimes placed there by beaver. Figure 3-9 is a sketch of the spillway.

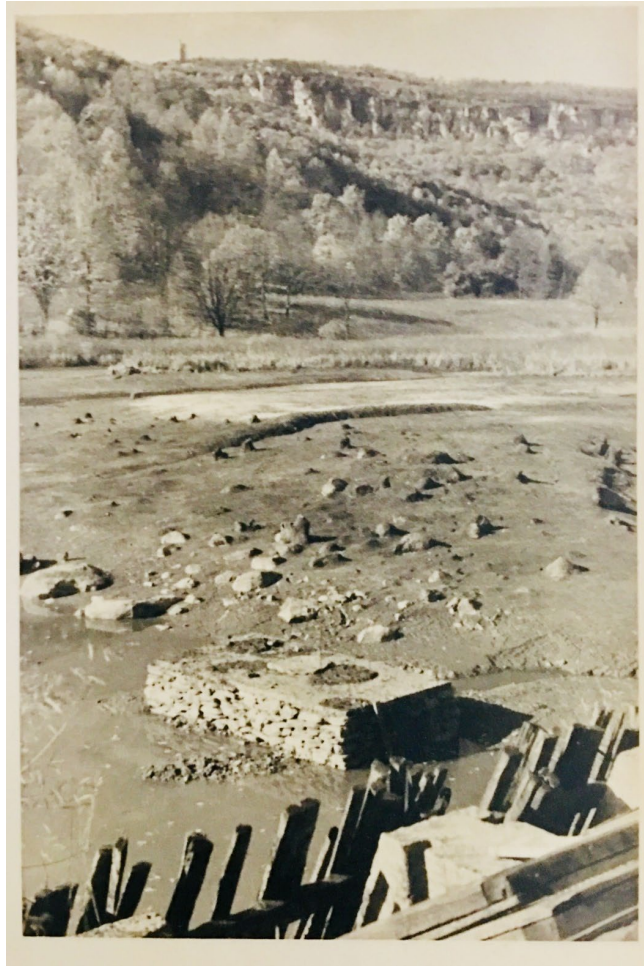
Figure 3-12 Low-level inlet structure (Mohonk archives, November 1932)

The low-level outlet works are visible in a chamber on the downstream face of the embankment (Figure 3-10 and Figure 3-11). The valves are inoperable, and the outlet pipes are live with water within the earth embankment. The inlet structure is below the surface of Duck Pond and is not visible but can be seen in a historic photo (Figure 3-12).

- Install new operational gate valve and outlet pipe integrated with the drop inlet spillway.

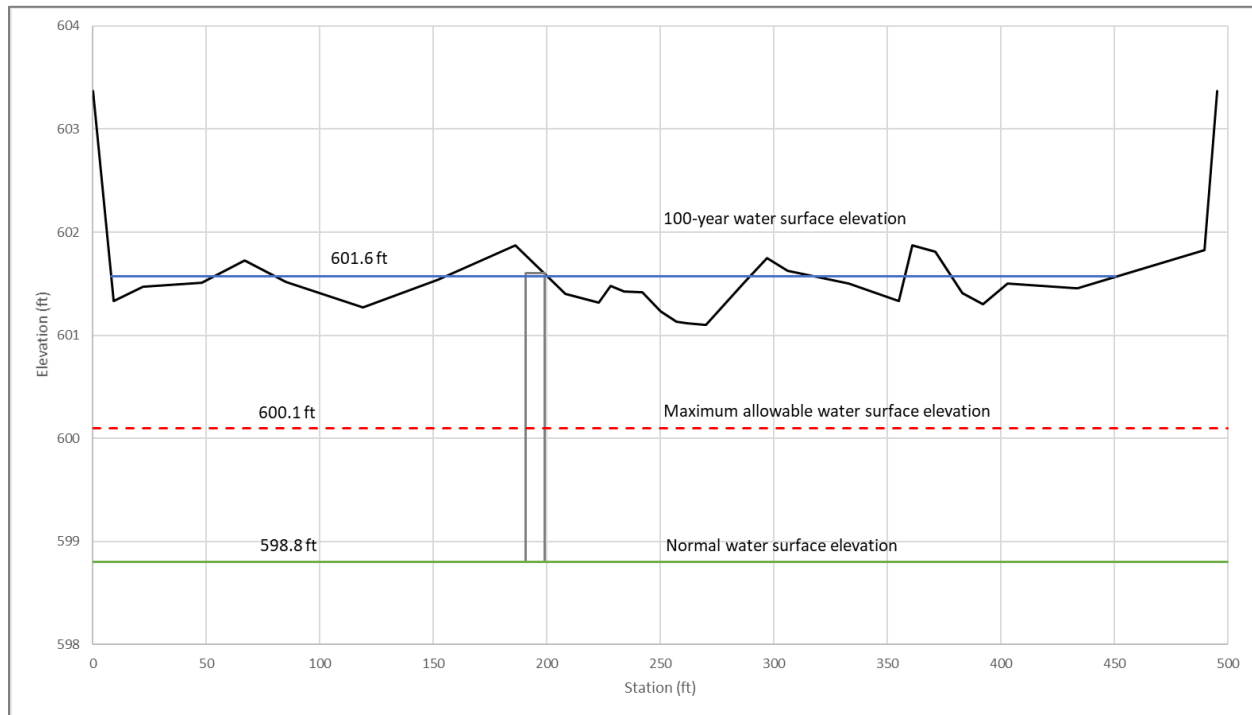
Figure 3-14 Hydraulic modeling results at Duck Pond Dam spillway

dam crest and the closure dike limit the maximum water surface elevation within the pond to 601.1 feet. Based on the modeling results, the existing spillway has the hydraulic capacity to pass the 10-year storm event, but all larger storm events exceed the capacity causing the dam to be topped. Duck Pond Dam does not have sufficient spillway capacity to pass the 100-year flood with at least 1 foot of freeboard, as is required by NYSDEC regulations. Under current conditions, the pond water surface elevations exceed the minimum freeboard requirement during all simulated storm events.

- Spillway inadequately sized to pass spillway design flood; hydraulic modeling indicates that the dam is overtopped during the 100-year flood event.
- Concrete and stone masonry has large cracks, spalling, and deterioration of mortar.
- Spillway slipped or tilted in downstream direction.
- Large transverse cracks present within spillway conduits.
- Erosion at toe due to the spillway flows dropping 15 feet vertically as it discharges through the dam.

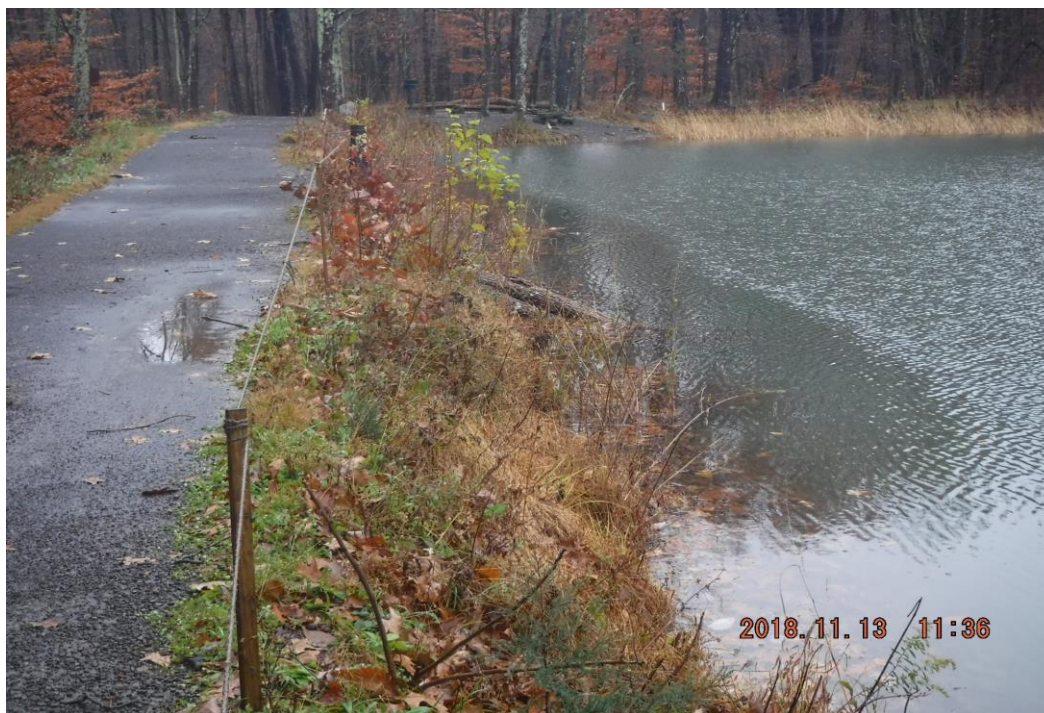
Photo 1 Dam ID# 193-5962 Duck Pond Dam 11/13/2018
Upstream slope
View looking right from left end of dam

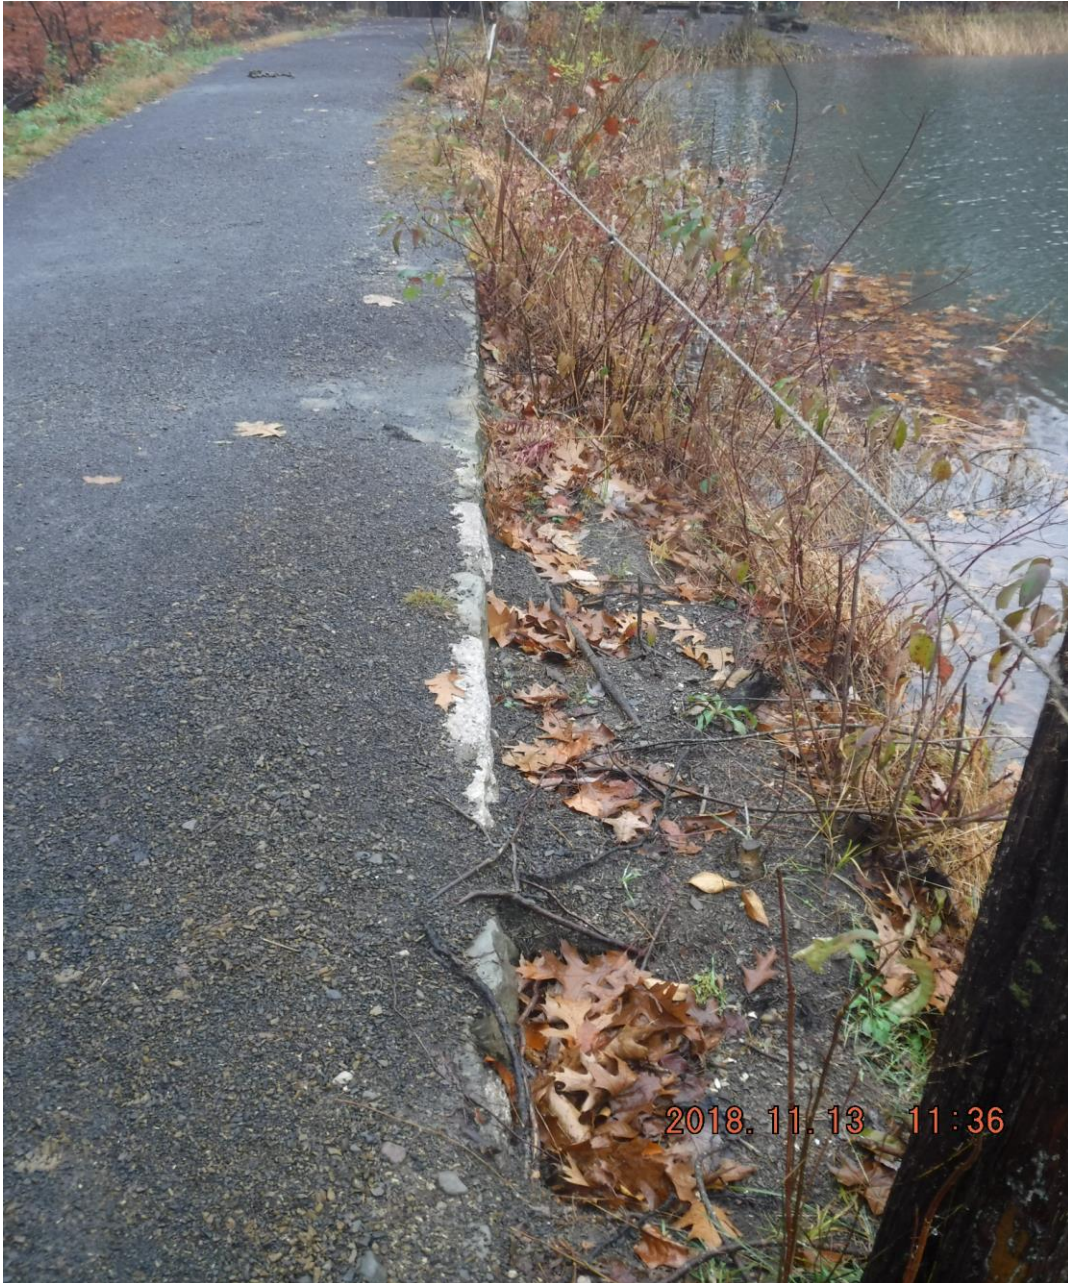
Photo 2 Dam ID# 193-5962 Duck Pond Dam 11/13/2018
Upstream crest/slope interface
View looking right

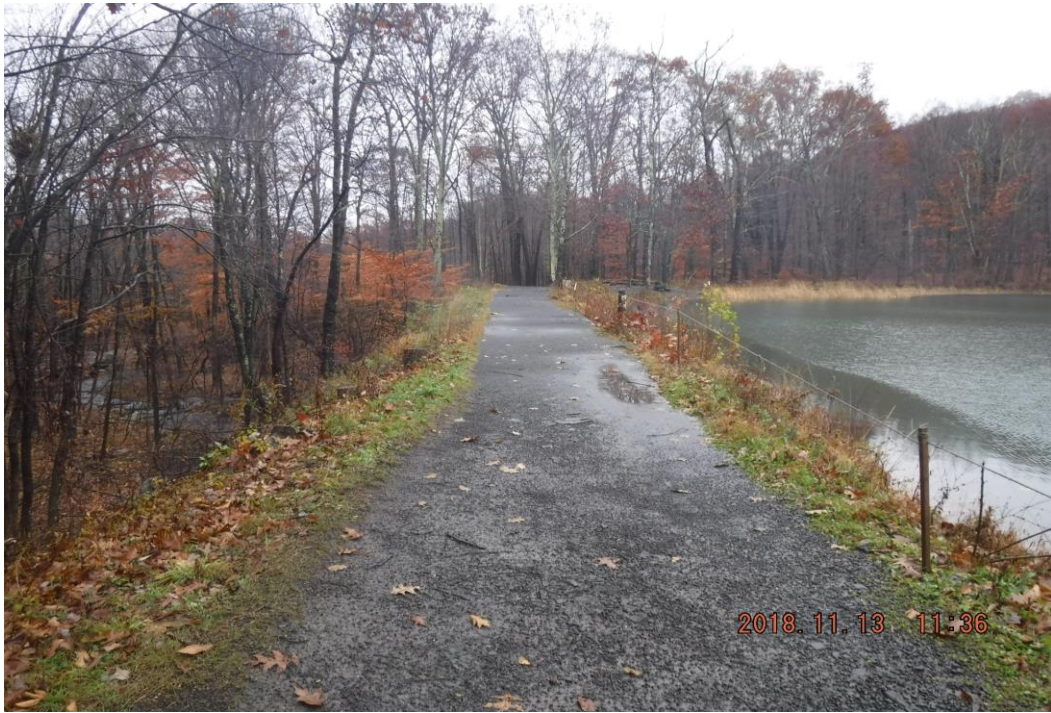
Photo 3 Dam ID# 193-5962 Duck Pond Dam 11/13/2018
Dam crest
View looking right from left end of dam

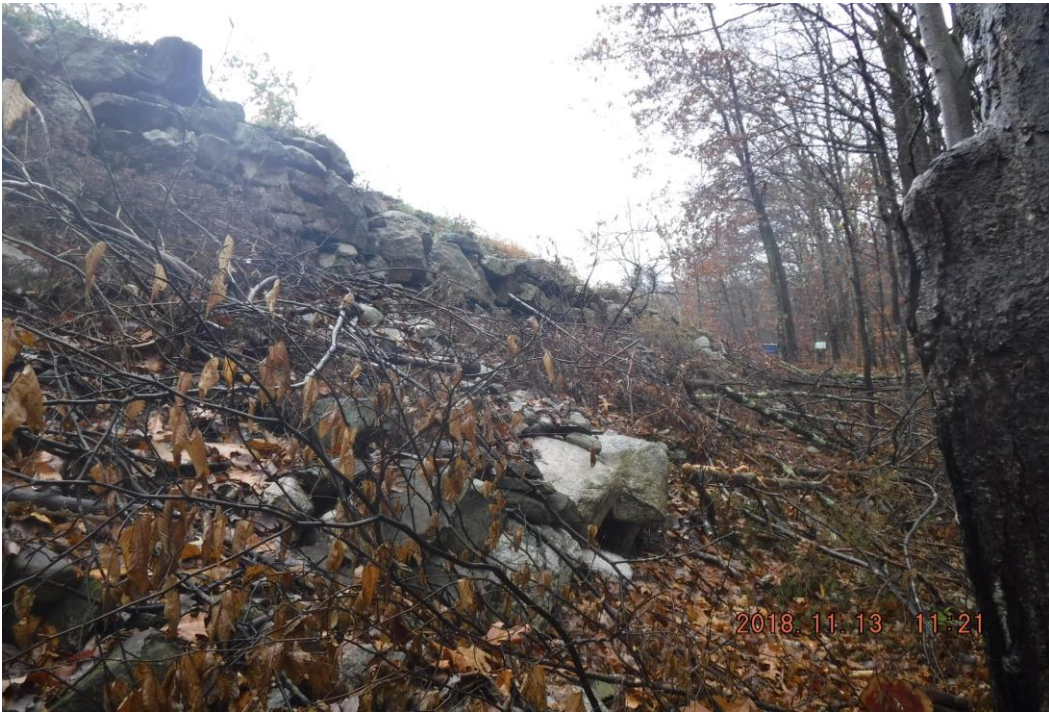
Photo 5 Dam ID# 193-5962 Duck Pond Dam 11/13/2018
Left downstream slope
View looking left from spillway toe

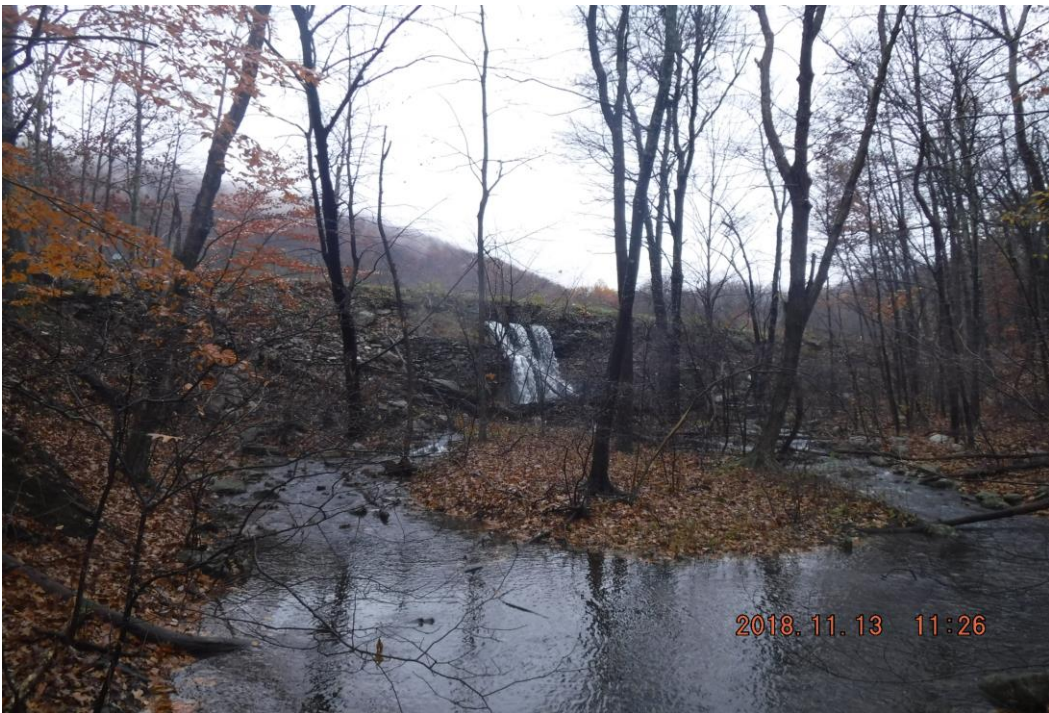
- Low level drains are comprised of two (2) 8-inch pipes.
- The two valves are located on the downstream side of the dam. Reported one valve is seized (frozen) shut, the other valve end is broken off and open. Reported that open outlet pipe flows, becomes clogged then will "let go", flowing full draining the impoundment.
- The low level outlet located at the downstream toe to the left of the service spillway.

Photo 6 Dam ID# 193-5962 Duck Pond Dam 11/13/2018
Downstream outlet channel and spillway face
View looking upstream
